Descent below minimum permitted altitude involving Boeing 747, N409MC

11 km E of Melbourne Airport, Victoria | 9 September 2012

ATSB Transport Safety Report
Aviation Occurrence Investigation
AO-2012-120
Final – 1 September 2015

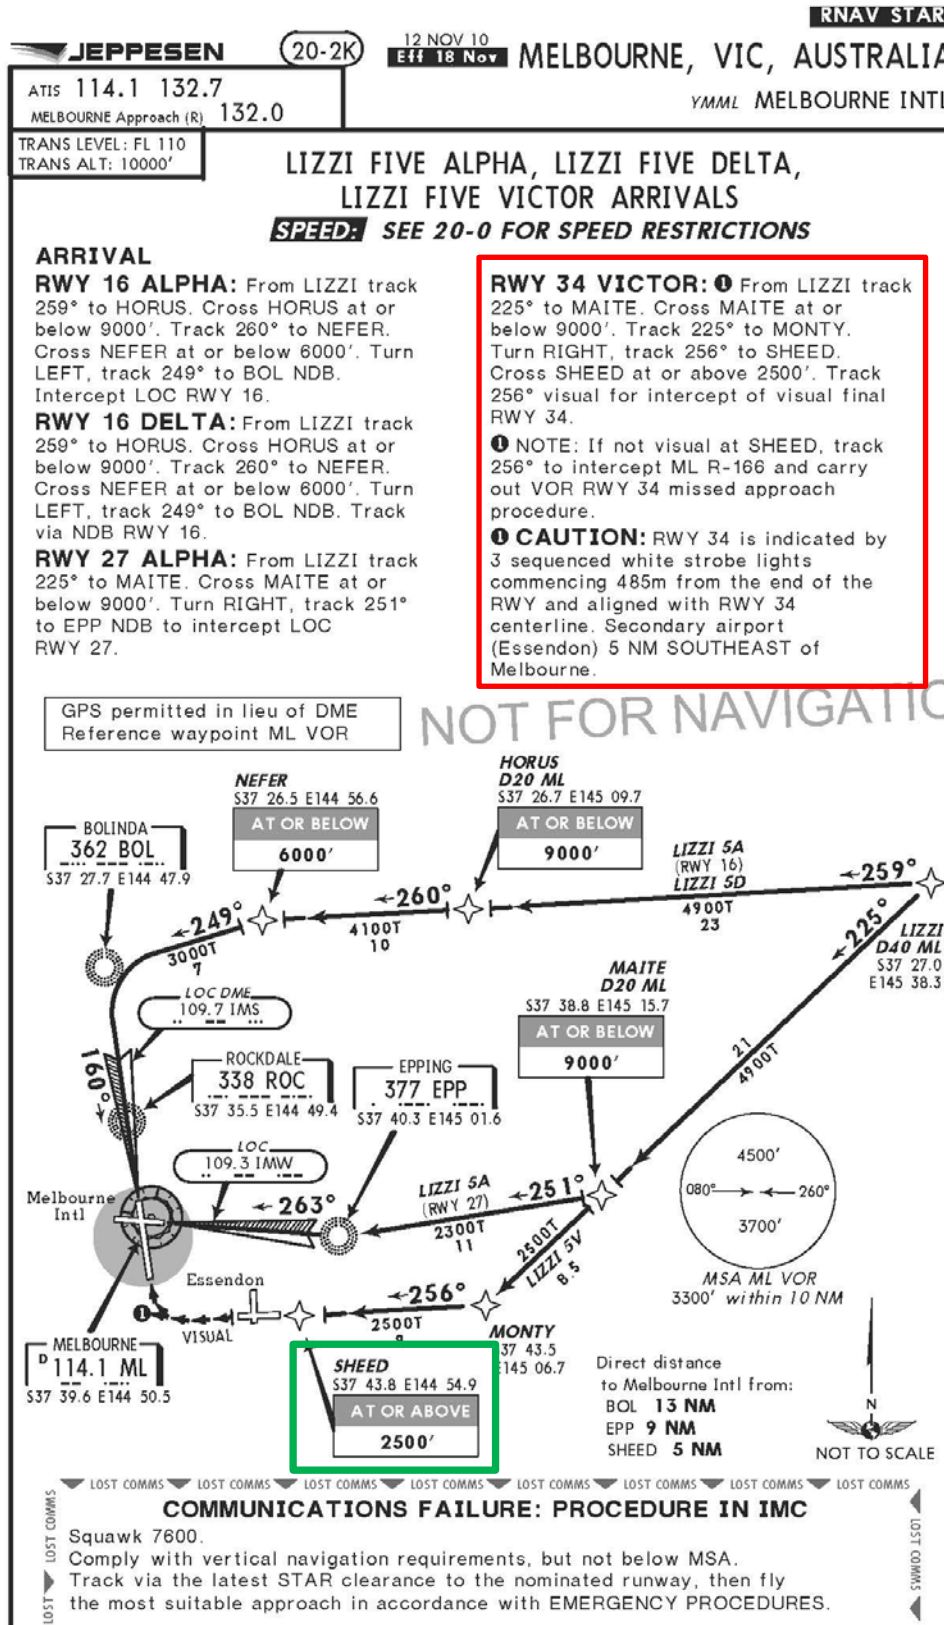
Figure 2: LIZZI FIVE ALPHA, DELTA AND VICTOR STAR ARRIVALs chart (RWY 34 VICTOR, which incorporates the SHEED waypoint, highlighted in red and the position of waypoint SHEED highlighted in green)

The LIZZI FIVE VICTOR STAR had a minimum altitude restriction that required aircraft to cross the SHEED waypoint at or above 2,500 ft (Figure 2). The STAR procedure stated that if the flight crew had not obtained visual reference at SHEED, they were to initiate a missed approach procedure (Figure 2).

The design of the LIZZI FIVE RWY 34 VICTOR ARRIVAL necessitated a descent profile of 3.5° for the visual approach from SHEED to the runway 34 threshold. A review of exceedances at SHEED by other operators highlighted that this increased angle resulted in higher descent rates, often in excess of 1,000 ft/min. This is the recommended maximum rate of descent for a stabilised approach. A higher descent rate increases the likelihood of an unstable approach during the descent from overhead the SHEED waypoint.

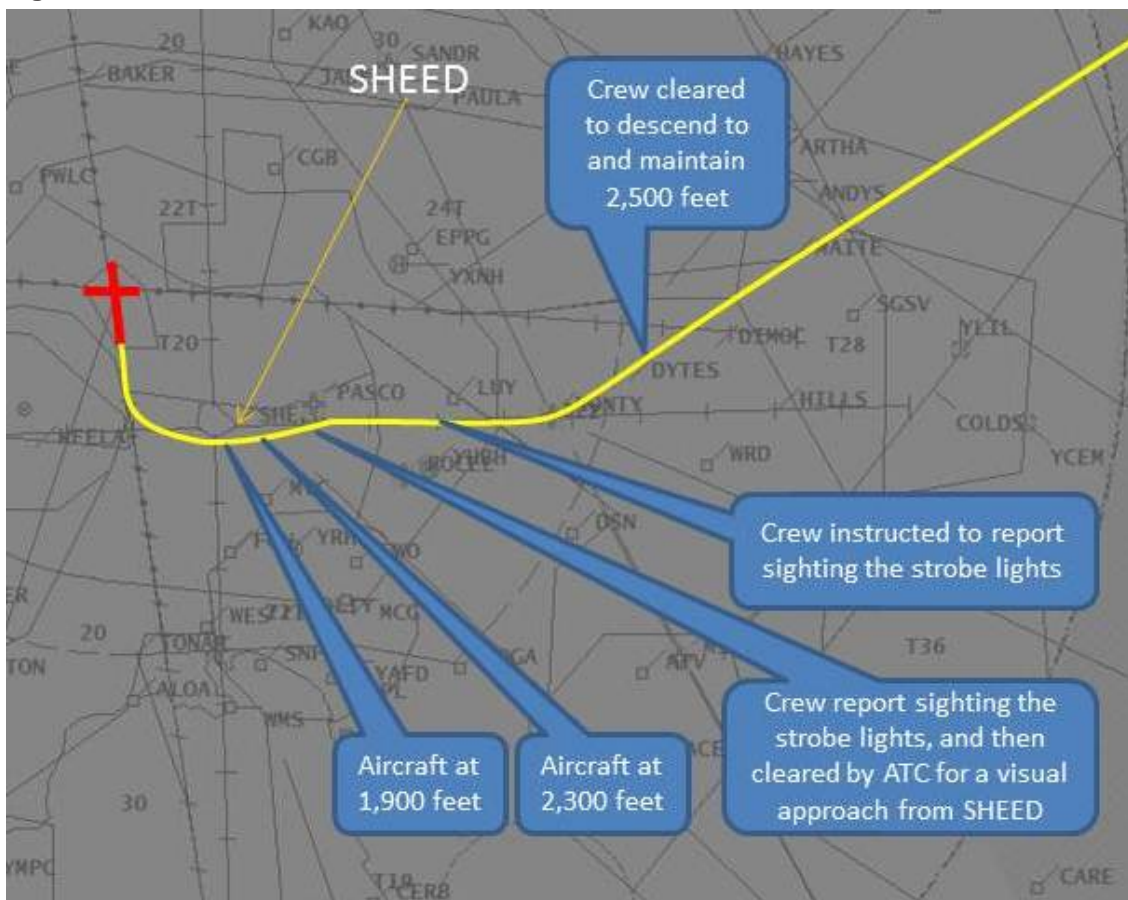
Figure 3: Aircraft radar track.

procedure. Recorded radar data showed the aircraft deviating left of track from about 3 NM (5.5 km) before SHEED, which the flight crew reported was to provide ‘more room’ for descent during the visual segment of the STAR.

At about 1749 the aircraft descended below 2,500 ft when still about 1.6 km before SHEED and was descending through 1,900 ft when passing abeam SHEED. The aircraft’s maximum deviation to the left of the arrival track was about 500 m. The pilot of a helicopter operating at 1,500 ft in the Essendon control zone saw the B747, thought it was lower than expected and descended the helicopter to 1,000 ft to ensure adequate separation.
