# Incident involving Absolute Signal Blocking

Warnervale, New South Wales | 24 November 2014

**ATSB Transport Safety Report**  
Rail Occurrence Investigation  
RO-2014-021  
Final – 17 September 2015

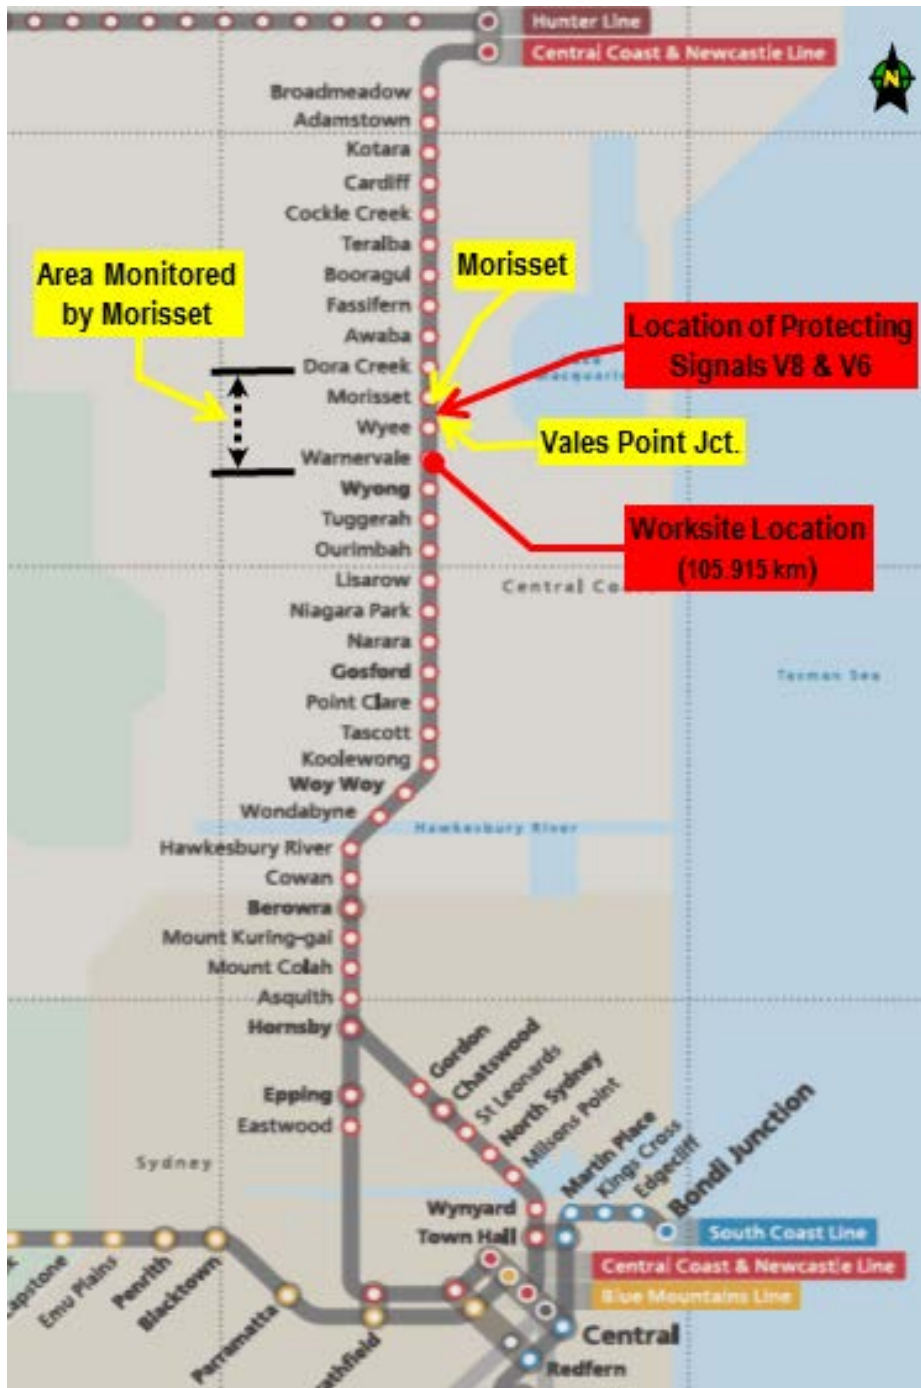
**Figure 1: Incident location**

At 1155, as testing was continuing, a ‘Signal Passed at Danger’ (SPAD) alarm for Signal 66.8 activated in both Morisset and Wyong Signal Boxes. The alarm at Wyong was also accompanied by a report from the driver of 4190 advising that he had passed Signal 66.8 by approximately 500 metres after it had returned to stop in front of the train.

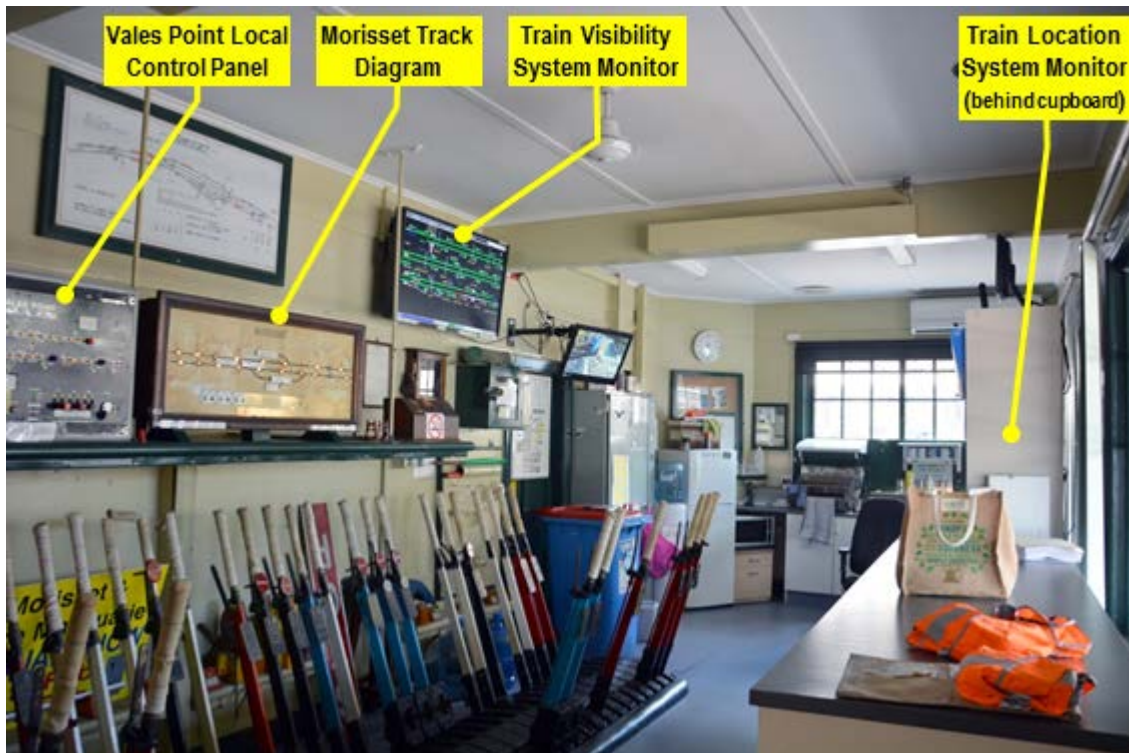
**Figure 3: Morisset Signal Box**

In accordance with current security requirements, all persons entering the station, other than members of the public entering or using public areas, are required to undergo a local safety induction. The induction is a mandatory briefing for all station visitors to make them aware of key safety related issues and requirements. This was not done for the NSW Police officers and their presence in the signal box was not managed during the time safety critical information was being exchanged.

- Consider the deployment of Network Operations personnel to oversee the implementation of any required worksite protection controlled by Morisset.
- Review the current ergonomics of the signal box and station facilities to minimise the potential for distraction of the signaller, from a Human Factors perspective.
- Consider the possibility of relocating the signalling operations currently carried out at Morisset to a dedicated signal complex.
- Consider the possibilities of providing a program of maintenance activities to Network Operations to facilitate the deployment of Network Operations personnel to oversee the implementation of any required worksite protection controlled by Morisset.

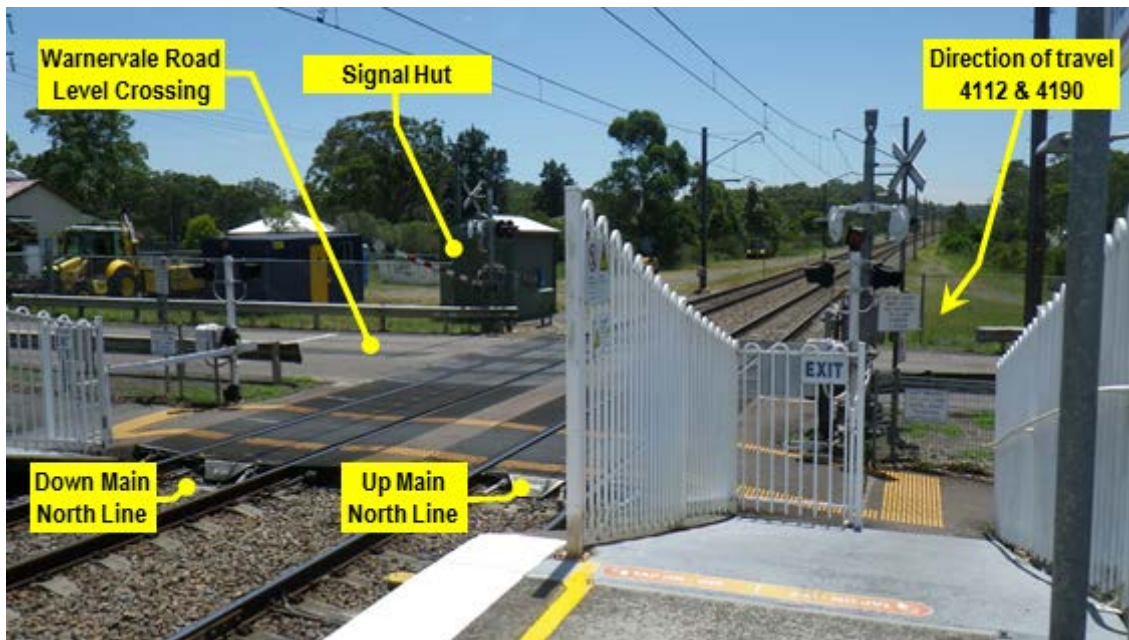
**Figure 4: Worksite at Warnervale**

Although a Train Controller checklist was compiled at the ASB request, it was only a single checklist but intended for multiple worksites. Further, the PO did not deploy any lookouts. As such, both these situations contravened the memorandum requirements.

While not deployed, the effectiveness of any lookouts in this incident would have been diminished by the following:
