Derailment of train 3WB3

Nambucca Heads, New South Wales | 14 May 2014

ATSB Transport Safety Report
Rail Occurrence Investigation
RO-2014-007
Final – 23 September 2015

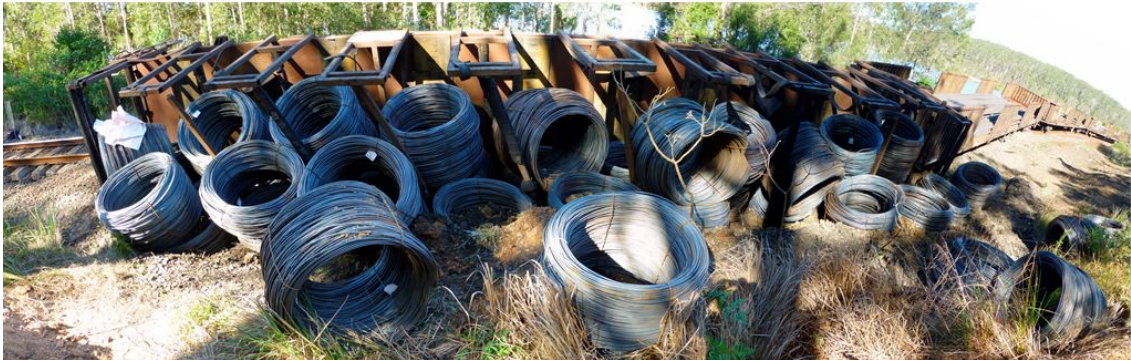
Figure 1: Derailed wagon RCOF20375S

The train continued to travel with the derailed wagon for 1,397 m, passing over two bridges and reached a speed of 44 km/h before wagon RCOF20375S tipped on its side (Figure 1). The train then parted between the fourth and fifth last wagons. As the wagons parted, the train brake pipe separated, allowing air to vent to atmosphere and the train brakes to apply, bringing the train to a stop in about 320 m.

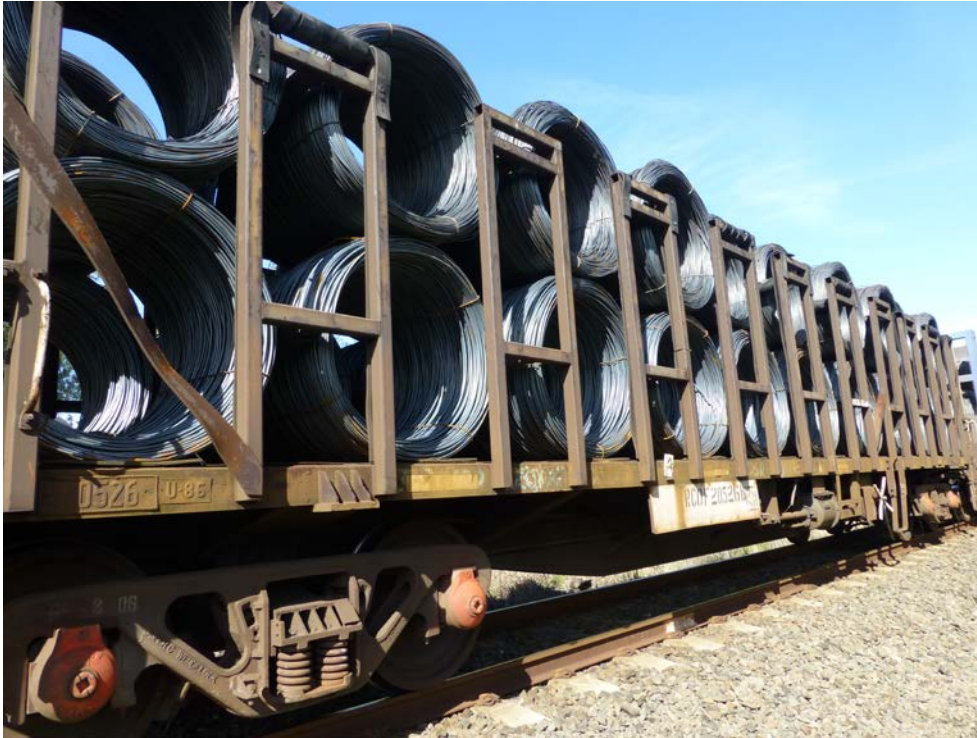
Figure 2: Loaded wagon RCOF20526B on train 3WB3 carrying rod-in-coil product

On-site inspection and preliminary examination of the derailed wagons found no indication of any serious anomalies in rolling stock condition. However, evidence of load shifting was observed in wagons not affected by the derailment, but carrying the same rod-in-coil product.

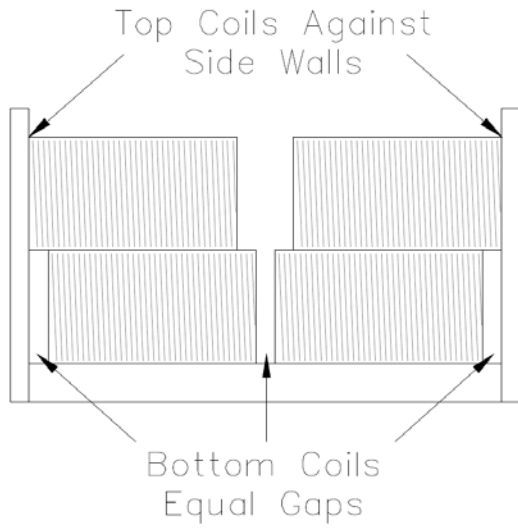
Figure 3: Loading requirements for rod-in-coil product on RCOF wagons

- a) Where possible, the top and bottom layer MUST cover the full width of the wagon's frame to ensure the load cannot collapse.
- b) Where the load does not cover the full width, the bundles are to be loaded as follows:
 - i. The bottom two bundles must be placed so that all gaps are consistent.
 - ii. The top two bundles are to be placed against the side walls of the cage.
- c) If the bottom bundles are too wide to allow all three gaps, place bundles against side walls of frames/stanchions.
- d) Coil bundles placed on the on bottom tier MUST be of sufficient strength to ensure coil collapse will not occur in transit.

Figure 3 illustrates the requirements specified above and has been reproduced from Pacific National's freight loading manual.

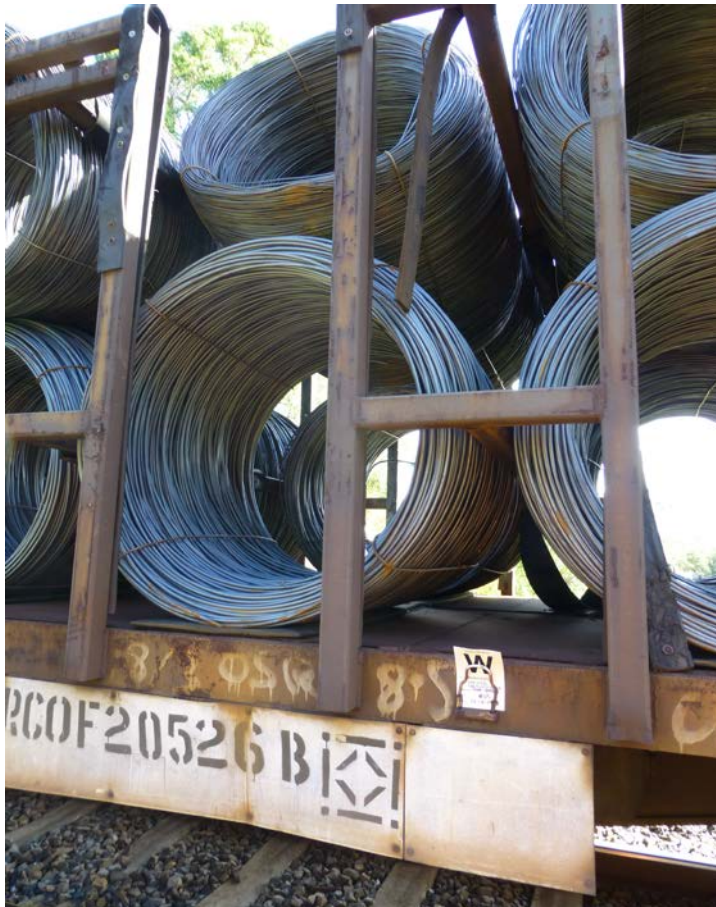
Figure 4: Loaded wagon RCOF20526B with shifted coils

On site observations indicated that rod-in-coil product on both RCOF and RQRY wagons exhibited inconsistent gaps on the lower level, with the upper level having collapsed towards the centre of the wagon (Figure 4).

It was also evident that the rod-in-coil product loaded on train 3WB3 (and most likely on wagon RCOF20375S) had collapsed (in most cases) to the left in the direction of travel. It could not be ascertained whether the load in wagon RCOF20375S had shifted prior to arriving at Nambucca Heads, or if it had dynamically shifted when passing through the curve. Regardless of when the load moved however, the effect of a load shift to the left would also transfer vertical forces from the wagon's right side-bearer to the left side-bearer, compounding the unloading of the right-hand wheels. A dynamic shift would also result in a lateral shock load, which could have added undesirable wagon dynamics and additional wheel unloading effects.

Following the incident, Pacific National reviewed the manual and published an update (FLM 05-13_08) dated 15 August 2014. The update added some detail as to how rod-in-coil must be loaded, but the requirements largely remained the same as the superseded version.

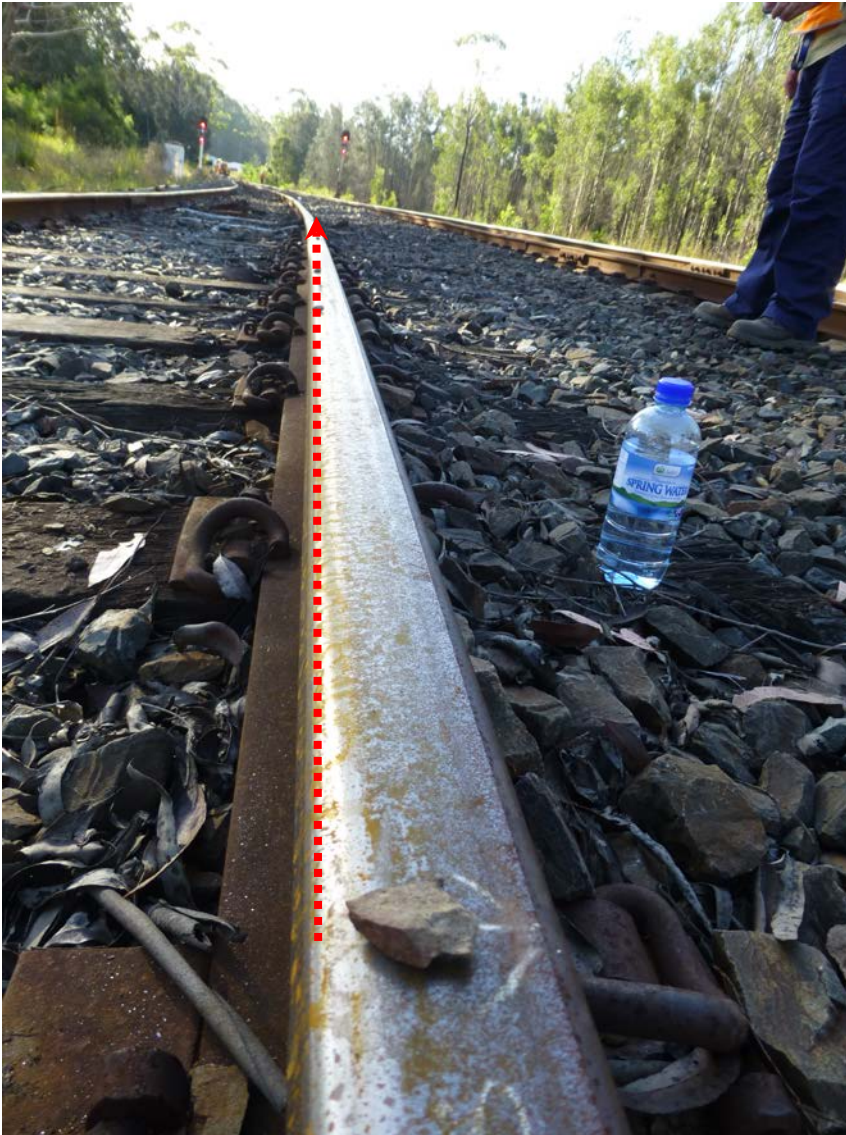
Figure 5: Point of climb and derailment

Evidence of flange climb was found on the high rail in a curve exit (Figure 5) at the 565.577 km point. The flange mark ran across the rail head and dropped off the field side of the high rail about 7 m further along the track. The rail did not show any signs of unusual wear.

It was evident from the measured track geometry that the derailment had occurred in the curve transition² where the curve superelevation³ runs-out to zero for the section of track leading to the turnout.

At the point of derailment, wagon RCOF20375S was negotiating a curve transition. Transitions apply a twist to the track as the superelevation is ramped in or out at the entry and exit of the curve. Any variation in track superelevation under the bogies of a wagon is another factor that can contribute to wheel unloading.

The ATSB concluded that a combination of superelevation, twist and (more importantly) uneven lateral loading had combined to unload the right-hand wheels of wagon RCOF20375S, which, when steering through a left-hand curve, resulted in flange climb and derailment. Regardless of whether the rod-in-coil load shifted before or during the train's passage through Nambucca Heads, its ability to shift in relation to the wagon was an undesirable condition that likely adversely affected the wagon's dynamic behaviour.

The ARTC performed rectification work on the track. The work involved the replacement of sleepers beyond the point of derailment, including part of the curve on the loop line. As part of the rectification work, the track was realigned and tamped which resulted in a reduction of superelevation and removal of the minor alignment variations through the curve near the point of derailment.

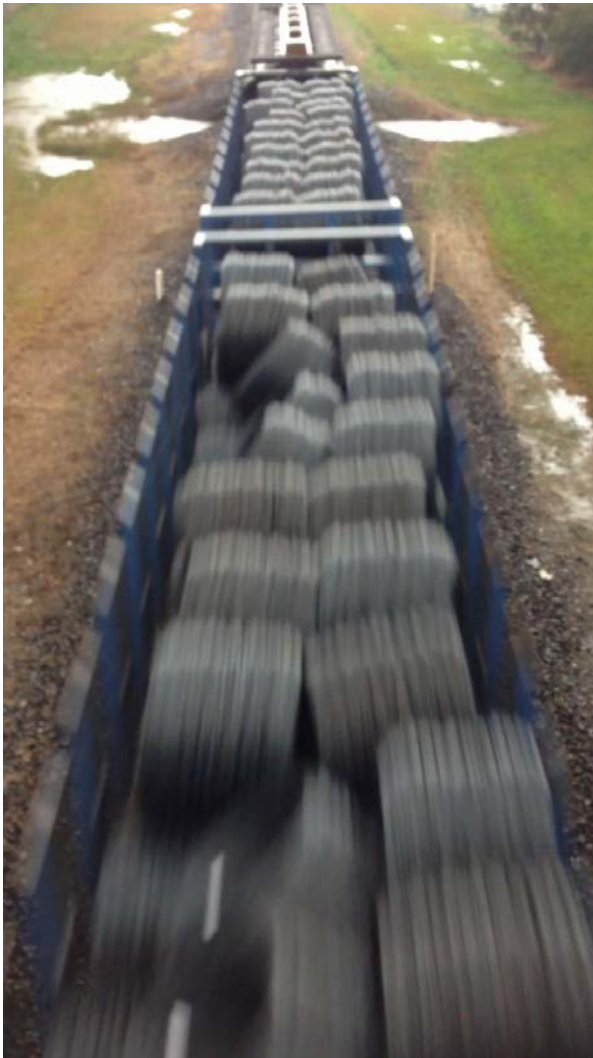
Figure 6: Rod-in-coil product on another train

Evidence indicated an issue with rod-in-coil load shifting while the train was en route. Closed circuit television camera (CCTV) footage from Telarah, Maitland, Wallarobba, and Dungog stations was analysed. The footage, through Maitland particularly, shows evidence of load-shift on the wagon RCOF20375S. It was also evident that this was not an isolated instance, as video evidence of other trains travelling to Brisbane showed similar movement and collapsing of rod-in-coil product into the central void (in most cases to the left in the direction of travel). Given the tendency of rod-in-coil product to move (and possibly bounce), it is very likely that the load within wagon RCOF20375S had shifted during the journey from Morandoo, or possibly as train 2WB3 travelled through Nambucca Heads.

On 13-14 January 2015 an Office of National Rail Safety Regulator (ONRSR) audit noted that rod-in-coil product had been shifting en route – in a manner very similar to that shown in Figure 6. Accordingly, while it is almost certain that trains had been arriving in Brisbane with shifted rod-in-coil loads, there was no indication that the condition of arriving loads had been regularly reported back to Pacific National for consideration and corrective action.

During a subsequent inspection, the ONRSR observed that the wagons were loaded predominately from the left side with a fork lift. The loading did not generally conform to the freight loading manual, which required equal lateral spacing of coils on the bottom layer. This was most likely due to the loading method and lack of specific awareness of Pacific National requirements. Post-loading inspections did not detect the loading irregularity and were mainly focussing on out-of-gauge (uncontained) product or rolling stock running gear defects.
