Stall warning event involving a Raytheon B200, VH-ZCO

Darwin Airport, Northern Territory, 17 May 2015

ATSB Transport Safety Report
Aviation Occurrence Investigation
AO-2015-049
Final –7 October 2015

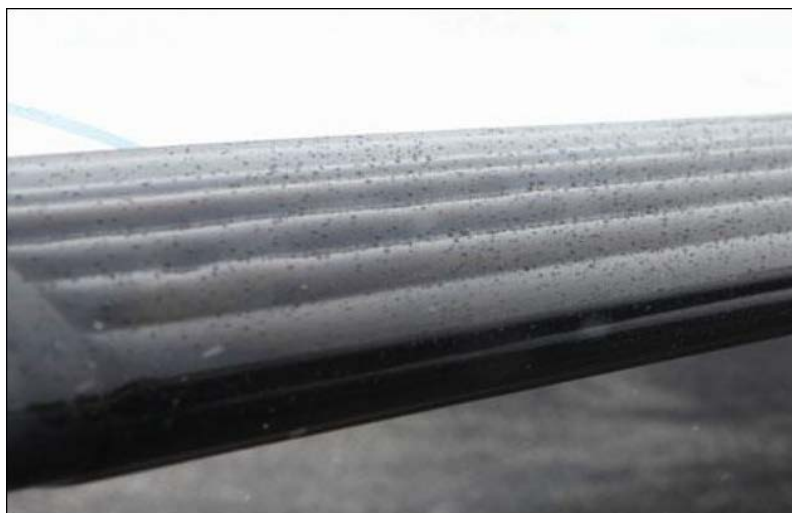
Figure 3: Inflated Raytheon B200 wing leading edge de-ice boot

The pilot had no difficulty handling the aircraft during the circuit and landing, but noted that substantially more power than normal was required to hold the desired speed. The stall warning horn remained silent throughout the approach and landing. The pilot landed without further incident and taxied to the aircraft parking position. The wing de-ice boots remained inflated until the engines were shut down.

Subsequent inspection by engineering staff found that the wing de-ice boots inflated again during an engine ground run, without having been selected. The boots returned to normal operation when the wing and horizontal stabiliser de-ice system control switch was cycled.⁶ Numerous subsequent system tests (in accordance with the relevant maintenance manual) found that the wing and horizontal stabiliser de-ice system functioned normally, and the aircraft was returned to service. The operator also advised CASA of the occurrence.
