Flight below minimum altitude involving an Avro 146, VH-NJW

near Granny Smith Airport, Western Australia, on 23 June 2015

ATSB Transport Safety Report
Aviation Occurrence Investigation
AO-2015-065
Final – 7 October 2015

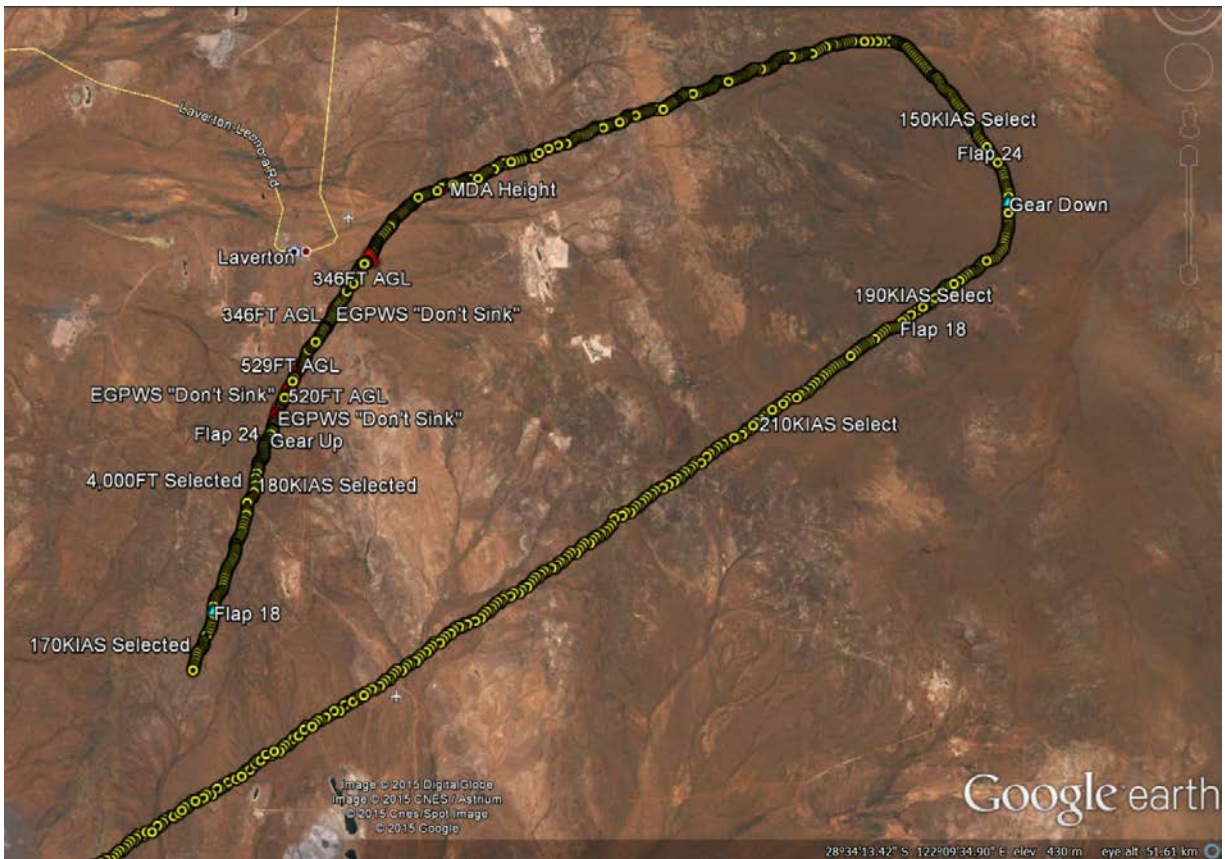
Figure 2: Plan view of the incident flight from the recorded flight data

The aircraft operator analysed the flight data (Figure 2). The data showed that during the transit from Laverton to Granny Smith, EGPWS 'DON'T SINK' alerts were triggered when the aircraft's altitude reduced to 346 ft AGL, and again 1 minute later at 529 ft and then 520 ft AGL.

The company immediately issued an operational notice to all flight crew, titled *Operations to airfields without instrument approach procedures*. The notice stated the following:

On arrival at the destination, descent below the LSALT is only permitted if, within 5 NM of the airfield, conditions exist to permit a visual approach as per the runway approach profiles specified in the applicable Operations Notice or the OM-C1.

It is not permitted to conduct an instrument approach at a nearby airfield to gain visual reference, and then transit to the destination airfield below LSALT.
