Derailment of locomotive and wagon during main line shunting

South Dynon Junction, West Melbourne, Victoria | 25 July 2013

ATSB Transport Safety Report
Rail Occurrence Investigation
RO-2013-020
Final – 16 October 2015

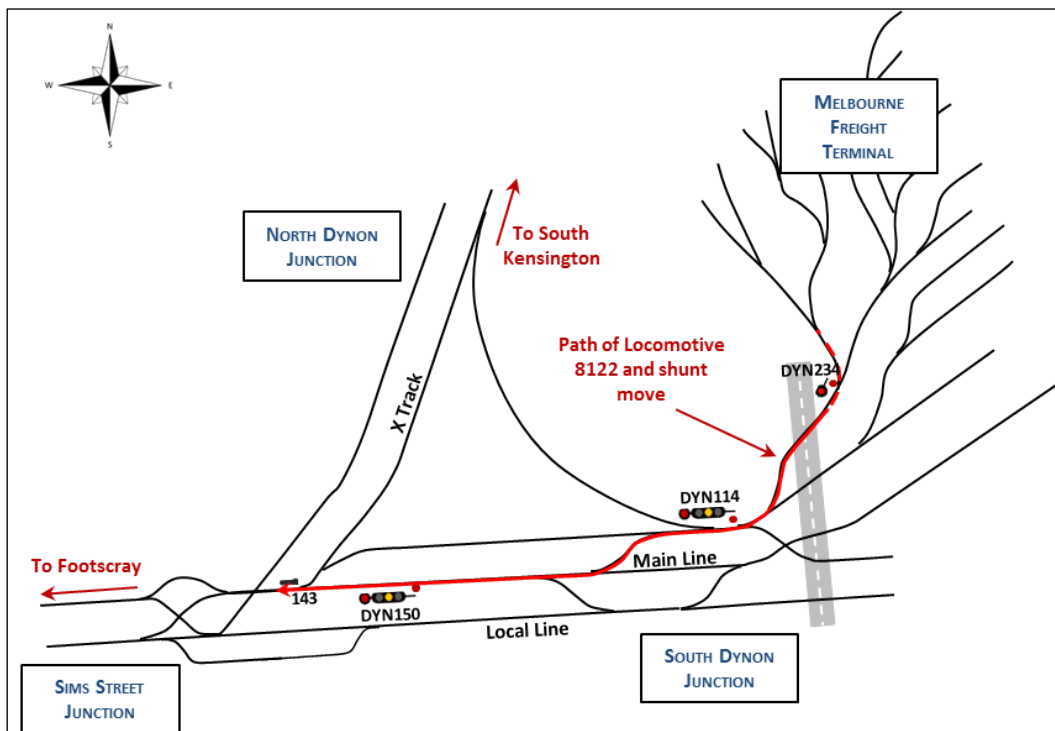
Figure 1: Track layout Sims Street Junction showing path of locomotive 8122

At about 1715³, at the request of the MFT shunt planner, the Australian Rail Track Corporation Network Control Officer (NCO) set a route onto the main line for locomotive 8122. About five minutes later, locomotive 8122 hauled a rake of six wagons from the MFT onto the main line and in the direction of Sims Street Junction (Figure 1). At about 1721, the locomotive passed signal DYN150 which was displaying a ‘medium speed warning’ aspect⁴. The locomotive continued beyond the signal for about 200 m before the shunter told the driver to stop.

About the same time, though still some distance away, train 9794 was approaching from Footscray intending to travel towards North Dynon Junction via points 143. Although the NCO selected the required route for train 9794, the signal interlocking system⁵ prevented the route from setting, due to locomotive 8122 occupying a track section that was also part of that route. The signal interlocking system stored the selected route until such time that all the required track sections were clear.

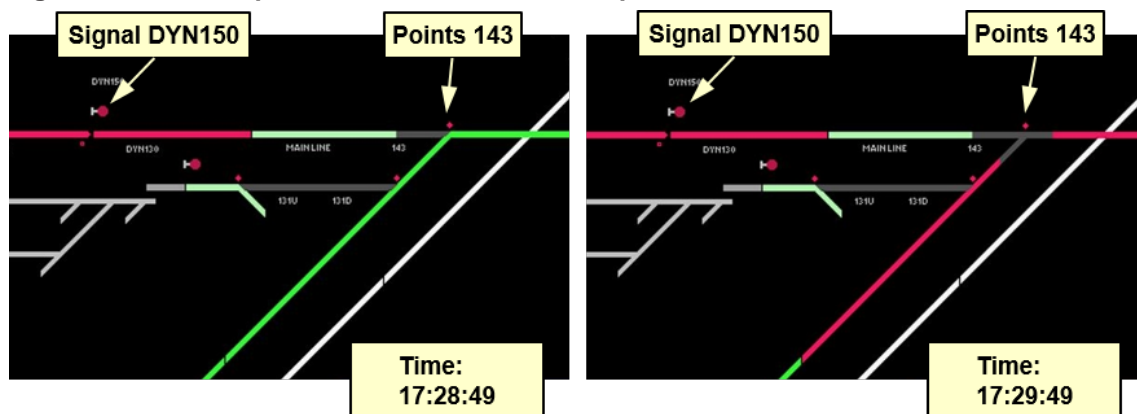
Figure 2: Screen captures from Phoenix control panel

As locomotive 8122 ran through the points, the signalling system lost detection of the point orientation. This, in conjunction with the new track occupancy, caused the cancellation of the route from Footscray. The Phoenix system reflected this change (Figure 2, Right), but it went unnoticed by the NCO.

The left-hand image shows the Phoenix control panel screen immediately after the signalling system detected locomotive 8122 occupying the track section ahead of Signal DYN150. The right-hand image shows the Phoenix control panel screen immediately after the signalling system loses detection of the points 143 orientation. Source: ARTC annotation by ATSB

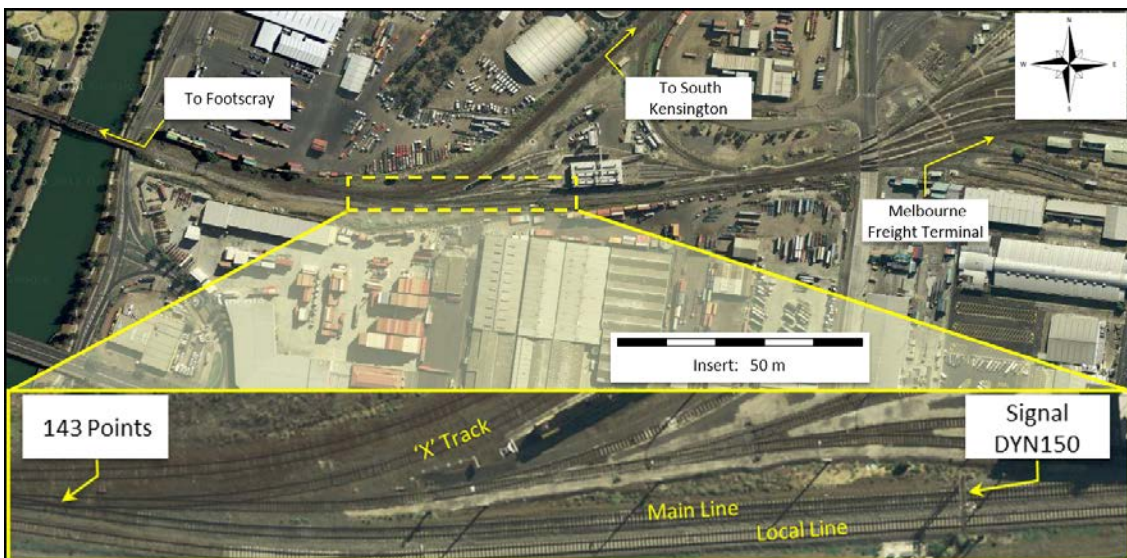
Figure 3: View of South Dynon Junction track layout including the main line, 'X' track and points 143

The derailment occurred at points 143, situated at the 4.429 km mark⁸ at the eastern end of Sims Street Junction. The distance from the points to signal DYN150 was about 177 metres. The connection between the 'X track' to South Kensington and the main line towards the MFT occurs at points 143 (Figure 3).

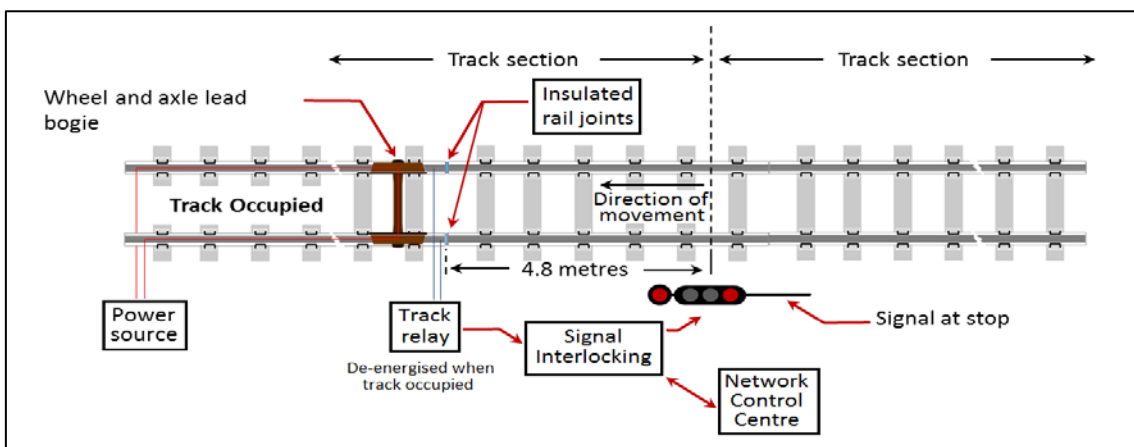
Figure 4: Schematic of rail vehicle axle, track circuit and signal displaying stop indication

In this case, an examination of the track infrastructure for signal DYN150 found the IRJs were located about 4.8 m ahead of the signal's physical position (Figure 4). This was non-compliant with the ARTC procedure¹⁴, which specified the following requirement:

ARTC inspection records from January 2009 listed the position of the signal relative to the IRJ as being correct. There was no record of any significant changes to the infrastructure associated with signal DYN150 between the 2009 inspection and the derailment. The ARTC had no record of the reasons or considerations behind the installation of the IRJs 4.8 m past signal DYN150.

The Australian Rail Track Corporation initiated actions to verify (within Victoria) the position of insulated joints relative to the respective signals and develop a prioritised remediation plan for any non-conforming arrangements.

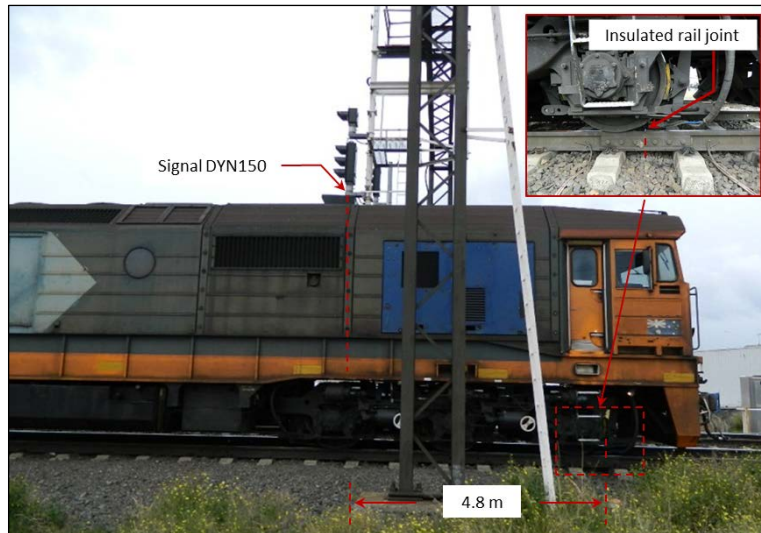
Figure 5: Exemplar locomotive near signal DYN150 and IRJ’s

In this case, the driver recalled pushing the shunt movement back into the MFT and stopping (under instruction of the shunter) in a position similar to that illustrated in Figure 5. The locomotive had not moved behind the signal and consequently the driver had no reason to believe he did not still have authority to continue shunt operations beyond signal DYN150. Had the locomotive been behind the signal, the driver may have observed the signal and been prompted to request a further authority to pass the signal for the next shunting move.

While there was insufficient evidence to discount the possibility that locomotive 8122 actually had pushed back behind signal DYN150, it was clear that the infrastructure configuration could permit a scenario whereby a locomotive driver may remain unaware that the expected route from signal DYN150 had not been maintained during shunt movements.
