Aviation Short Investigations Bulletin

Issue 44

ATSB Transport Safety Report
Aviation Short Investigations
AB-2015-118
Final – 4 November 2015

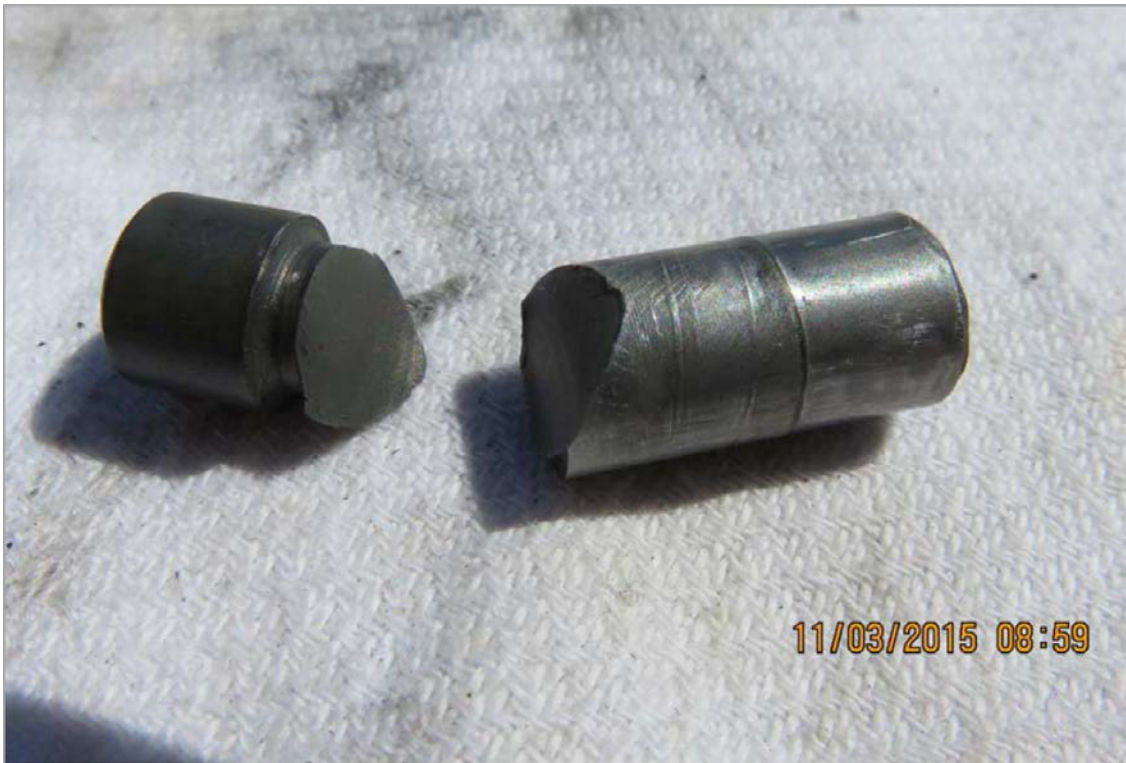
Figure 1: Failed nose landing gear downlock pin

The owner of the aircraft conducted an investigation into the incident. As part of their investigation, they determined that one of the nose landing gear down lock pins had failed. The pin had failed in the area of the machined groove for the pin retention roll pin (Figure 1). The failed down lock pin migrated out and interfered with the nose landing gear actuator. This movement prevented the nose landing gear down lock mechanism from engaging in the down and locked position (Figure 2). The other down lock pin was serviceable.

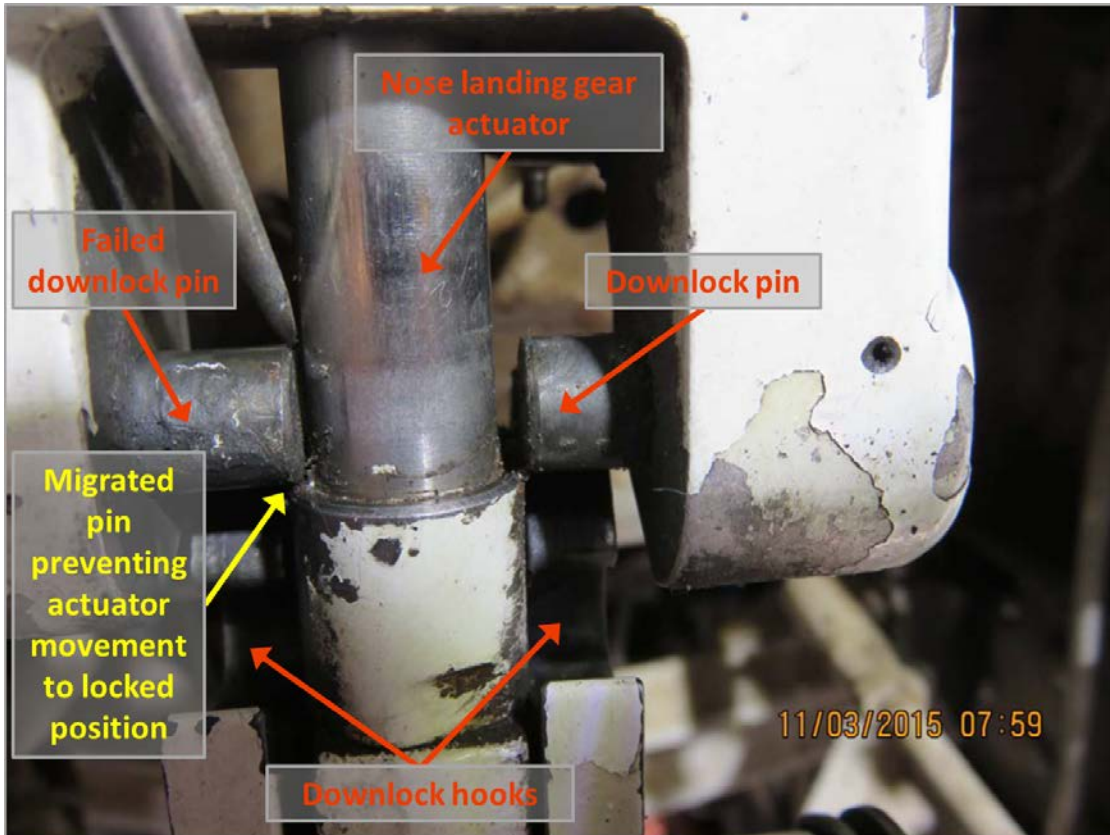
Figure 2: SMP nose landing gear downlock assembly, showing the failed downlock pin preventing actuator movement to the locked position

Cessna had introduced the service bulletin as they had received reports that the nose landing gear actuator downlock pins had cracked and failed. It was found that the pins had failed at a circumferential groove that was used to secure the pin in the actuator bearing end. The service bulletin indicated that non-compliance could result in failure of the nose landing gear to lock in the down position and possibly collapse.

The recommended inspection was to be carried out initially within the next 200 hours operation or 12 months, whichever occurred first. Subsequent inspections at each landing gear retraction check were not to exceed 200 hours of operation thereafter. After the installation of the downlock actuator pin replacement, the repetitive inspection was not required.

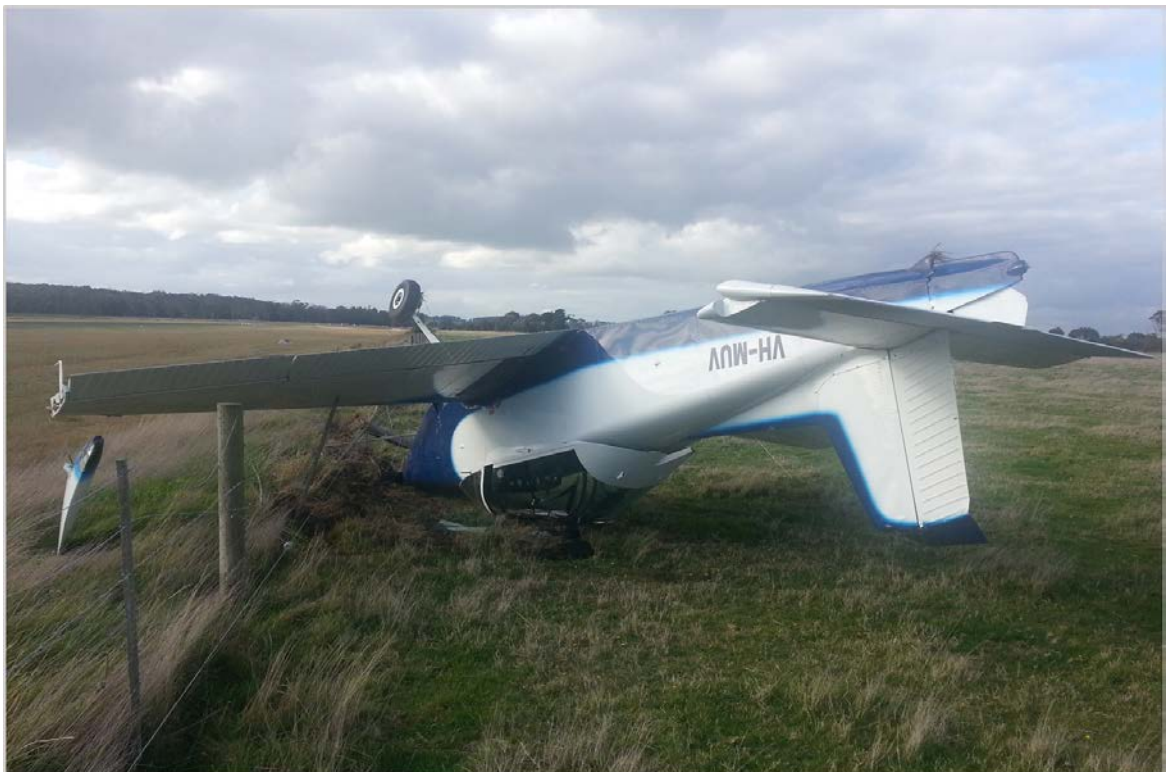
Figure 1: VH-MUV inverted after flipping over the airport perimeter fence

The aircraft continued to drift further away from the runway centreline. The student noticed the flaps were in the down position and, thinking that it would assist and without checking with the instructor, retracted the flaps to the up position. The aircraft descended and about 100 m past the threshold of runway 22, the aircraft collided with the airport perimeter fence. After a further 20 m, the aircraft flipped over the fence and came to rest upside down. The instructor and student exited the aircraft quickly through the broken canopy, as fuel was gushing from the fuel tanks. The instructor and student pilot received minor injuries and the aircraft was substantially damaged (Figure 1).

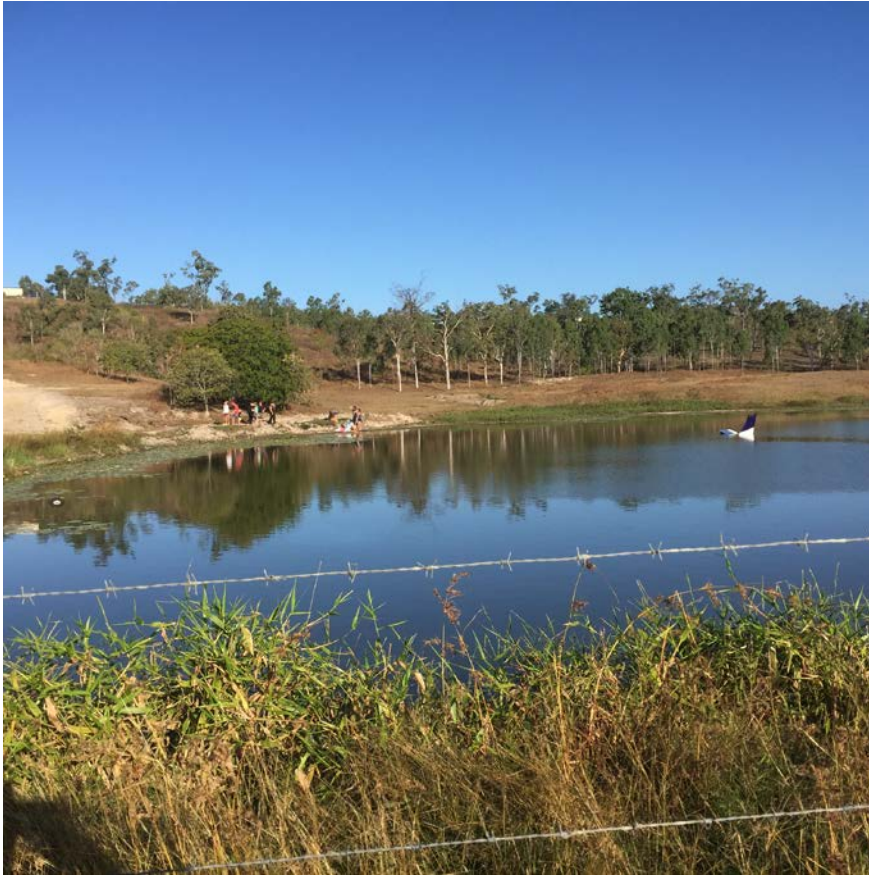
Figure 5: Post accident showing VH-BDG partially submerged in the dam

One of the passengers sustained serious injuries, and the pilot and another passenger, minor injuries. The aircraft was almost completely submerged resulting in substantial damage (Figures 5 and 6).

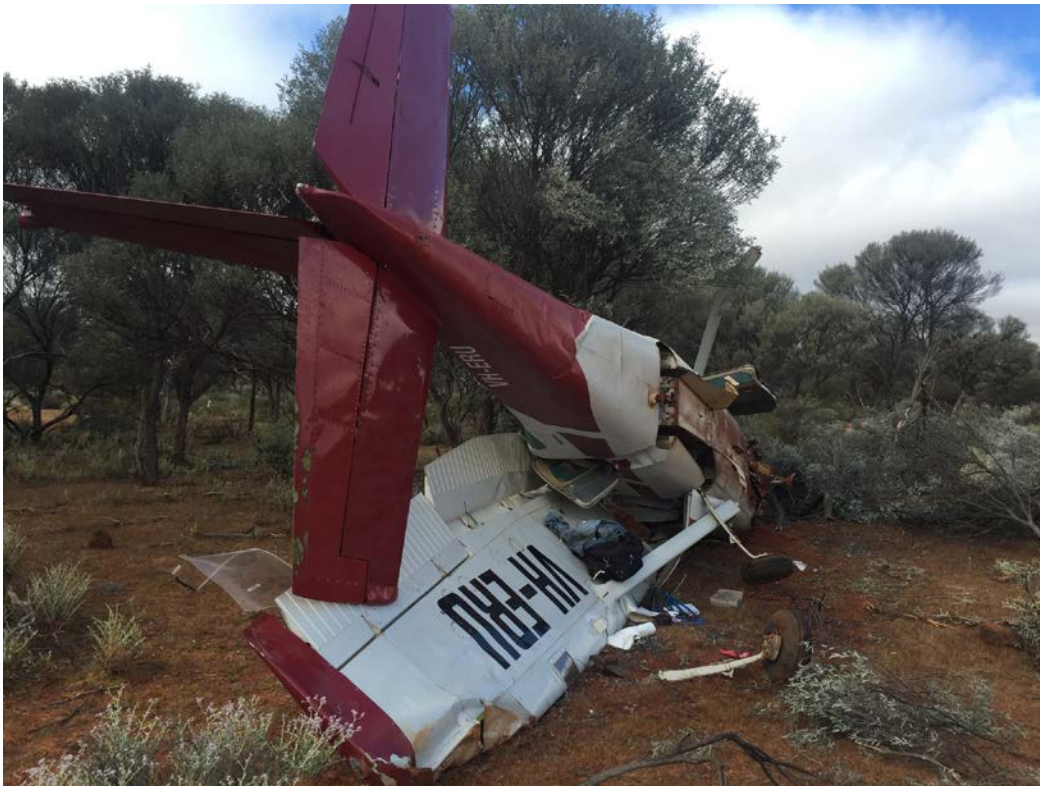
Figure 2: Accident site showing damage to VH-ERU

When about 500 ft above ground level, the vibration further increased and the engine failed with a bang. Smoke emanated from the engine compartment and over the windscreen, reducing the pilot's visibility through it. The pilot then sighted a fence line to the right and prepared for a forced landing, aiming to touchdown in a cleared area alongside the fence.

The aircraft was damaged beyond repair. At the time of completing this report, no engineering inspection of the engine had been, or was expected to be, conducted following the accident.

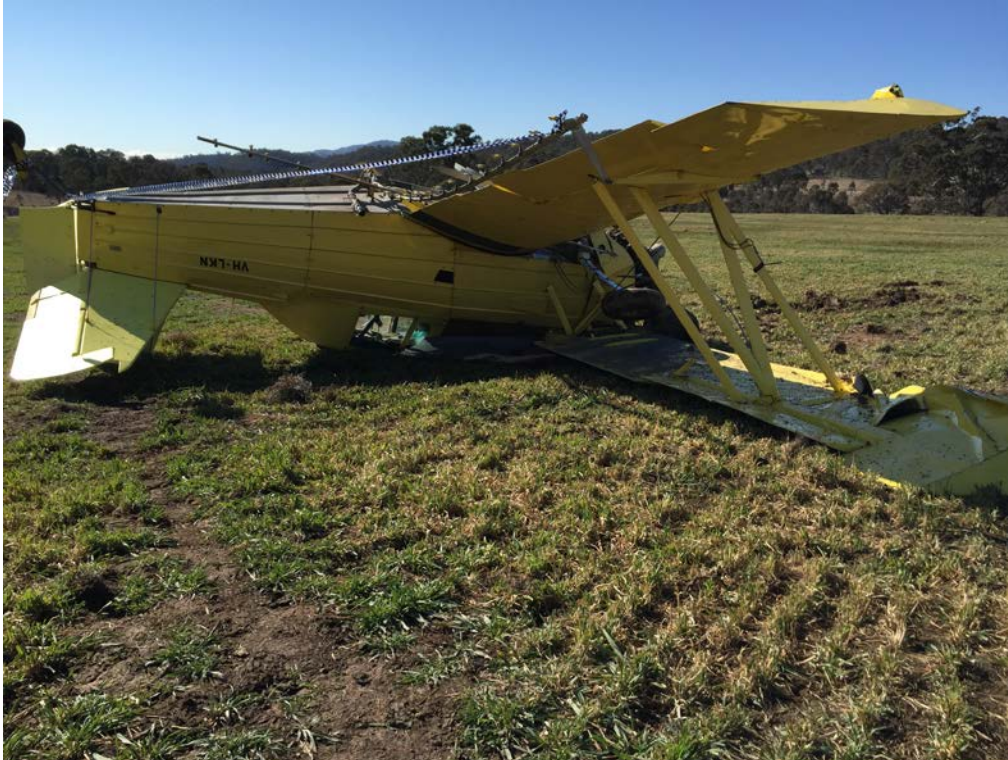
Figure 2: Damage to VH-LKN

The pilot sustained minor injuries and the aircraft was substantially damaged (Figure 2).

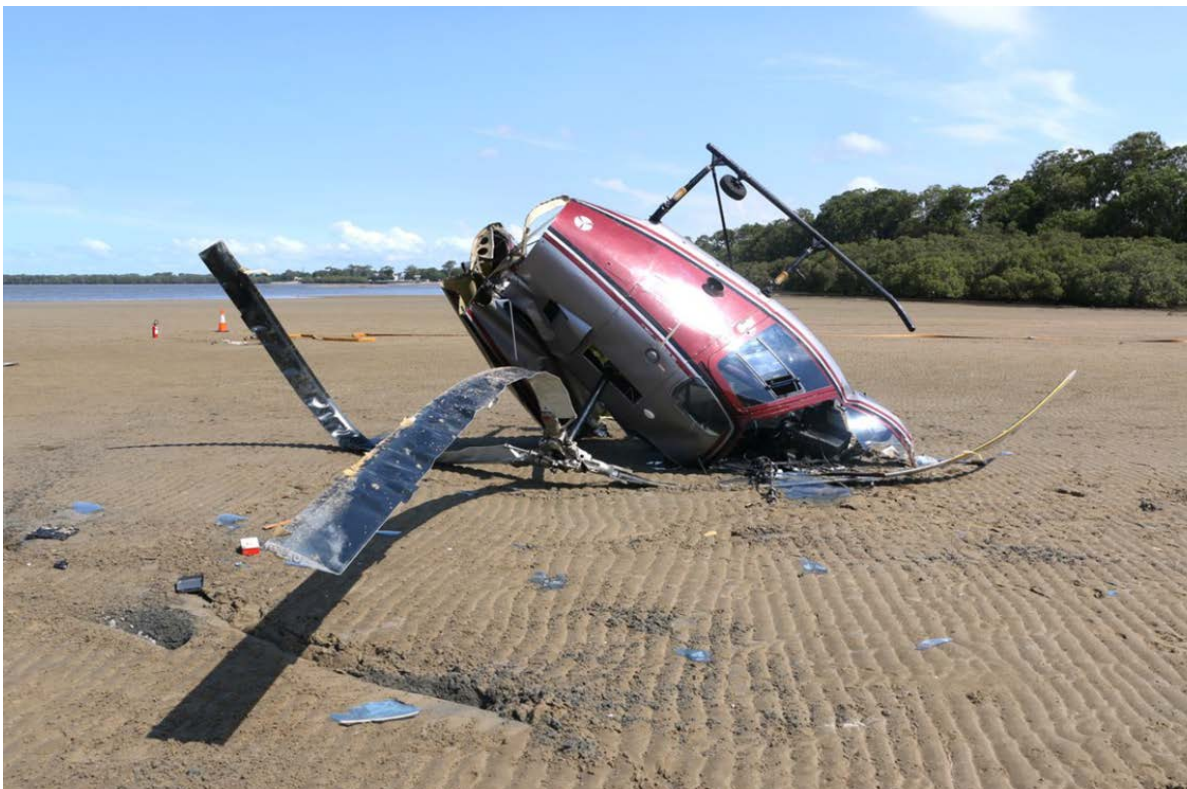
Figure 1: Accident site showing the damage to VH-YHD

At about 1,000 ft AGL, the pilot heard a bang and the engine stopped. This caused the helicopter to yaw to the left violently. The pilot then attempted to restart the engine but was unsuccessful. At about 800 ft AGL, the helicopter entered autorotation¹ and the pilot prepared to land on the beach. The pilot observed people swimming in the sea and manoeuvred the helicopter to an area where there were no people. The pilot arrested the descent and the skids contacted the sand. The helicopter continued to move forward along the sand, and then a few seconds later the helicopter blades impacted the sand, and the helicopter rolled over. The pilot received minor injuries and the helicopter was destroyed (Figure 1).

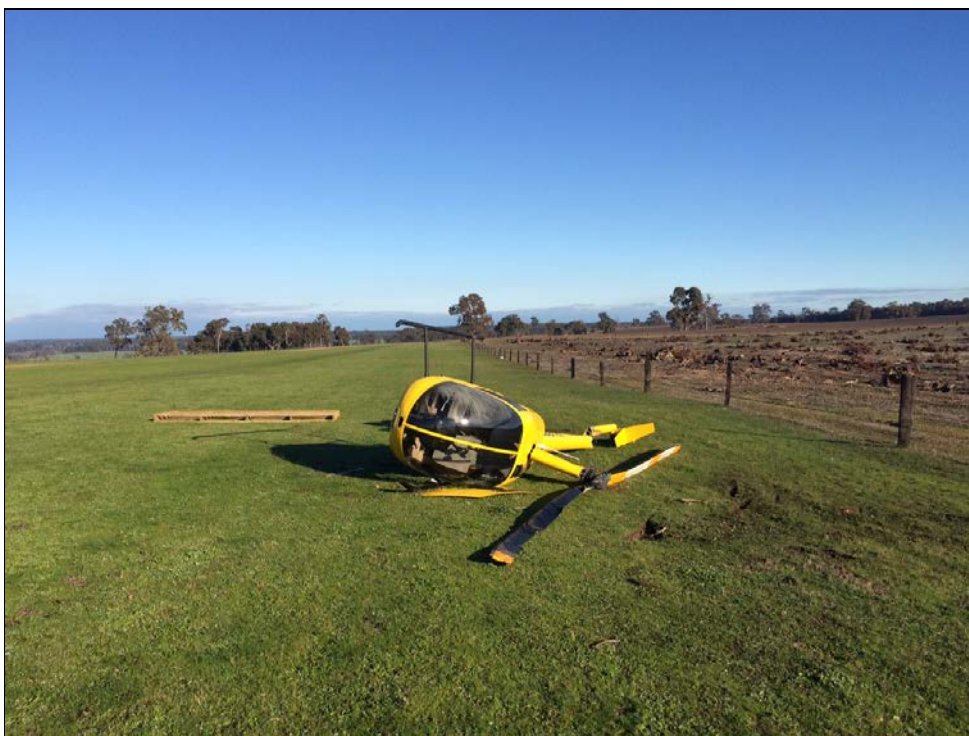
Figure 2: VH-RBT at rest on the left side. Note the broken tail boom and rotor blades

Now about 30-40 ft above the ground, the pilot elected to put the helicopter back on the ground. Manoeuvring slightly left to avoid the assumed position of the drain, the pilot unexpectedly felt the tail and rear skids of the helicopter strike the ground. The pilot stated this was a heavy collision, and resulted in the helicopter bouncing back into the air. The pilot applied some collective and the helicopter bounced again then yawed rapidly to the right. The pilot applied full left pedal in an attempt to prevent the helicopter from entering a spin, however the yaw continued, so the pilot rapidly reduced the throttle to idle. As the yaw decreased, the helicopter fell onto its left side (Figure 2).
