Separation issue involving a Pacific Aerospace CT/4B, VH-YCU, and a Diamond DA 40, VH-UNV

near Quirindi, New South Wales, 4 June 2015

ATSB Transport Safety Report
Aviation Occurrence Investigation
AO-2015-060
Final – 4 November 2015

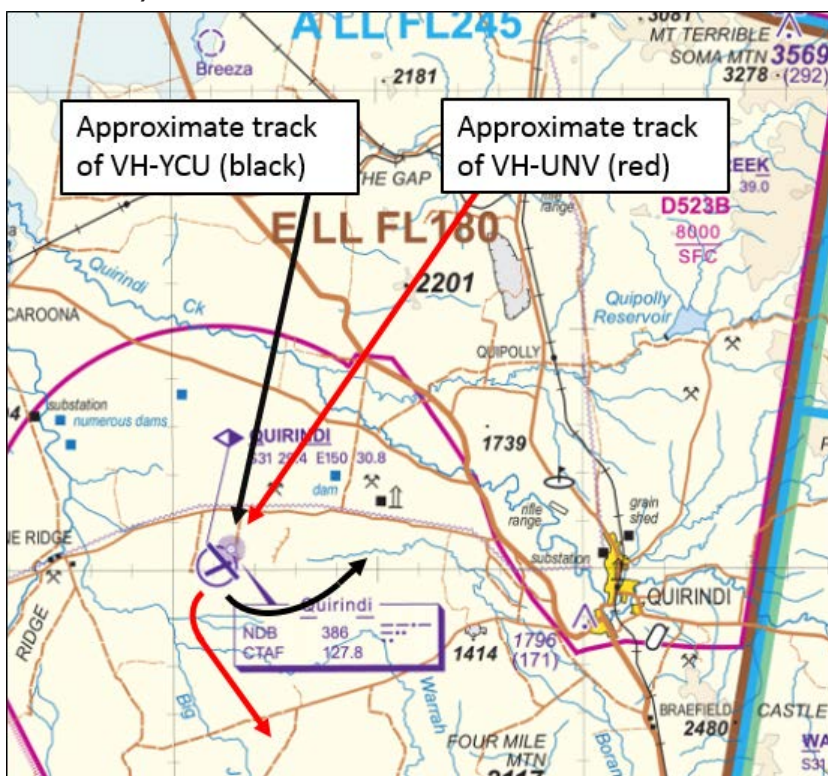
At about the same time, UNV was tracking from Gate South (a reporting point south-west of Tamworth) towards Quirindi, also at 4,500 ft (Figure 1). The crew of UNV planned to overfly Quirindi then turn to the south-east and track towards Scone. The crew of UNV were monitoring the area VHF,⁵ but not the Quirindi CTAF. As such, the crew of UNV did not hear the CTAF broadcasts made by the student in YCU. Even though the crew of both aircraft were monitoring the area VHF, neither had made any broadcasts on that frequency, so neither crew was aware of the other aircraft. At the time, both were tracking towards Quirindi at the same altitude.

Figure 1: Extract from a visual chart showing the manner in which the tracks of the two aircraft converged as they neared Quirindi, and the general direction of flight of each aircraft after they passed Quirindi (YCU turning to the north-east and UNV turning to the south-east)
