# Loss of control involving a Bell 206L3, VH-BLV

Falls Creek, Victoria, on 20 July 2015

**ATSB Transport Safety Report**  
Aviation Occurrence Investigation  
AO-2015-091  
Final – 4 November 2015

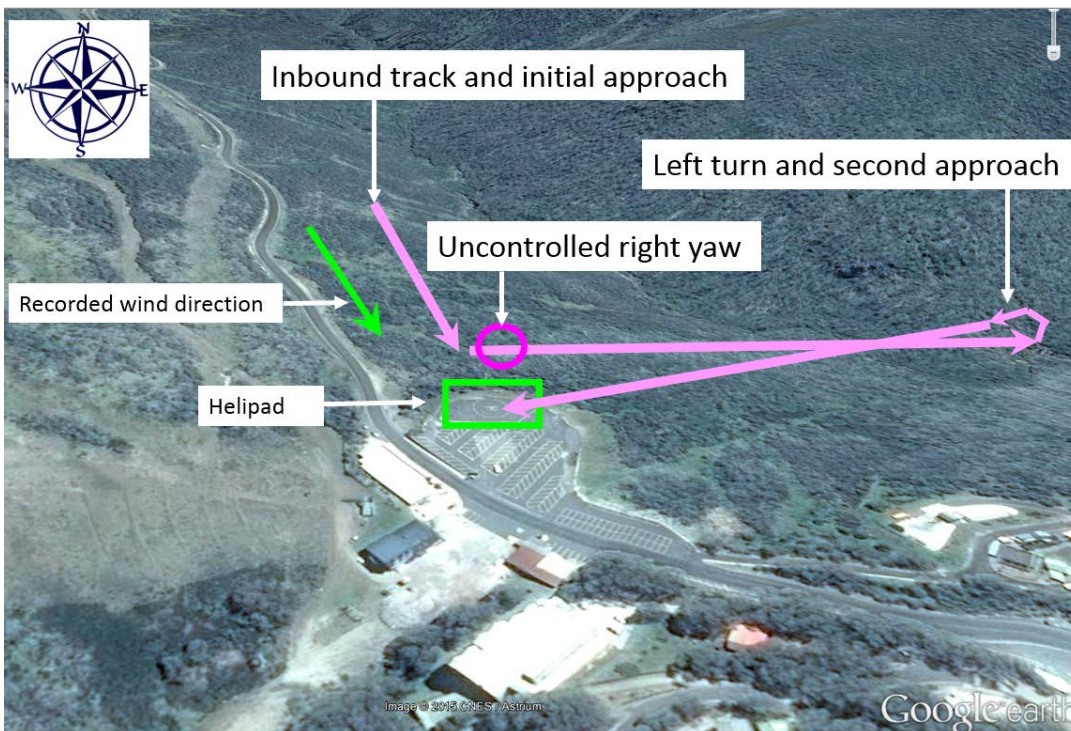
**Figure 1: Falls Creek helipad, approximate helicopter track and wind direction**

At about 1030, while 700 ft above ground level and tracking from the north-west, the pilot conducted a shallow approach towards the helipad at Falls Creek (Figure 1). As the helicopter descended to about 50 ft above ground level, the pilot found that significantly more power was required to conduct the approach than anticipated. The pilot assessed that there was insufficient power available to continue to land, and elected to abort the approach. The pilot pushed forwards on the cyclic<sup>1</sup> to increase the helicopter's airspeed and conducted a left turn towards the valley.

As the helicopter turned left, it started to yaw<sup>2</sup> rapidly towards the right. The pilot applied full left pedal to counteract the yaw, but the helicopter continued to yaw. The helicopter turned through one and a half revolutions, as the pilot lowered the collective.<sup>3</sup> Lowering the collective reduced the

The Bureau of Meteorology provided the ATSB with a report of weather observations for Falls Creek. The automatic weather station is located south of the helipad at about 5,790 ft above mean sea level, above the village. Between 1020 and 1040, the recorded wind speed was from 17 to 20 kt, gusting to 24 kt, and wind direction was from 327° to 344° (degrees true), or 314° to 331° (degrees magnetic). The temperature was -1 °C.
