Australian Government
Australian Transport Safety Bureau

Aviation Occurrence Statistics

2004 to 2013

ATSB Transport Safety Report
Aviation Research Statistics
AR-2014-084
Final – 5 November 2014

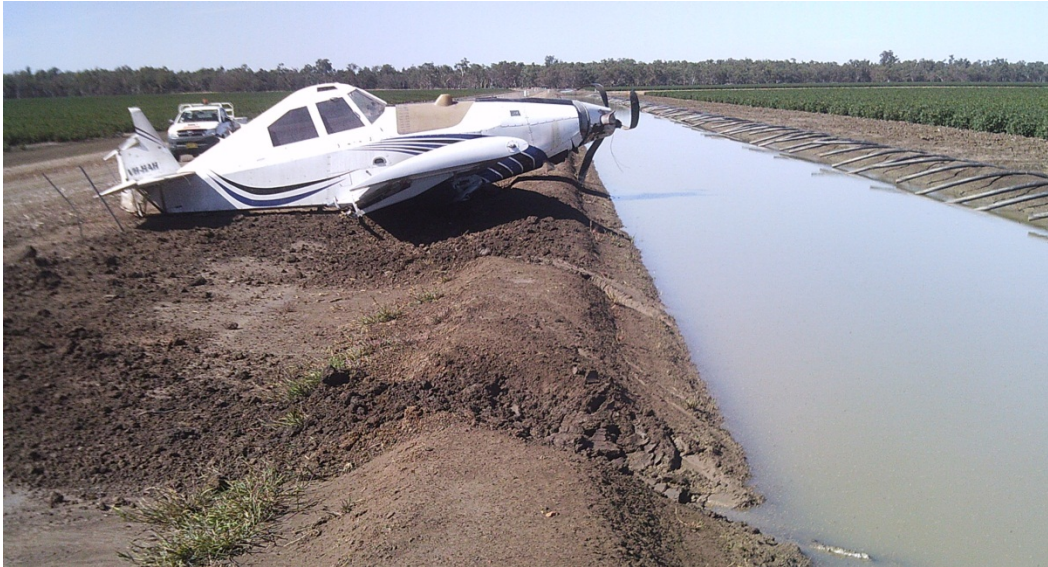
Wirestrike involving Ayres S2R Thrush (VH-HAH), 7 km SE of Condobolin Airport, New South Wales (ATSB investigation AO-2013-033)

- An Ayres S2R Thrush struck power lines while conducting aerial spraying near Condobolin, NSW. The pilot was uninjured, but the aircraft was substantially damaged. The pilot was carrying out the final clean-up run before returning to the airstrip. The pilot was flying from west to east, parallel to the main power line, which was located beside the field, outside of the area being sprayed. Another smaller power line with three wires ran diagonally across the field from the main power line. Once the pilot had run out of product, he pulled up to gain altitude, when he struck the smaller power line that ran diagonally across the field. Two of the wires were cut by the aircraft's wire protection system and the third wrapped around the propeller hub arresting the aircraft and pulling it around in a half circle where it came to rest on the ground. As a result of this accident, the electricity distribution company is installing a marking system on the power line (ATSB investigation AO-2013-033).

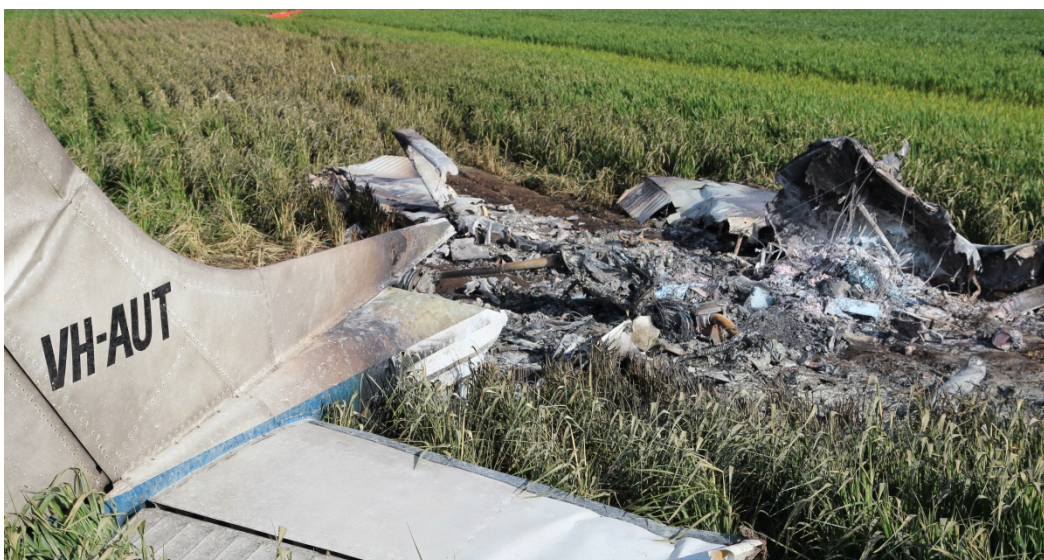
Collision with terrain involving Cessna 182R Skylane (VH-AUT), near Hamilton Airport, Victoria (ATSB investigation AO-2013-163)

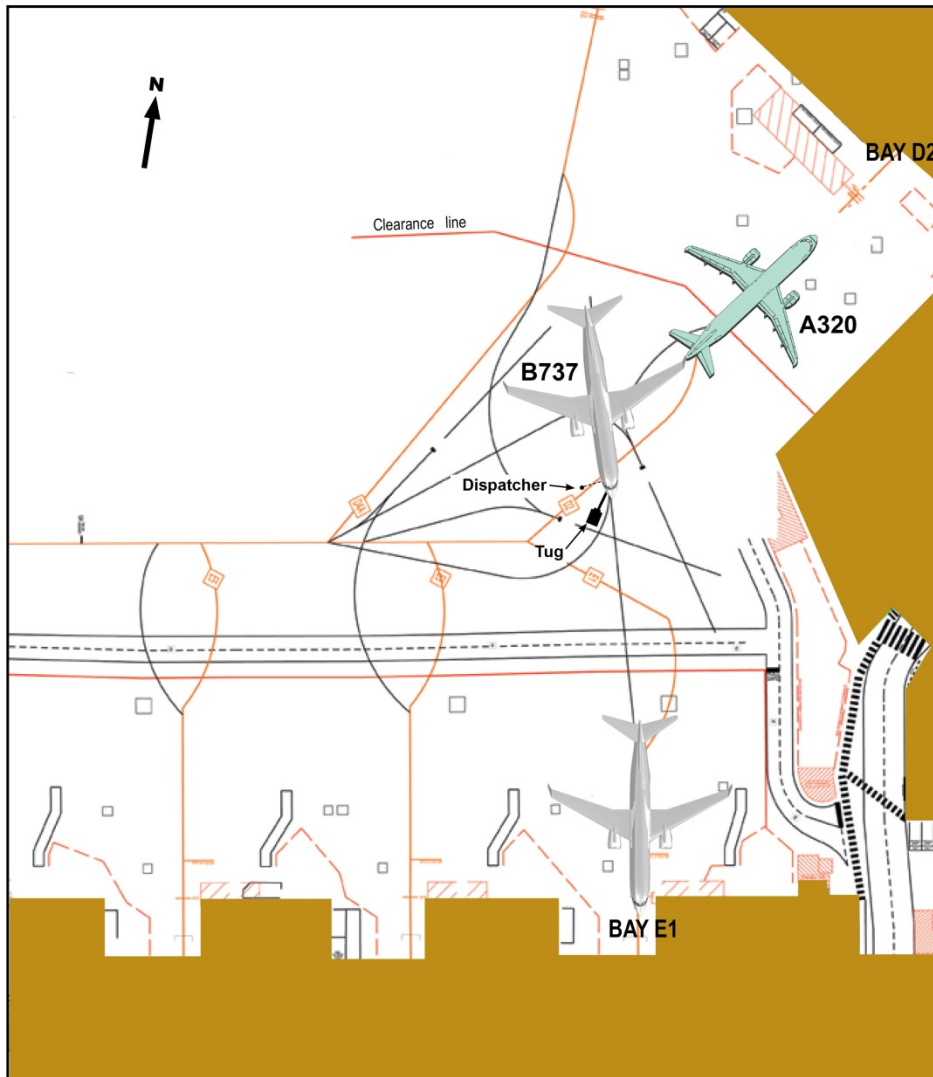
- A Virgin Australia Boeing 737 was being pushed back from gate E1 at Melbourne Airport terminal. At the same time, a Jetstar Airbus A320 was stationary on a taxi line behind and to the left of the Boeing, waiting to dock at gate D2. During the pushback of the Boeing, the two aircraft collided, resulting in damage to the left winglet of Boeing and to the tail cone of the Airbus. There were no reported injuries to persons on the aircraft or to ground staff. The Boeing was being pushed back by a tug, using a towbar connected to the nosewheel to steer and push the aircraft. The pushback was being controlled by a dispatcher who was walking beside the aircraft on the right side. The ATSB determined that the left wing could not be seen from the dispatcher’s position, and the flight crew reported they could only see the wingtips with difficulty from the cockpit. The Boeing had been approved by the surface movement controller (SMC) to push back from gate E1 once the Airbus was ‘on the gate’ for gate D2. The Airbus, which was taxiing to the gate at the time the surface movement controller had given the Boeing clearance, had stopped about 20 m before its intended parking position due to a ‘STOP WAIT’ display on the automatic visual guidance display system. The Airbus crew notified the SMC they had stopped short (and outside of the clearance line for gate D2), but due to an over-transmission this was not heard by the SMC or the Boeing crew. The Boeing flight crew relayed the pushback approval to the dispatcher including the caveat of ‘once the Airbus was on the gate’. The dispatcher recalled that he looked under the Boeing fuselage and after he had observed the Airbus stopped for some time and believing that the aircraft was on the gate, initiated the pushback. The tug driver concentrated on directional control to keep the Boeing following the marked lines for the pushback. The ATSB determined that from the dispatcher’s viewpoint it was not possible to see the clearance line for gate D2, or to see enough to ensure that an aircraft was on the gate at D2. The ATSB identified that the SMC was dealing with a high workload at the time controlling many aircraft, and was situated 1.5 km away in the

Melbourne Airport control tower. The ATSB investigation is continuing (ATSB investigation AO-2013-125).

Collision during pushback operations between Boeing 737-800 (VH-YID) and Airbus A320-200 (VH-VGR), Melbourne Airport, Victoria (ATSB investigation AO-2013-033) – diagram shows the movement of each aircraft leading up to the collision

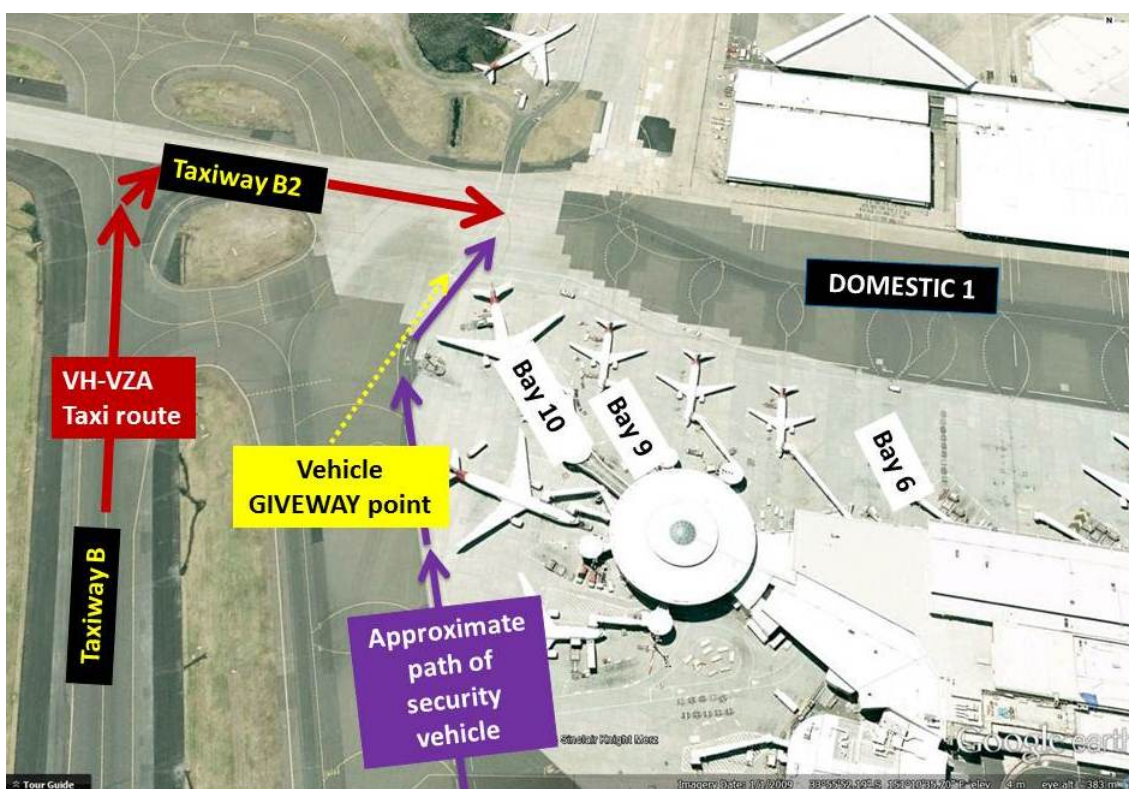
- During the taxi to the parking bay area at Cairns Airport, the captain of a Qantas Boeing 737 observed the lights of a security vehicle approaching about 50 m from the right side of the aircraft near the intersection of the airside road and taxiway B2. The captain thought the vehicle would continue along the airside road, however, as the car continued in a northerly direction across the intersection the captain believed it was on a collision course with the Boeing. Realising the vehicle driver had not seen the aircraft, the captain immediately stopped the aircraft. The security vehicle continued toward the aircraft, then came to an abrupt stop about 10 m to the right of the aircraft's nose. The ATSB investigation determined that the vehicle driver had slowed down as he approached the taxiway B2 intersection and looked towards the taxiway on his left, but did not see the lights of the Boeing and continued to drive into the parking bay area to the right assuming the area was clear (ATSB investigation AO-2013-135).

Ground proximity event between Boeing 737-800 (VH-VZA) and a security vehicle at Sydney Airport, New South Wales (ATSB investigation AO-2013-135) – diagram shows the relative positions of the aircraft and vehicle

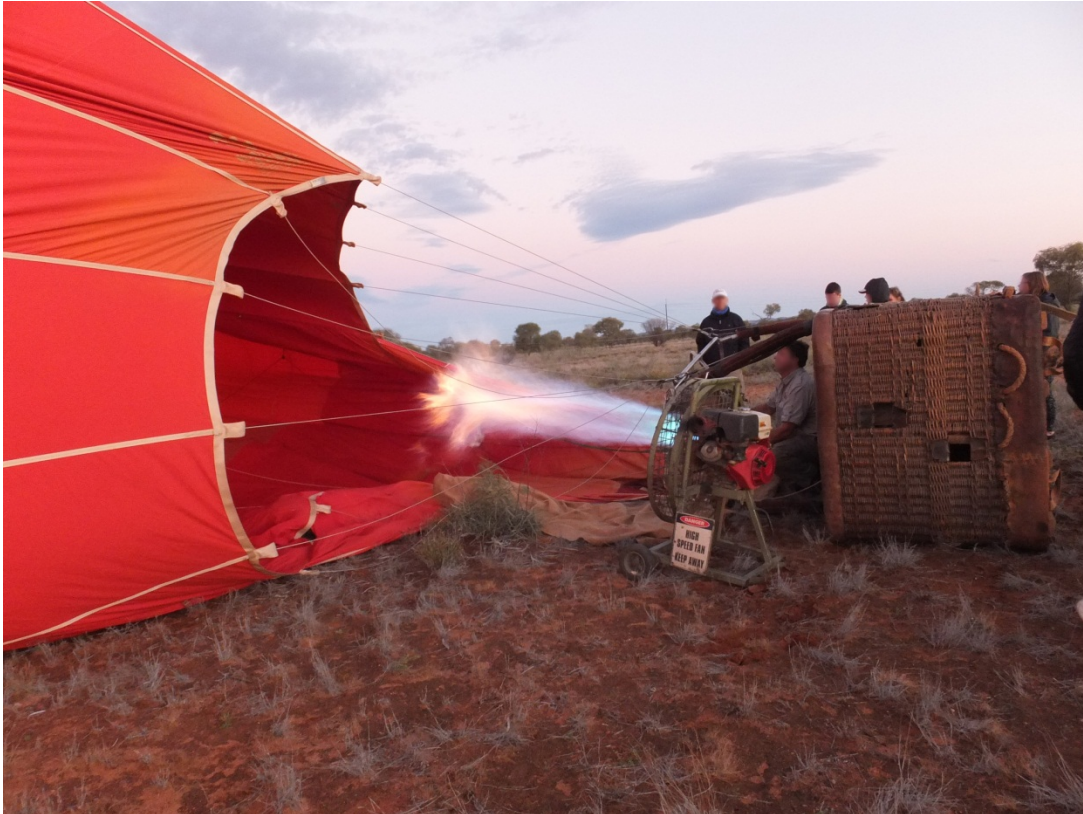
- While preparing for a flight from Alice Springs, NT, a passenger suffered serious injuries as she was about to climb into the basket of a Kavanagh E260 hot air balloon. A long scarf she was wearing was drawn through the mesh guard of the cold air inflation fan that was being used to fill the balloon with air, and became entangled in the fan. The passenger later

succumbed to her injuries. Following this accident, the balloon operator modified their procedures relating to the movement of passengers in the vicinity of cold-air inflation fans and alerted their staff to the related hazards. The ATSB also released a Safety Advisory Notice to all hot air balloon operators to reassess their risk controls in relation to passenger proximity and securing of loose items when near cold air inflation fans. The ATSB is currently investigating this accident, focusing on the preparation of the balloon for flight, the actions of crew and passengers, and the regulatory framework affecting commercial balloon operations (ATSB investigation AO-2013-116).

Flight preparation event involving Kavanagh Balloons E260 (VH-FSR), near Alice Springs Airport, Northern Territory (ATSB investigation AO-2013-116)

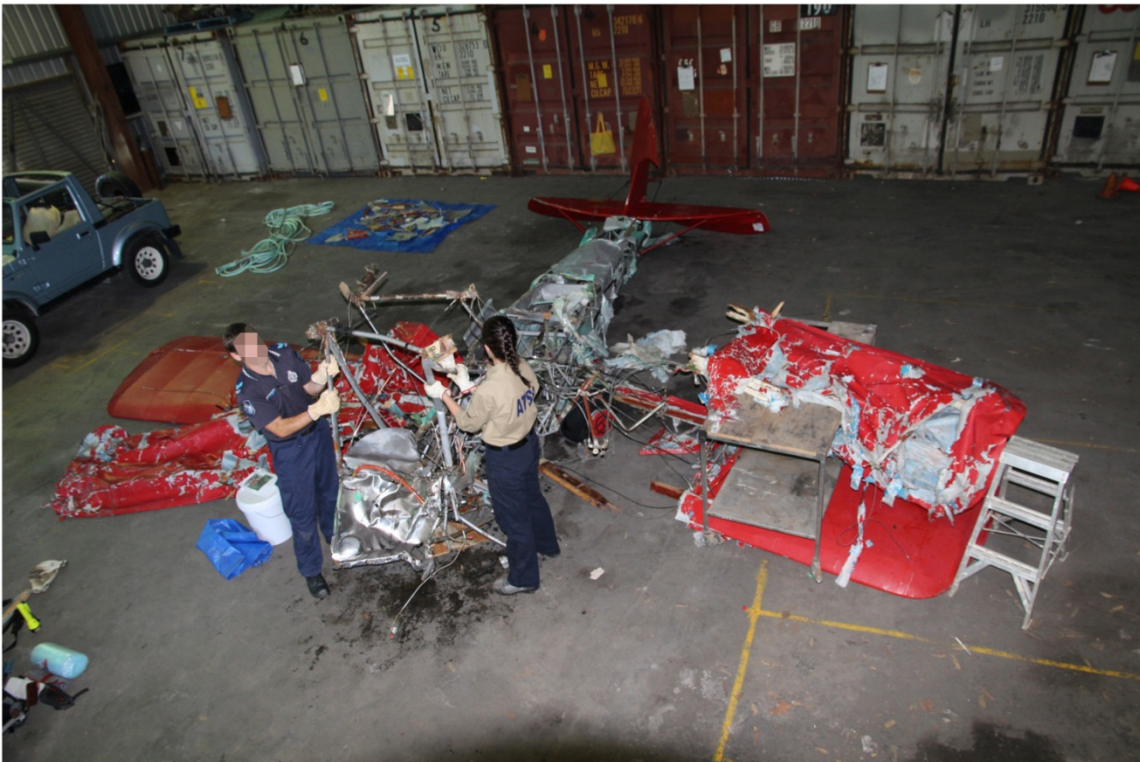
- A de Havilland DH.82A Tiger Moth took off from Pimpama, Qld with a pilot and passenger on board to conduct a joy flight in the Gold Coast area. Shortly after the pilot commenced aerobatics, the aircraft's left wings failed and it descended steeply into the water about 300 m from the eastern shoreline of South Stradbroke Island. The aircraft was destroyed and both occupants fatally injured. Preliminary examination of the wreckage by the ATSB indicated that both of the aircraft's fuselage lateral tie rods (which join the lower wings to the fuselage) had fractured, despite a service life for these parts that was significantly less than the published retirement life for DH.82A tie rods. The fractures occurred at areas of significant, pre-existing fatigue cracking in the threaded section near the join with the left wing. The ongoing ATSB investigation will examine whether the failure of the fuselage lateral tie rods, or another mode of wing structural failure, was the initiator of the left wing separations. The ATSB has released a Safety Advisory Notice to all Tiger Moth operators, the Civil Aviation Safety Authority (CASA), the tie rod manufacturer, the New Zealand and United Kingdom aviation authorities advising of the premature failure of the tie rods in this accident (ATSB investigation AO-2013-226).

In-flight break-up involving de Havilland DH.82A Tiger Moth (VH-TSG), South Stradbroke Island, Queensland (ATSB investigation AO-2013-226)

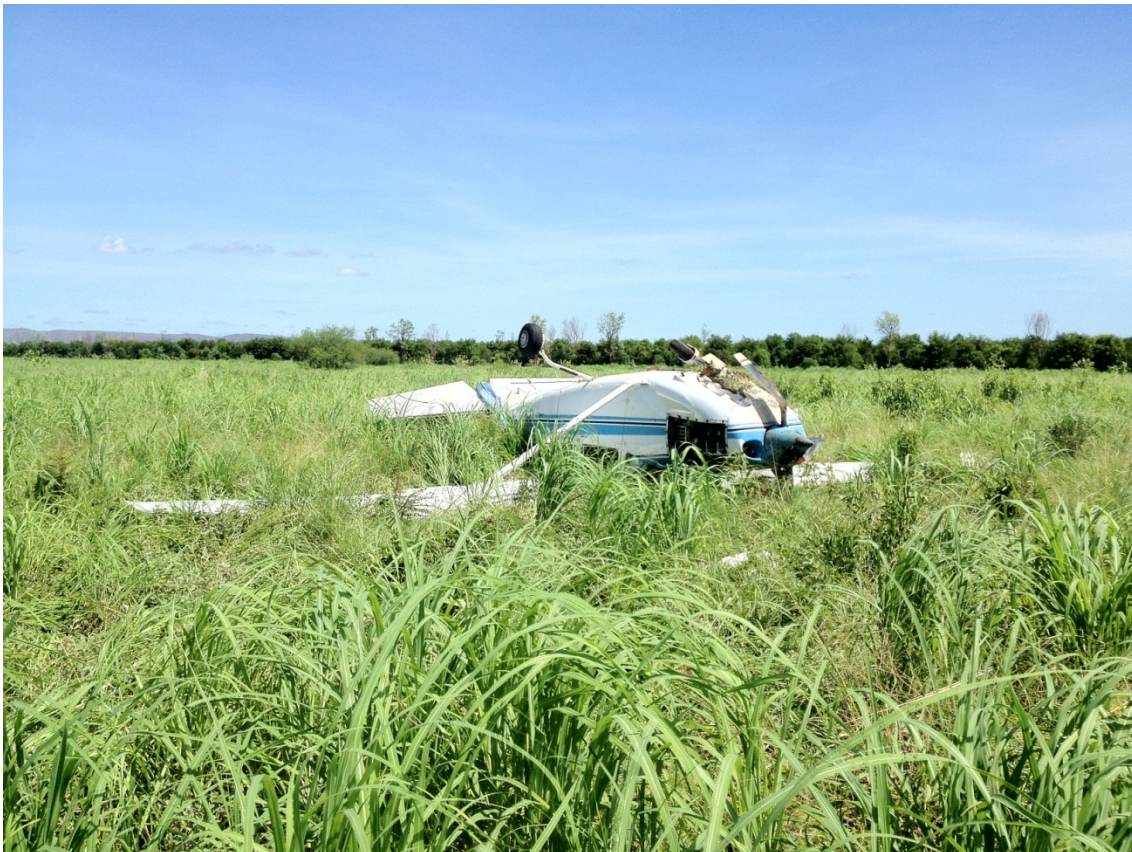
- A Cessna 182R took off from Kununurra Airport, WA on a charter flight with one passenger. When at about 100 ft above ground level, with insufficient runway distance remaining to abort the takeoff, the pilot retracted the landing gear. Immediately after, the engine failed. Due to the low altitude, the pilot confirmed that the engine controls were in the full forward position and that the fuel tank selector was on 'both'. The pilot then looked for a suitable place to land and saw a suitable field to the north. After extending the landing gear and selecting full flap, the main landing gear touched down in long grass and the aircraft decelerated rapidly. When the nose gear touched down, it dug into boggy ground and the aircraft flipped over, coming to rest inverted. The pilot and passenger received minor injuries and the aircraft sustained substantial damage. An engineering examination of the aircraft found no contaminants in the fuel or filters, and could not determine the reason for the engine failure (ATSB investigation AO-2013-023).

Engine failure involving a Cessna 182R Skylane (VH-OWZ), Kununurra Airport, Western Australia (ATSB investigation AO-2013-023)

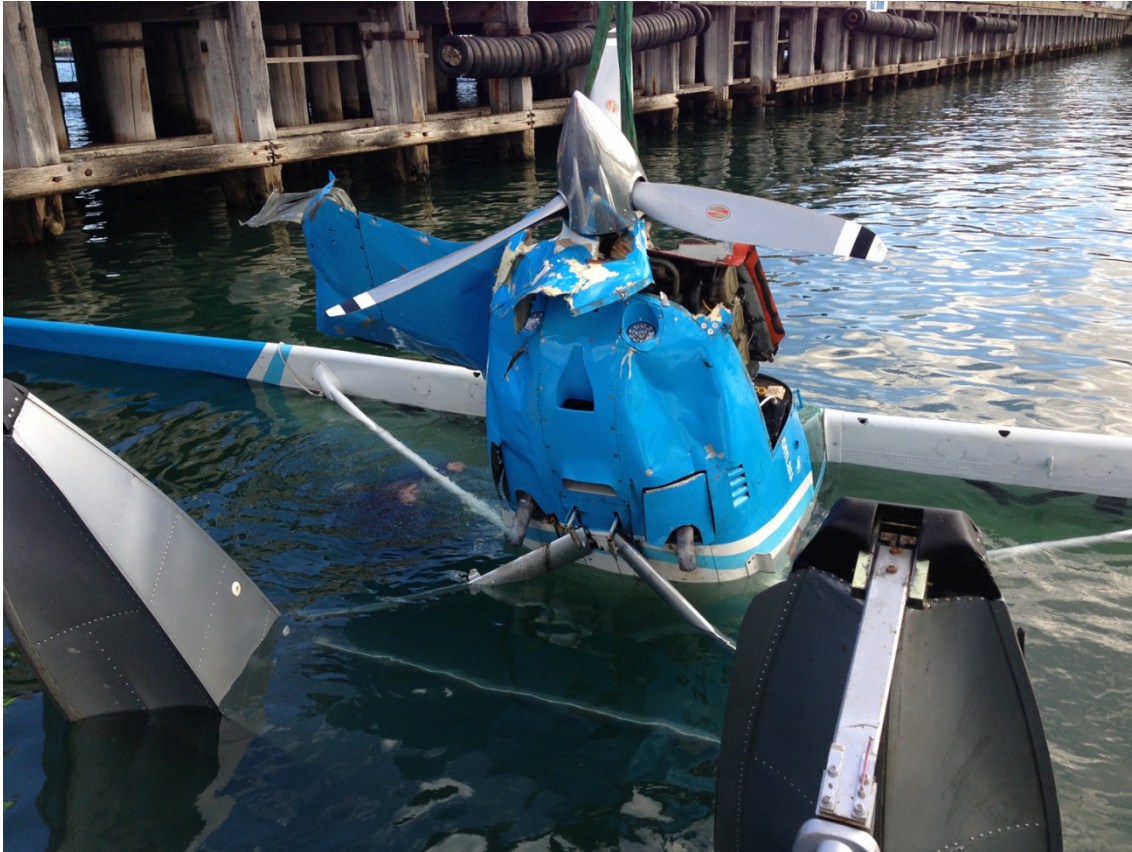
- A Cessna U206F amphibious aircraft was conducting a seaplane joy flight from Corio Bay, Vic. with two passengers on board. During the flight the pilot refuelled the aircraft at Barwon Heads Airport, necessitating the use of the landing wheels. On the return trip, the pilot detoured for local sightseeing before heading back to Corio Bay for a water landing. On touchdown, the aircraft pitched over and came to rest inverted. The pilot assisted the two passengers to evacuate the aircraft before rescue vessels arrived. All three occupants sustained minor injuries, and the aircraft was substantially damaged. The ATSB investigation found that the pilot was distracted during the departure from Barwon Heads, and as a result did not retract the landing wheels during the after take-off checks. On returning to Corio Bay, the pilot shortened the approach due to perceived time pressure and did not complete the normal downwind and short final checks. In not completing those checks, the pilot reduced the likelihood of identifying that the landing wheels were still extended. The operator's requirement for passengers to wear life jackets throughout the flight enhanced the survivability of the passengers (ATSB investigation AO-2013-020).

Wheels-down water landing involving a Cessna U206F Stationair floatplane (VH-UBI), Corio Bay, Victoria (ATSB investigation AO-2013-020)

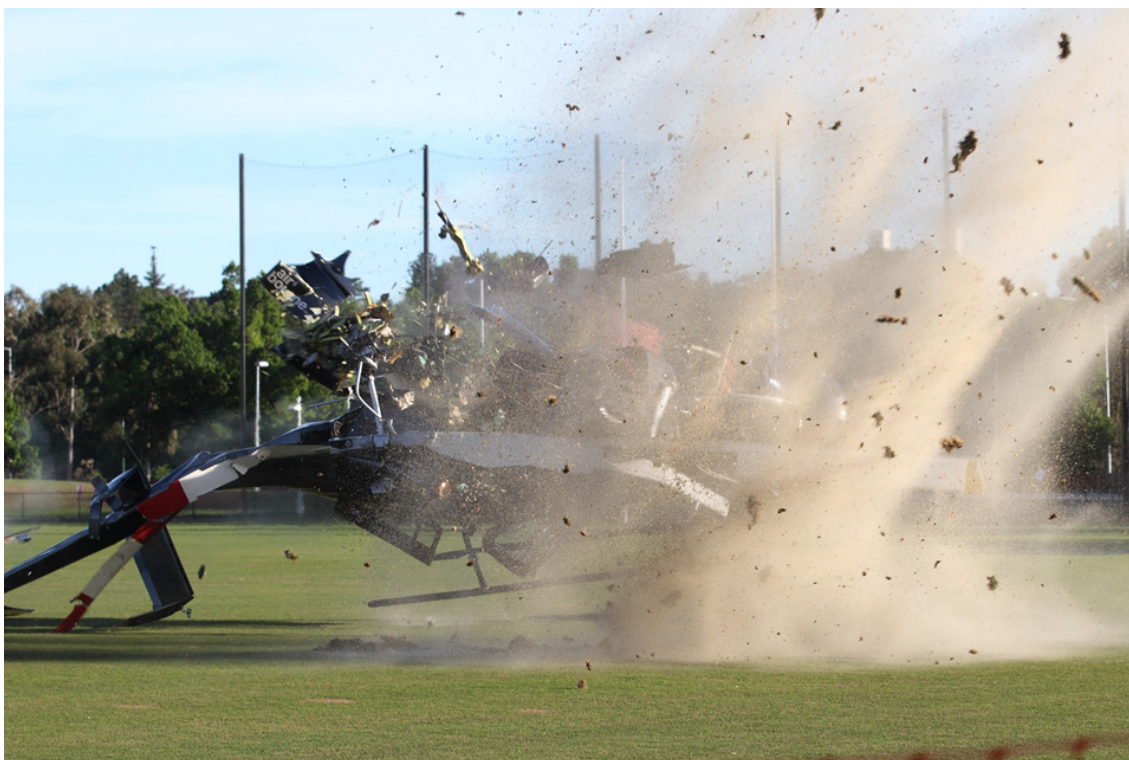
- A Bell 206L helicopter was conducting passenger ferry operations between Olympic Park and Flemington racecourse in Melbourne. Prior to the accident, the pilot was preparing to reposition the helicopter from one of the temporary helipads on the western side of the oval to a position that would allow the helicopter to depart for the racecourse. As the pilot began to lift the helicopter into a hover, witnesses observed the helicopter commencing to roll about the right skid. In rapid succession the left skid continued to rise and the helicopter rolled further right until the helicopter's main rotor blades contacted the ground. A large amount of high energy debris was released from the helicopter and impacted a nearby marquee and vehicles, including the helicopter on the adjacent helipad. The helicopter was extensively damaged, but no bystanders or persons in the cars or marquee were injured. The pilot sustained minor injuries and was able to exit the wreckage. The ATSB is currently investigating this accident and will be reviewing the planning of the charter operation, including the consideration of public safety. In the interim, the ATSB advises owners, operators and pilots of aircraft involved in public events to review their operations to assure themselves that existing risk controls address the hazards associated with operating aircraft in such environments (ATSB investigation AO-2013-199).

Collision with terrain involving a Bell 206L helicopter (VH-VDZ), Melbourne, Victoria (ATSB investigation AO-2013-199) – picture shows right roll and main rotor ground strike

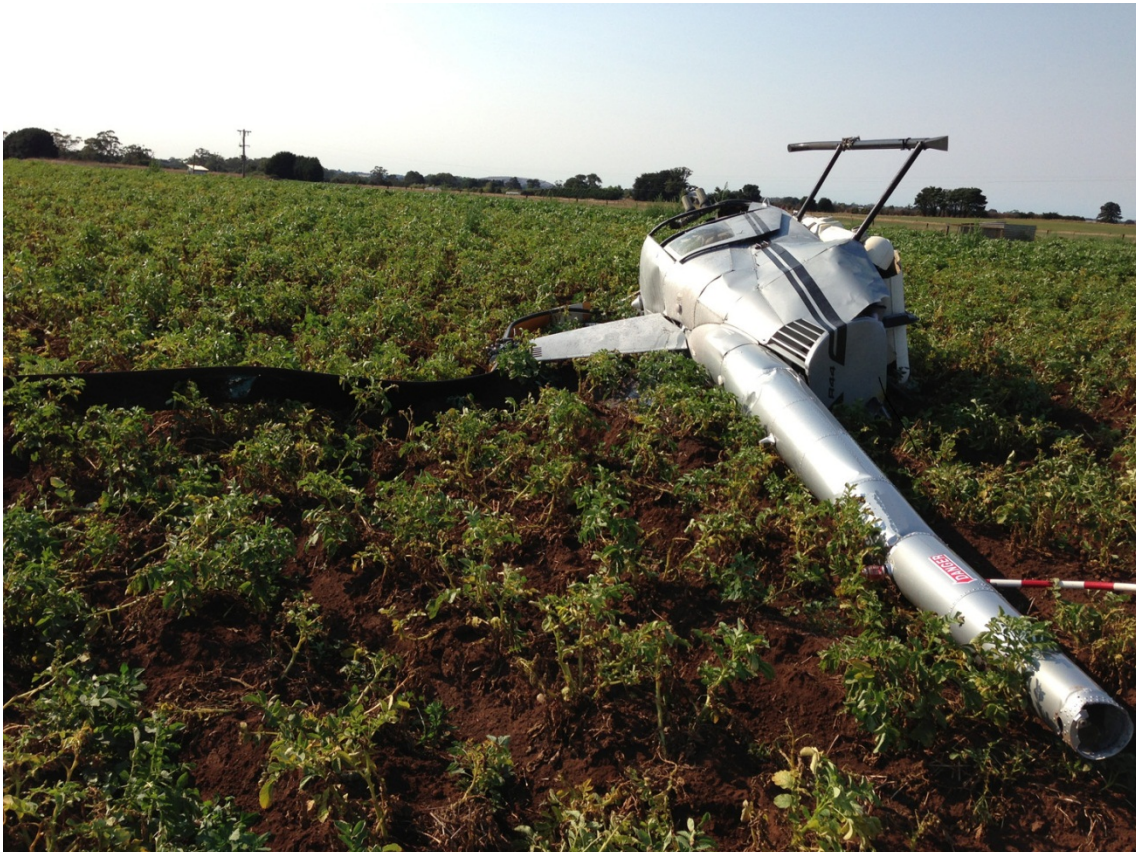
Wirestrike involving a Robinson R44 helicopter (VH-HGF), near Ballarat, Victoria (ATSB investigation AO-2013-042)

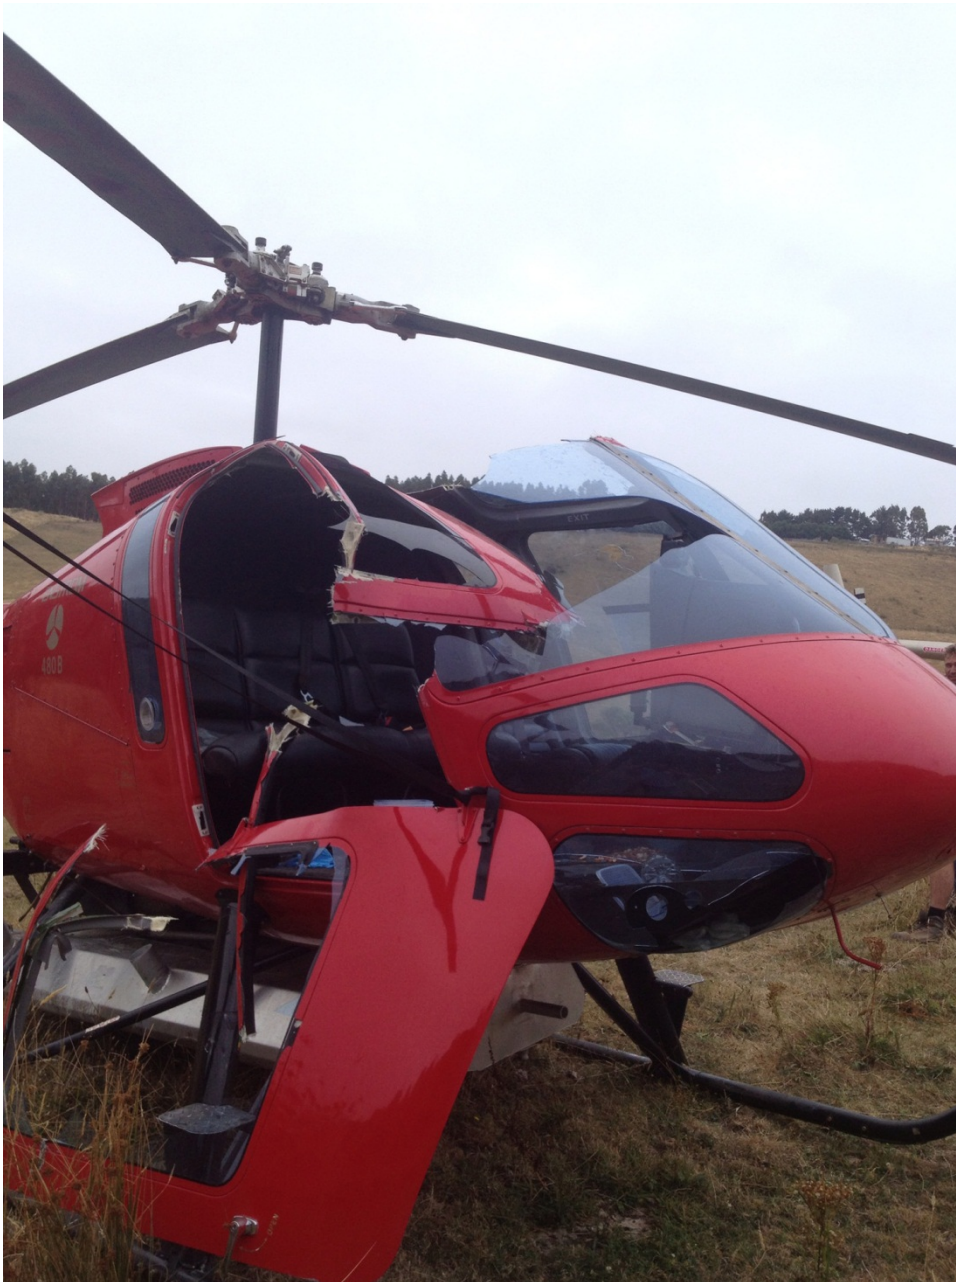
reception, the pilot commenced a left turn at about 50 kt indicated airspeed to return to the paddock and recommence the application run. The pilot then heard a loud bang and felt a shudder through the airframe as the helicopter struck a wire. The pilot performed a run-on landing in the nearest clearing but had difficulty in maintaining yaw control because the tail rotor control cables had lost tension. The pilot was able to exit the helicopter without injury, however, the helicopter was substantially damaged. The ATSB was advised by the owner of the wire that it was marked with five marker discs, however, the pilot advised that the wire was unmarked at the time of the wirestrike. The ATSB investigation was unable to independently confirm that the maker discs were still in place at the time of the wirestrike. As a result of this accident, the wire was replaced and arrangements are being made to install markers on the line (ATSB investigation AO-2013-031).

Wirestrike involving an Enstrom 480B helicopter (VH-VDC), near Ballarat, Victoria (ATSB investigation AO-2013-031)

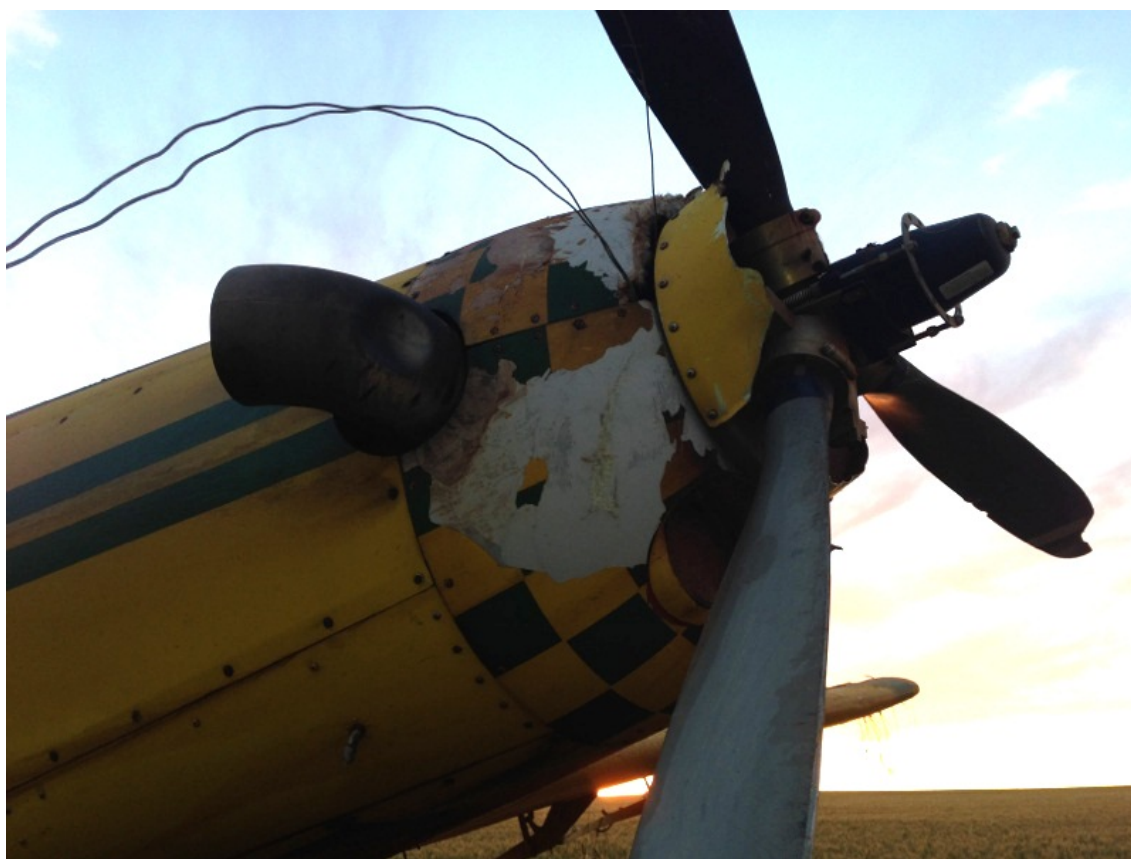
Wirestrike involving an Air Tractor AT-502 (VH-CJY), near Temora, New South Wales (ATSB investigation AO-2013-180)

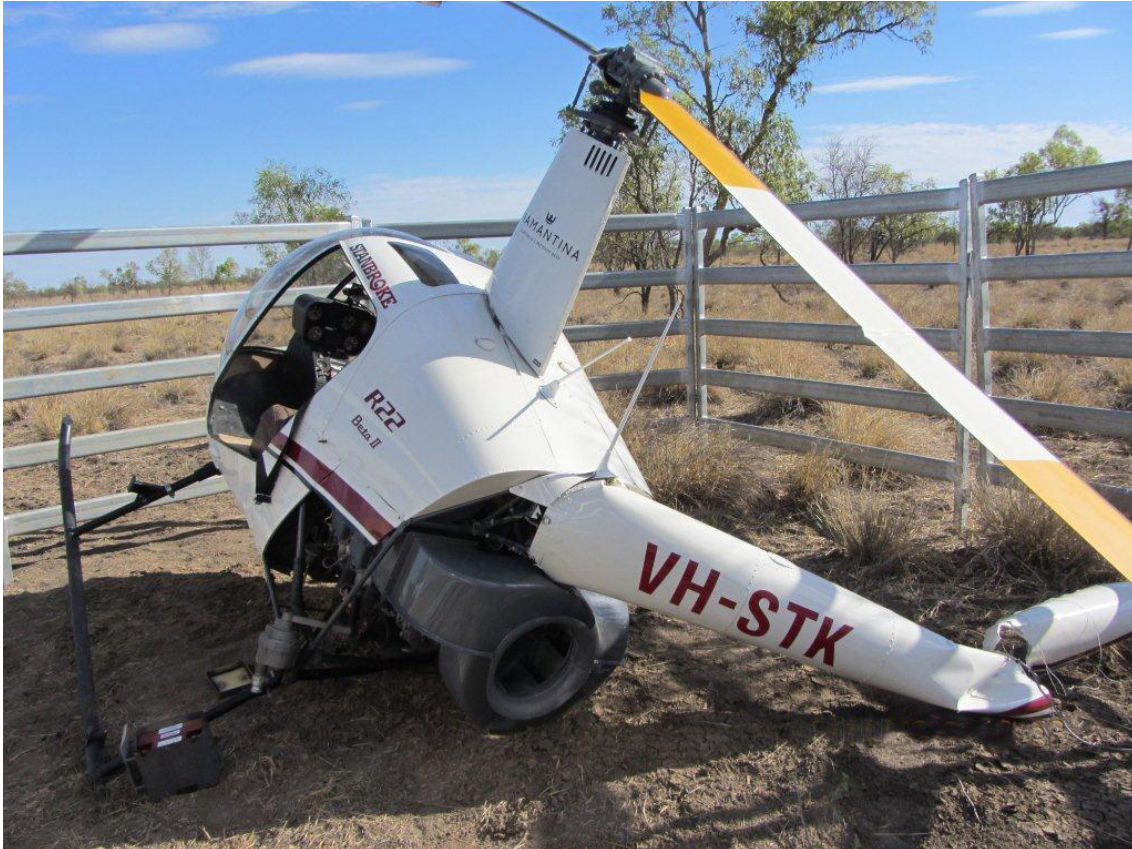
Total power loss involving a Robinson R22 helicopter (VH-STK), 155 km south-west of Normanton, Queensland (ATSB investigation AO-2013-211)

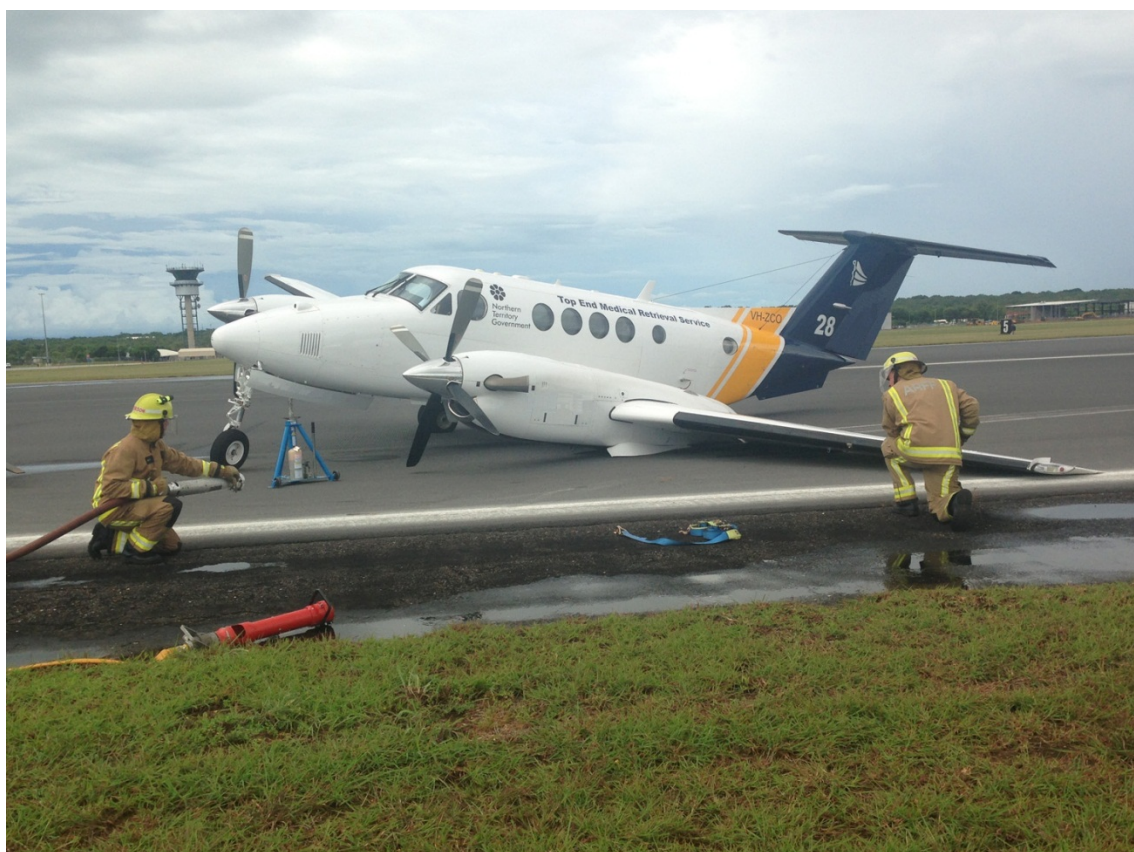
Left main landing gear collapse involving a Beech B200 King Air (VH-ZCO), at Darwin Airport, Northern Territory (ATSB investigation AO-2013-062)

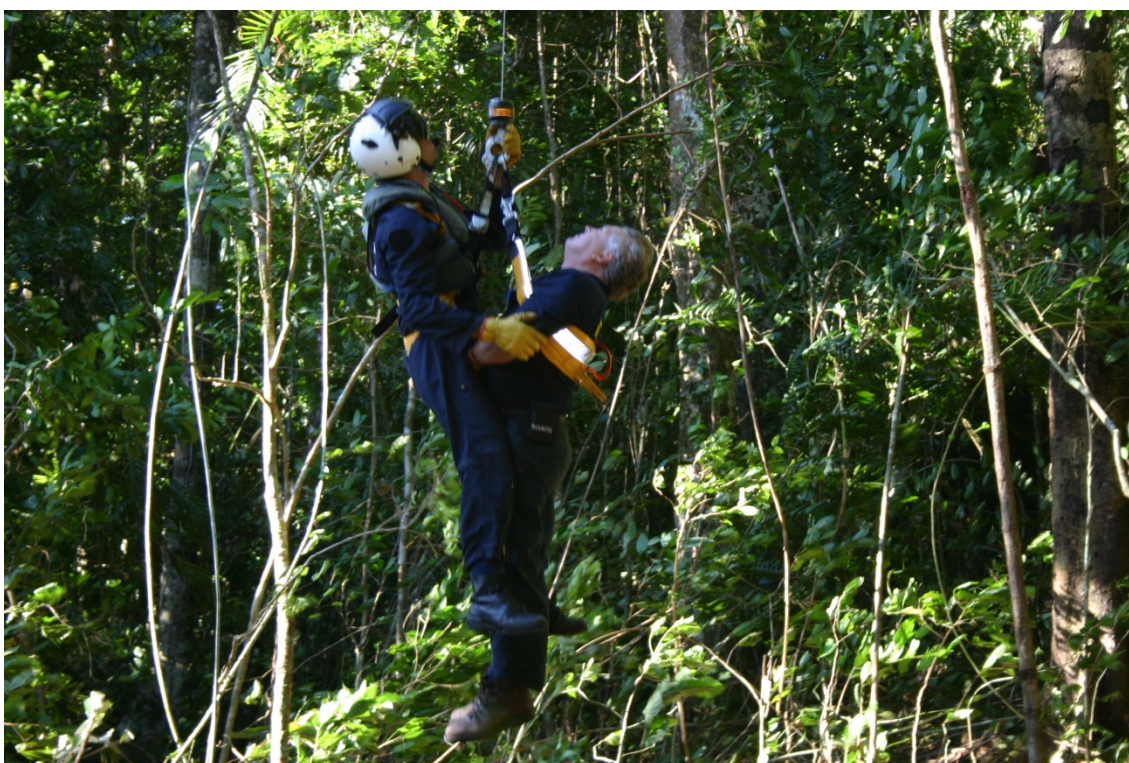
Operational accident involving a Bell 412 helicopter (VH-VAS), near Mansfield, Victoria (ATSB investigation AO-2013-136) – example of a double-lift with a rescue/retrieval strop

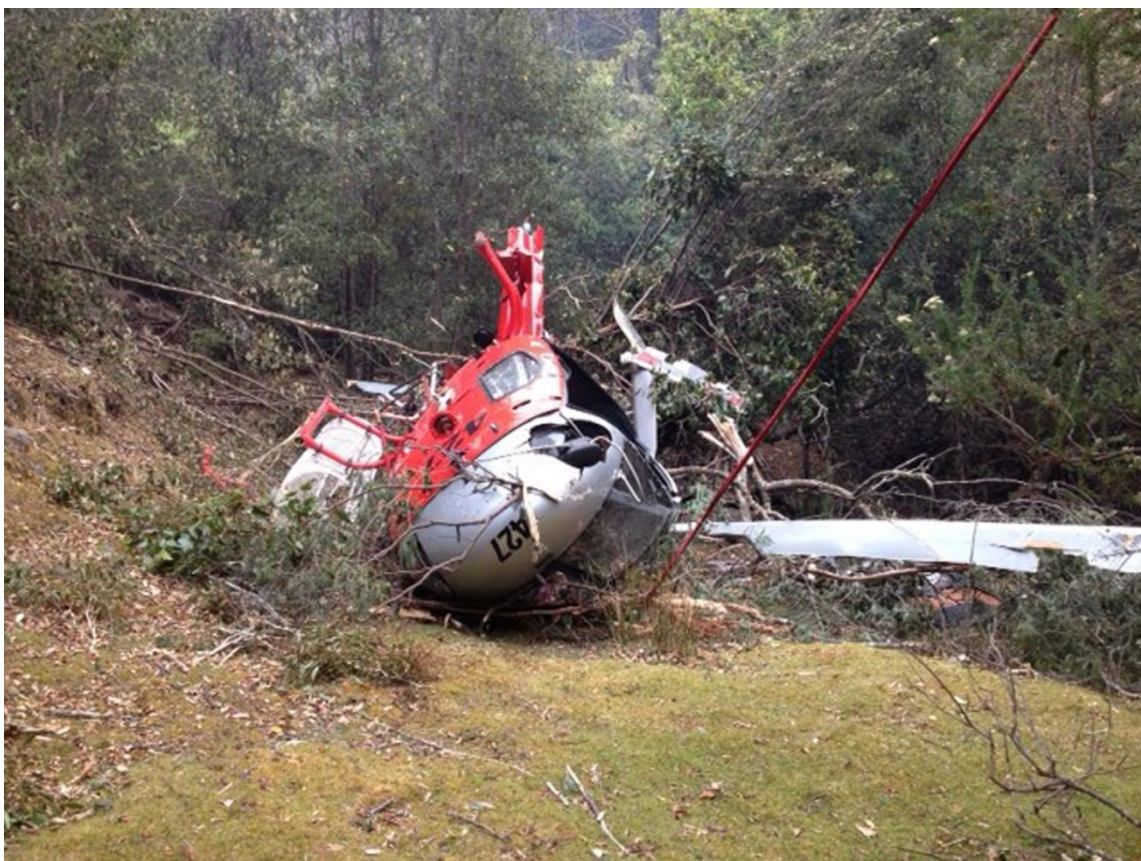
Collision with terrain involving a Eurocopter AS.350 B2 helicopter (VH-EWM), near Hobart, Tasmania (ATSB investigation AO-2013-026)

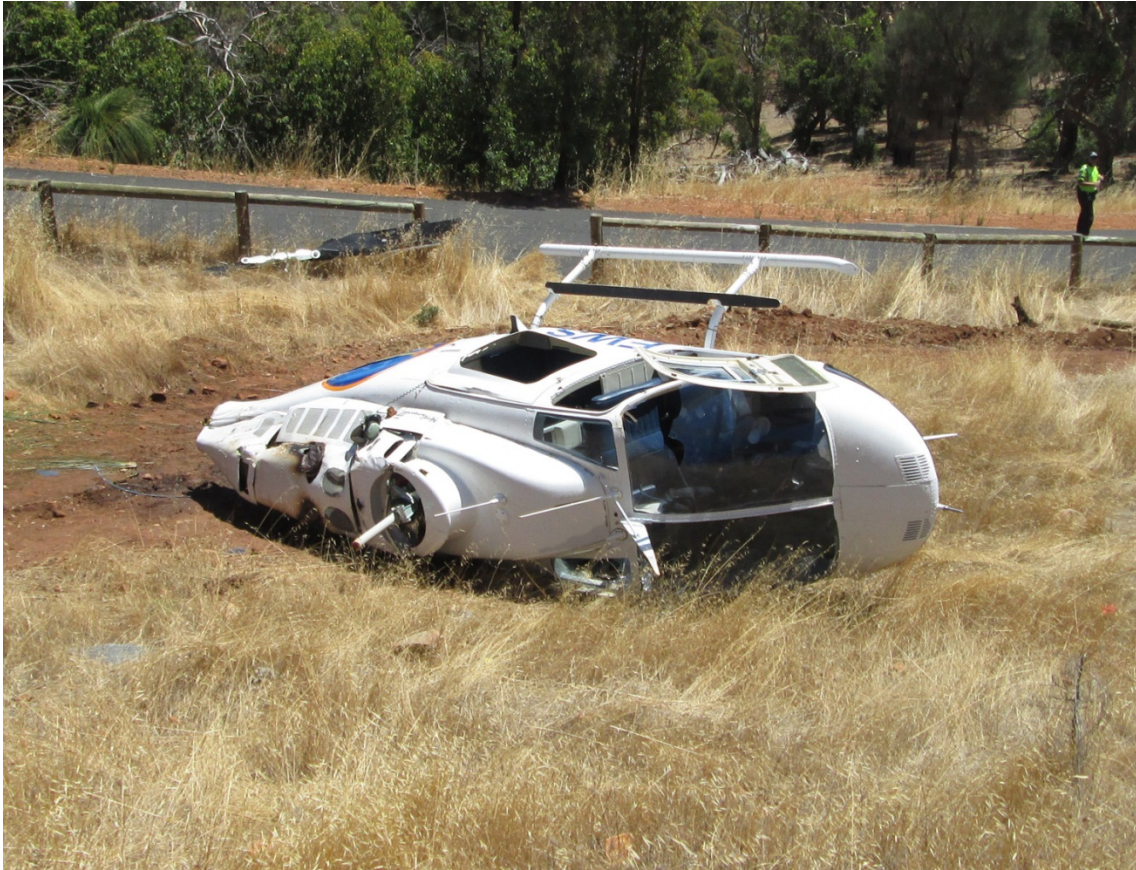
Loss of control and forced landing involving a Bell 206B helicopter (VH-ZMN), near Perth, Western Australia (ATSB investigation AO-2013-016)

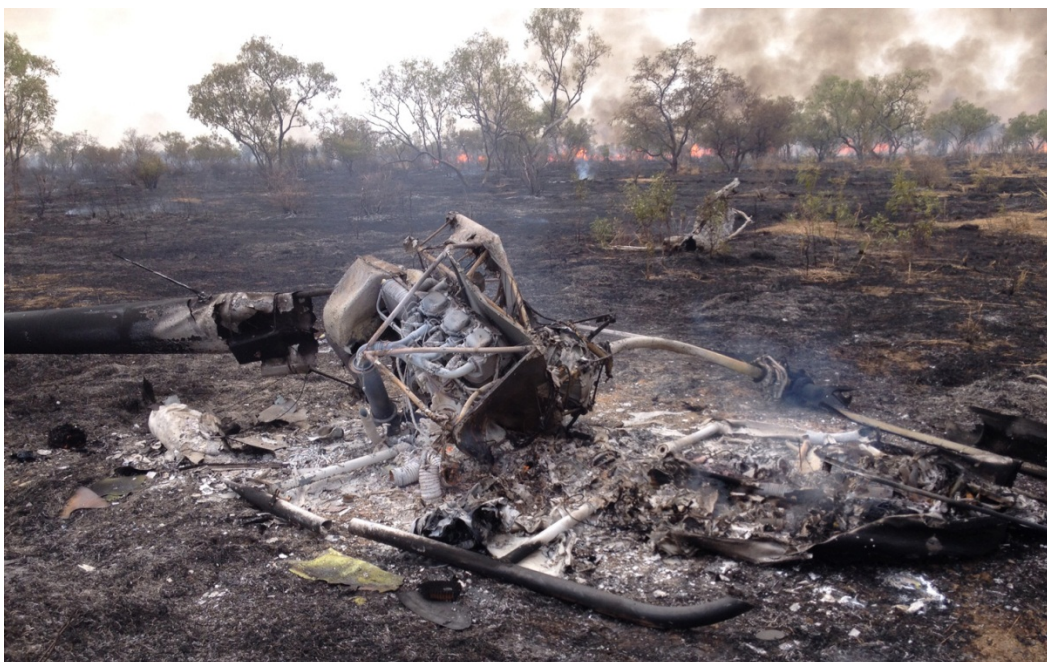
Ground fire involving a Robinson R44 helicopter (VH-TZE), near Daly Waters, Northern Territory (ATSB investigation AO-2013-192)

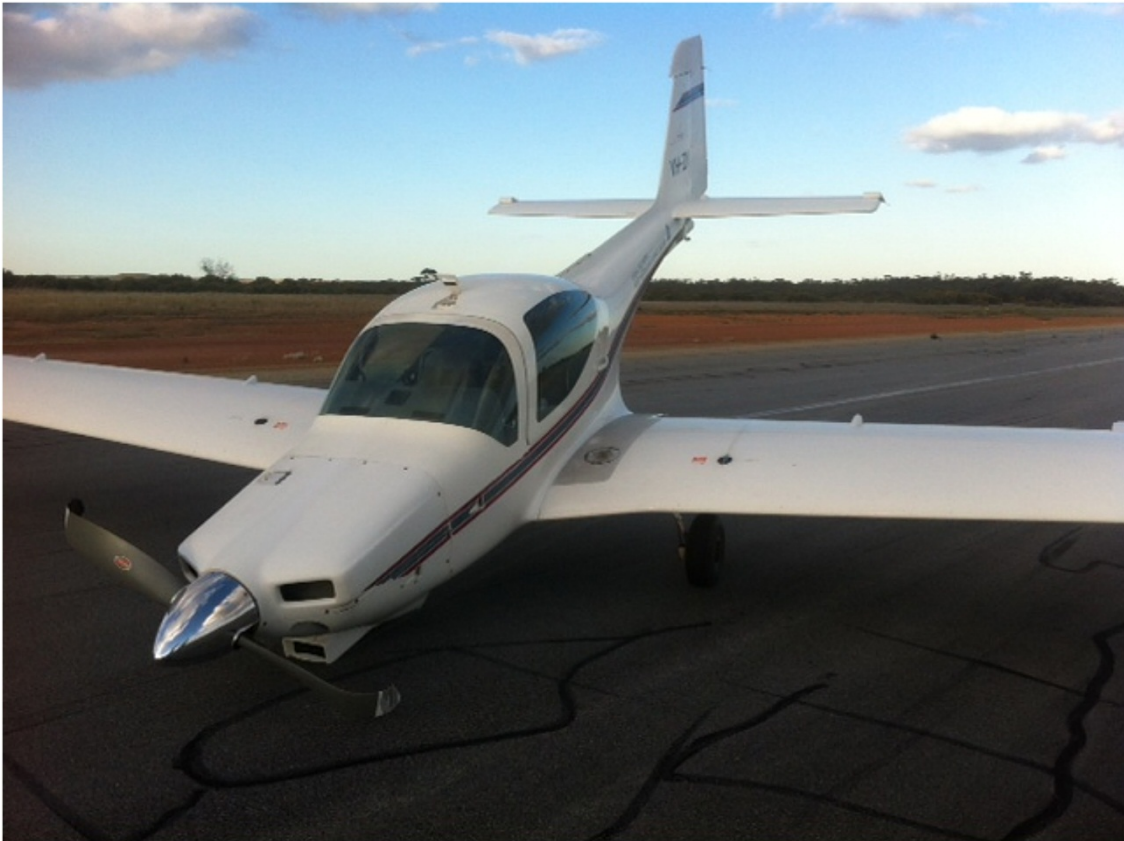
Hard landing involving a Grob G-115 (VH-ZIV), at Merredin, Western Australia (ATSB investigation AO-2013-178)

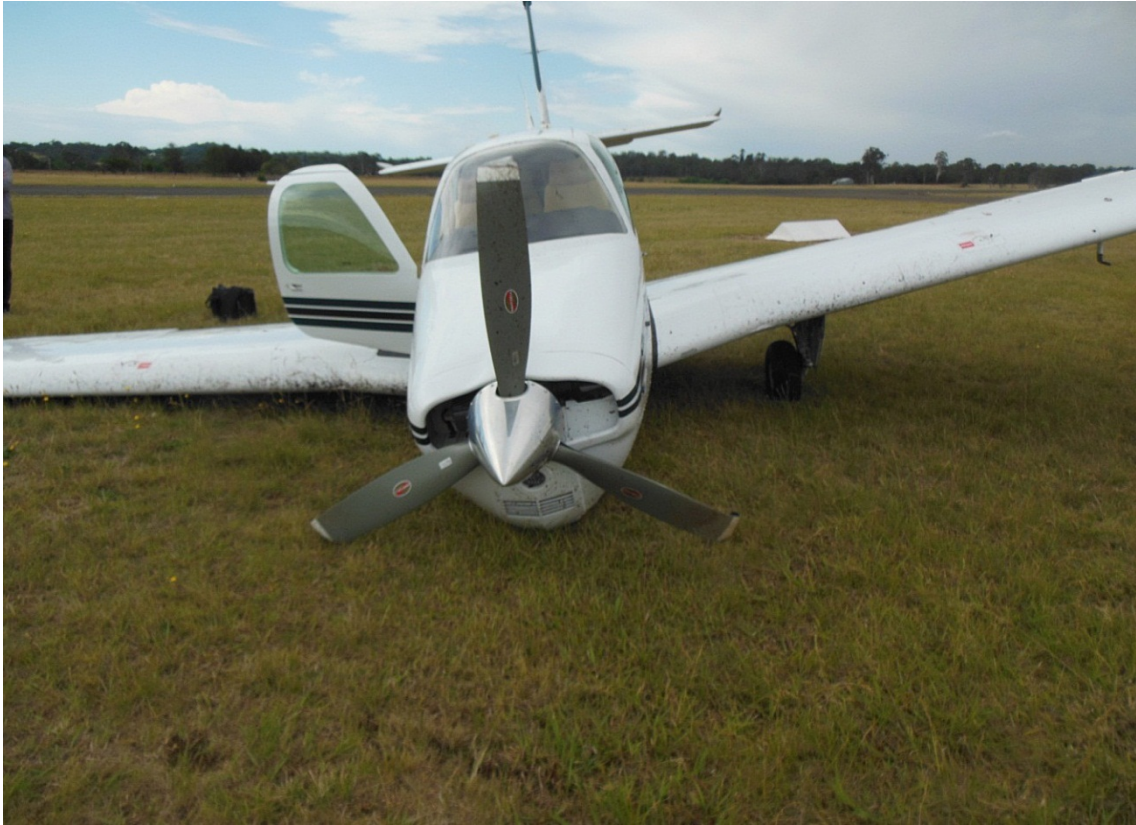
Incorrect configuration event involving a Beech A36 Bonanza (VH-YEN), at Camden Airport, New South Wales (ATSB investigation AO-2013-207)
