Australian Government
Australian Transport Safety Bureau

Aviation Occurrence Statistics

2004 to 2013

ATSB Transport Safety Report
Aviation Research Statistics
AR-2014-084
Final – 5 November 2014

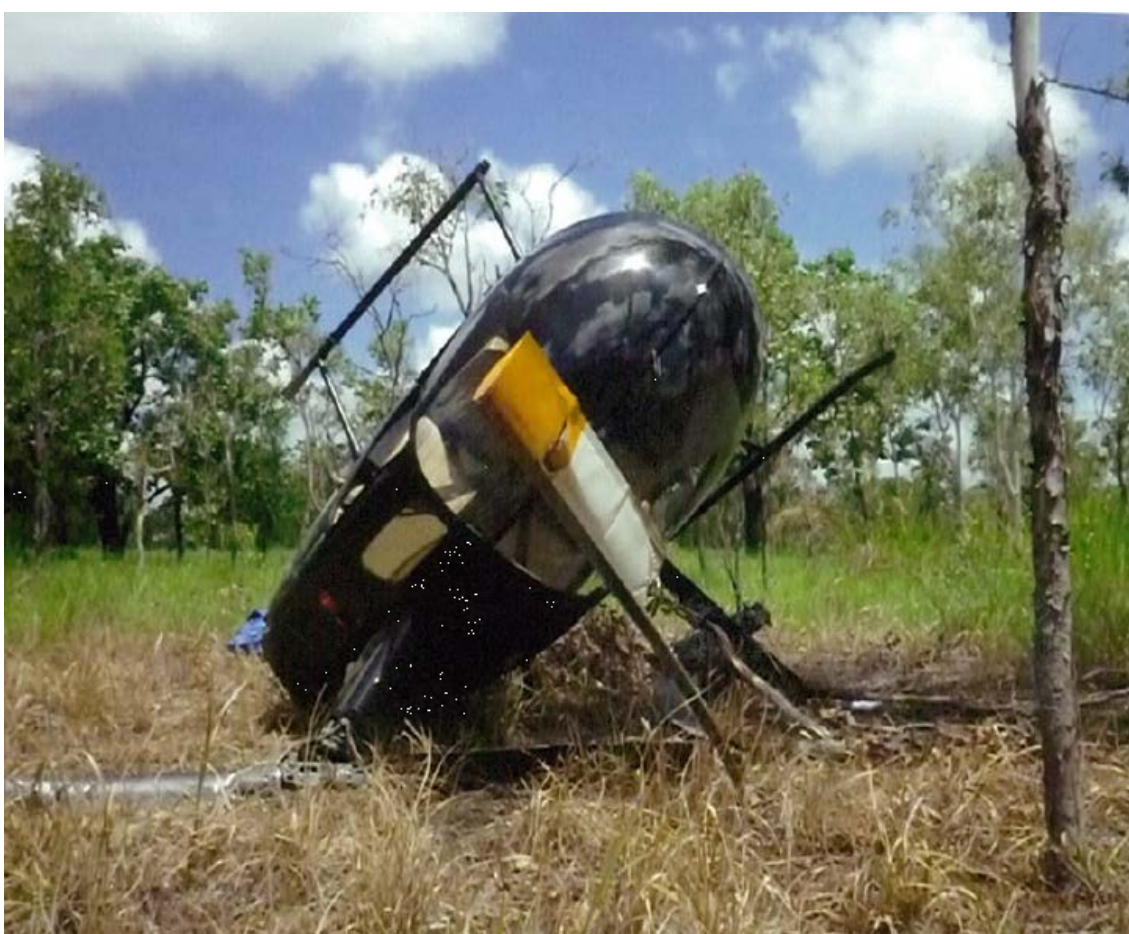
Loss of control involving a Robinson R22 helicopter (VH-HGI), at Adelaide River Station, Northern Territory (ATSB investigation AO-2013-021)

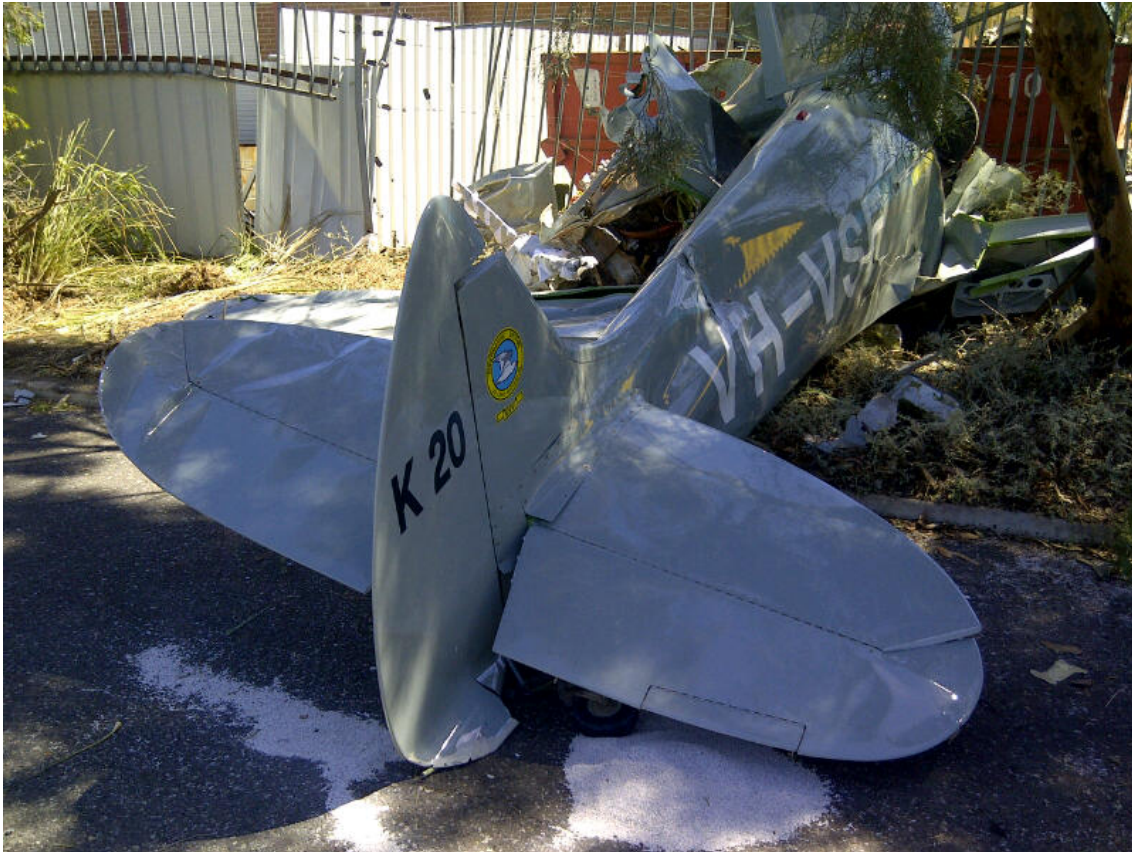
Loss of control involving a Supermarine Spitfire scale-replica (VH-VSF), near Parafield Airport, South Australia (ATSB investigation AO-2013-051)

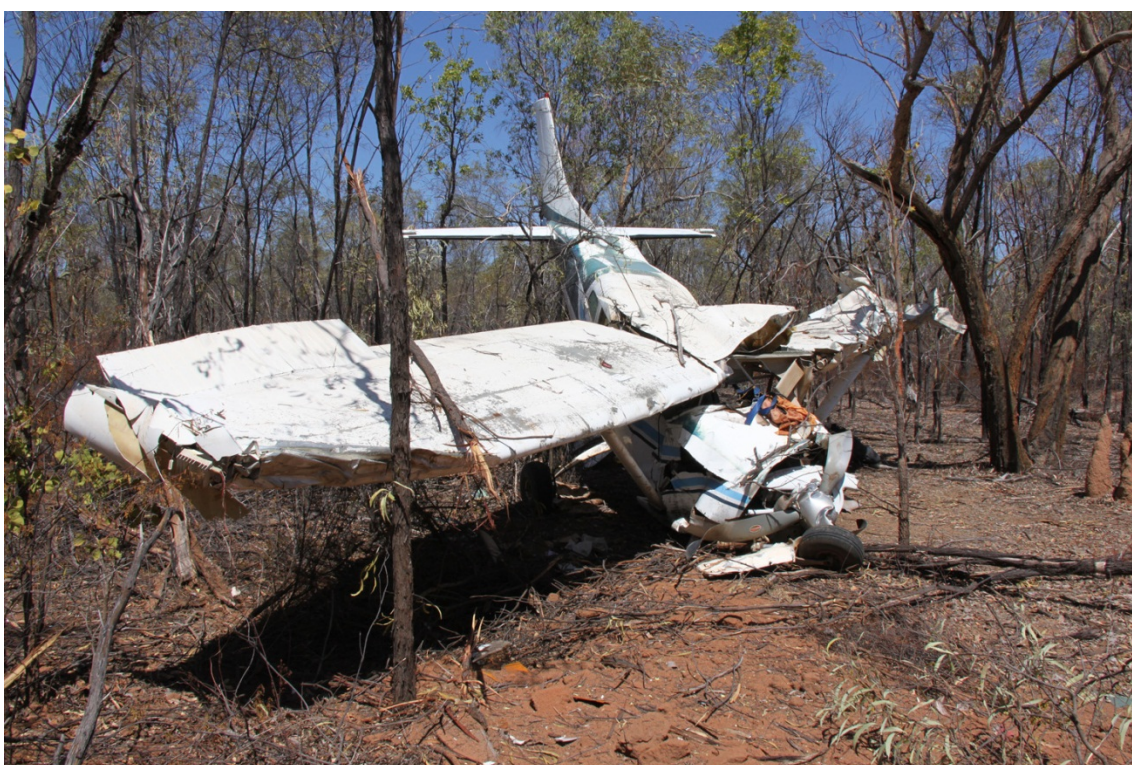
Collision with terrain involving a Cessna 206 Stationair (VH-WAV), 156 km south-southeast of Croydon, Queensland (ATSB investigation AO-2013-151)

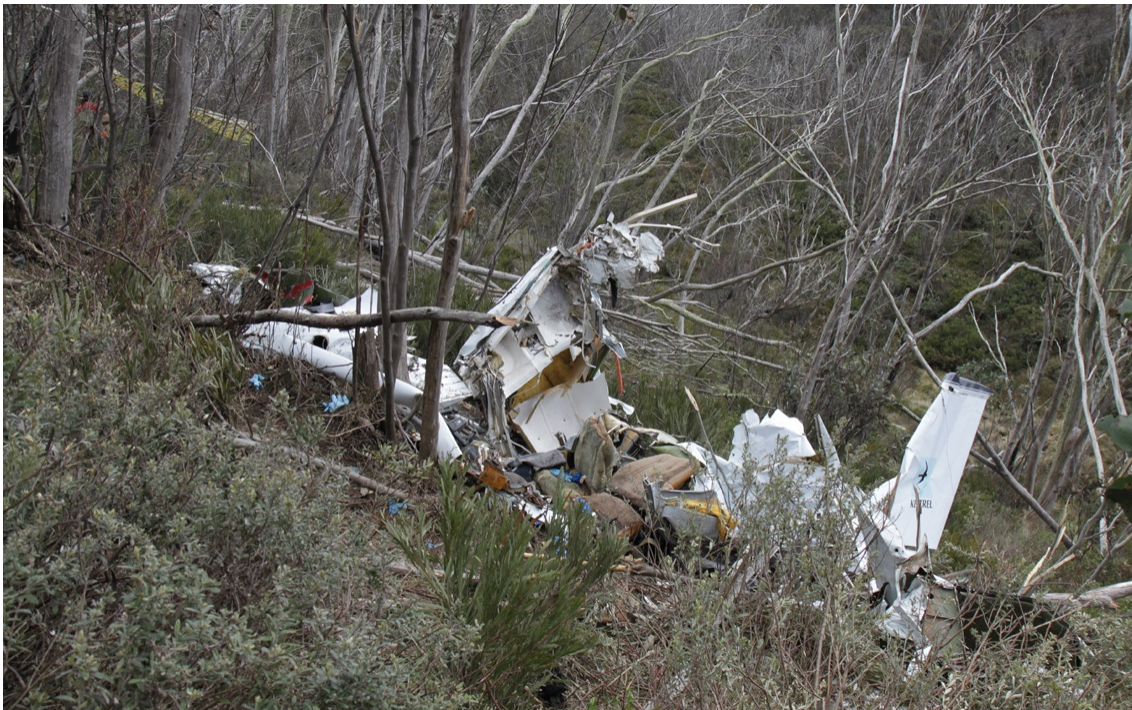
Collision with terrain involving a Cessna 182 Skylane (VH-KKM), near Mount Hotham, Victoria (ATSB investigation AO-2013-186)

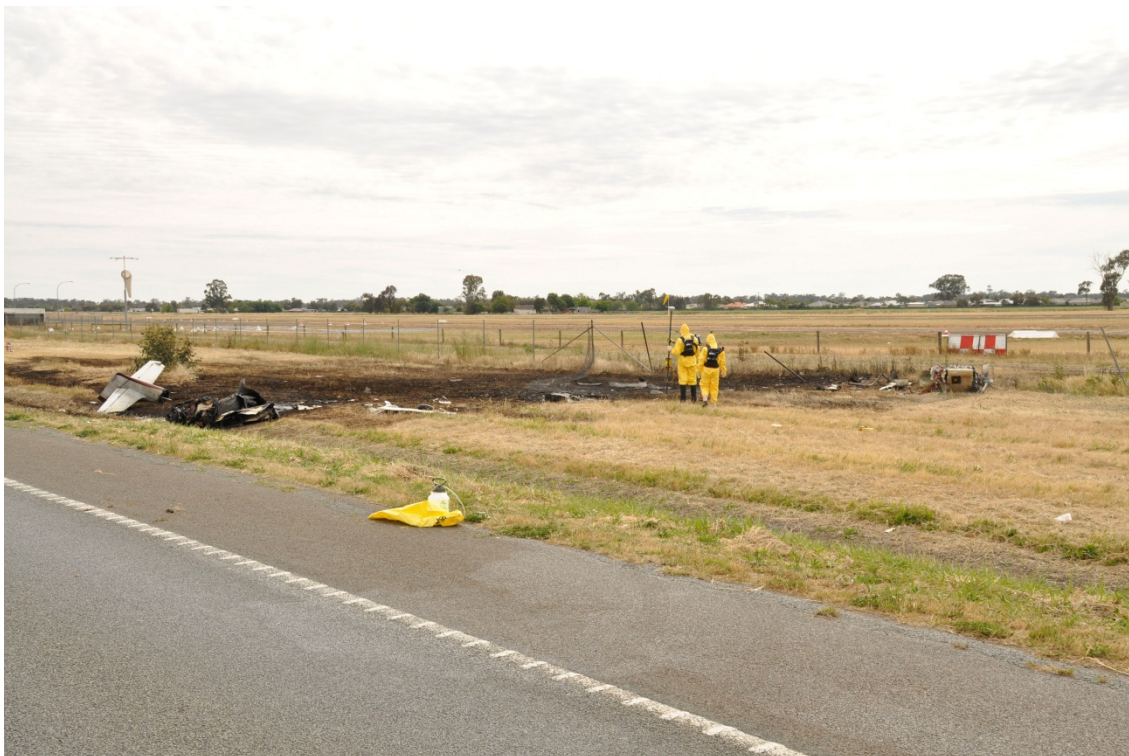
Collision with terrain involving a Lancair Legacy (VH-ICZ), at Shepparton Airport, Victoria (ATSB investigation AO-2013-193)

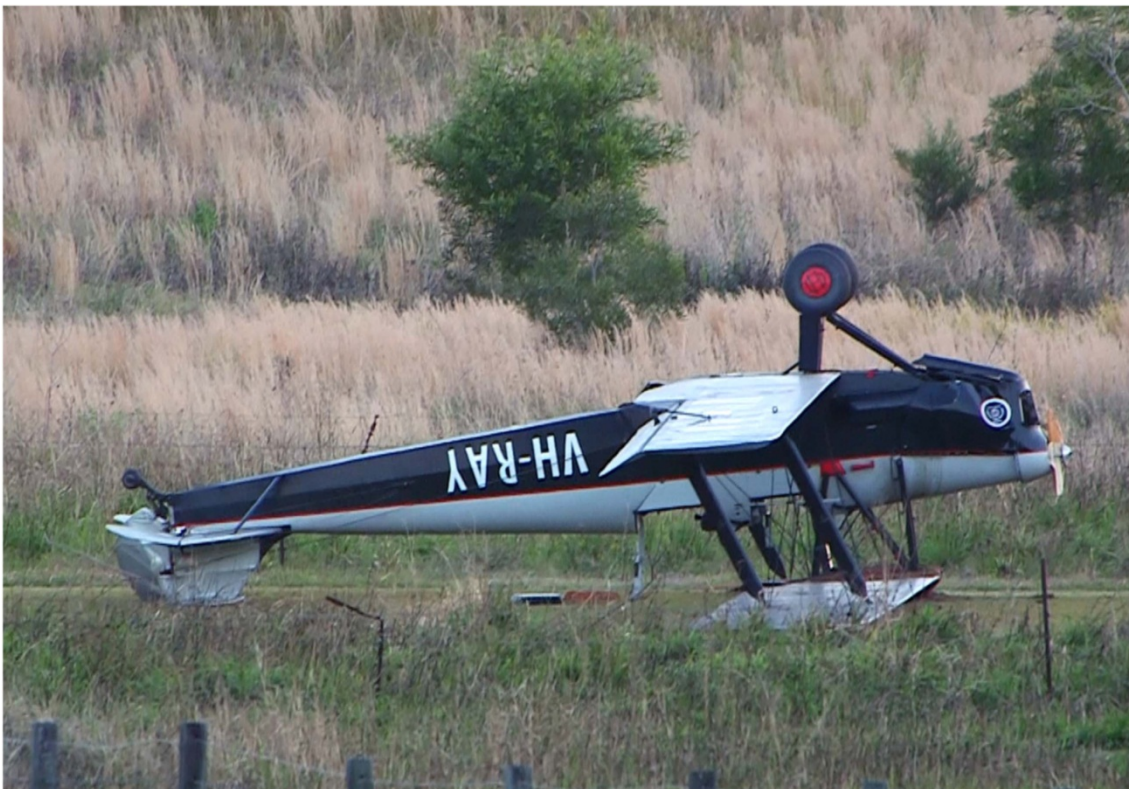
Take-off event involving a de Havilland DH.82 Tiger Moth (VH-RAY), near Coffs Harbour, New South Wales (ATSB investigation AO-2013-190)

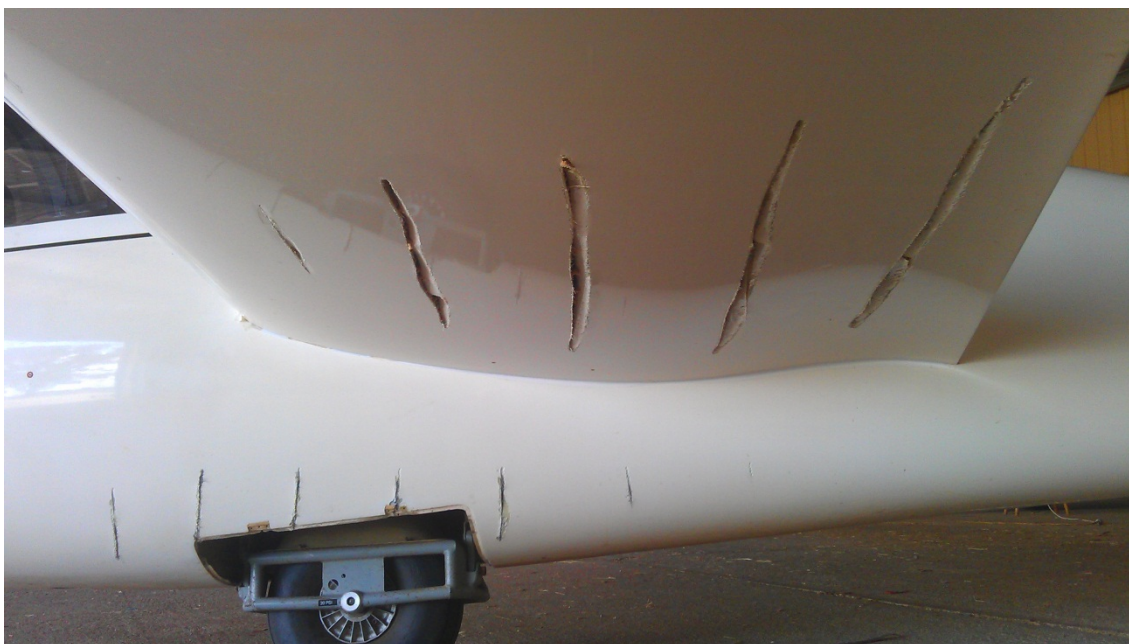
Collision on runway between a Grob G103 Twin Astir glider (VH-UIZ) (pictured) and a Cessna 150 (VH-ROZ), at Tocumwal Airport, New South Wales (ATSB investigation AO-2013-048)

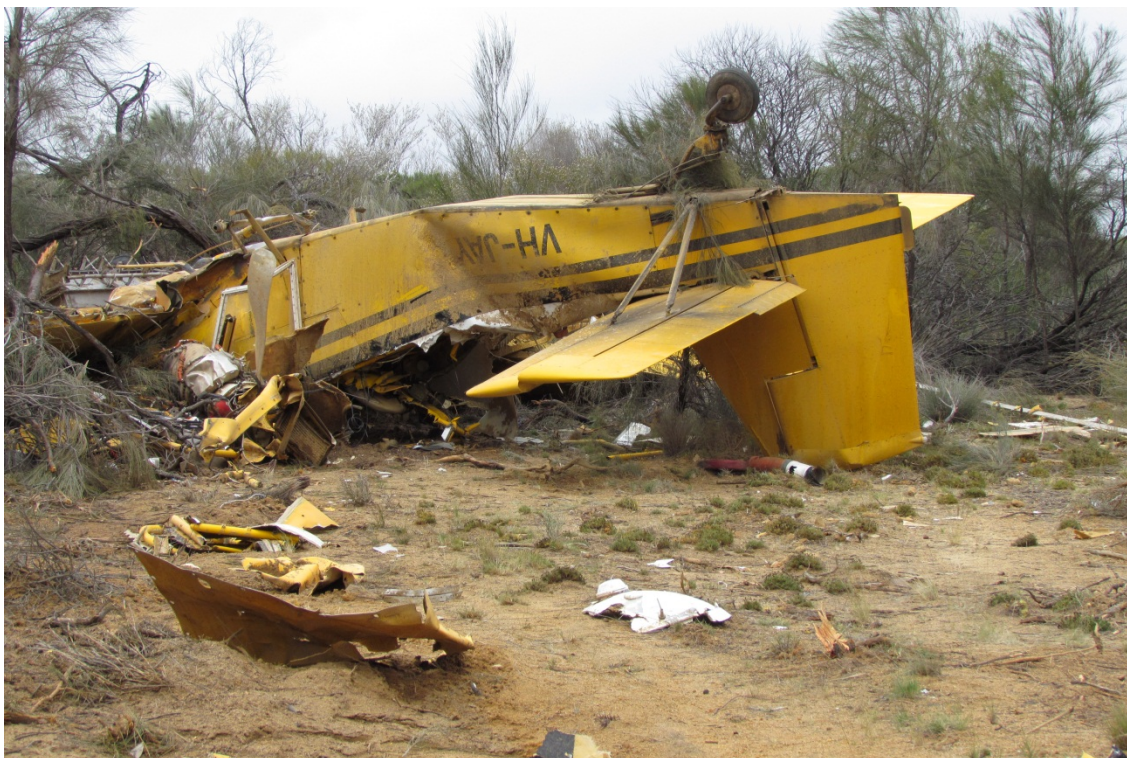
Collision with terrain involving an Ayres S2R Thrush (VH-JAY), near Hyden, Western Australia (ATSB investigation AO-2013-183)

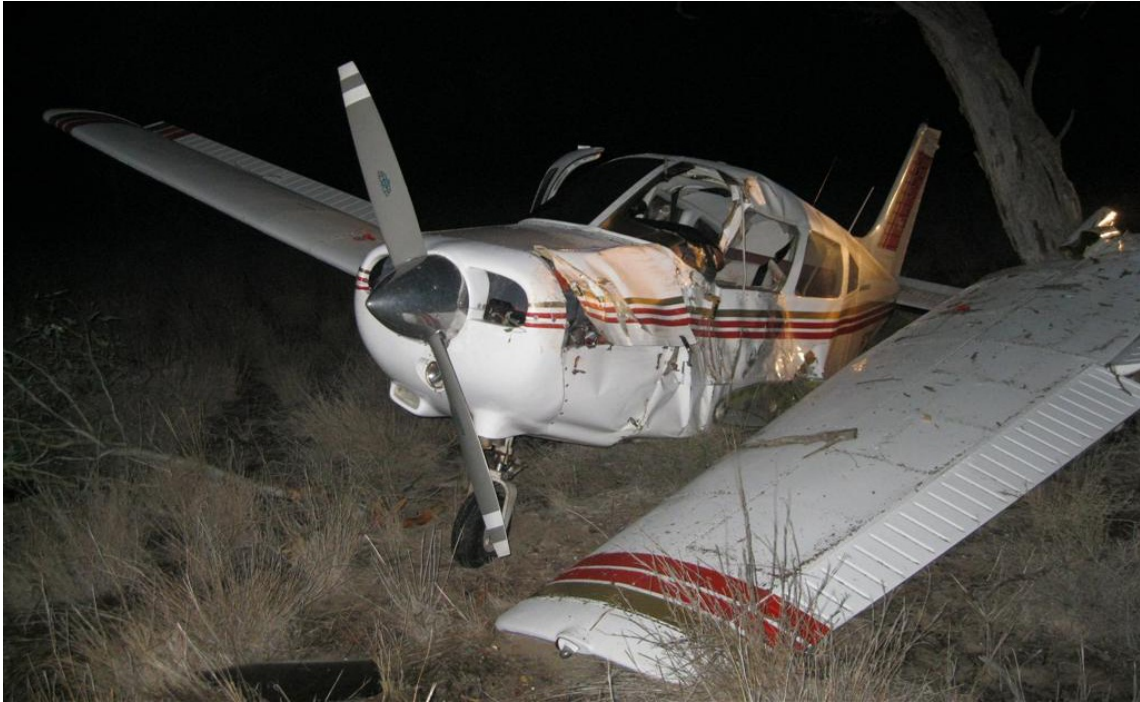
Total power loss involving a Piper PA-28-161 Warrior (VH-CCQ), near Cunnamulla, Queensland (ATSB investigation AO-2013-168)

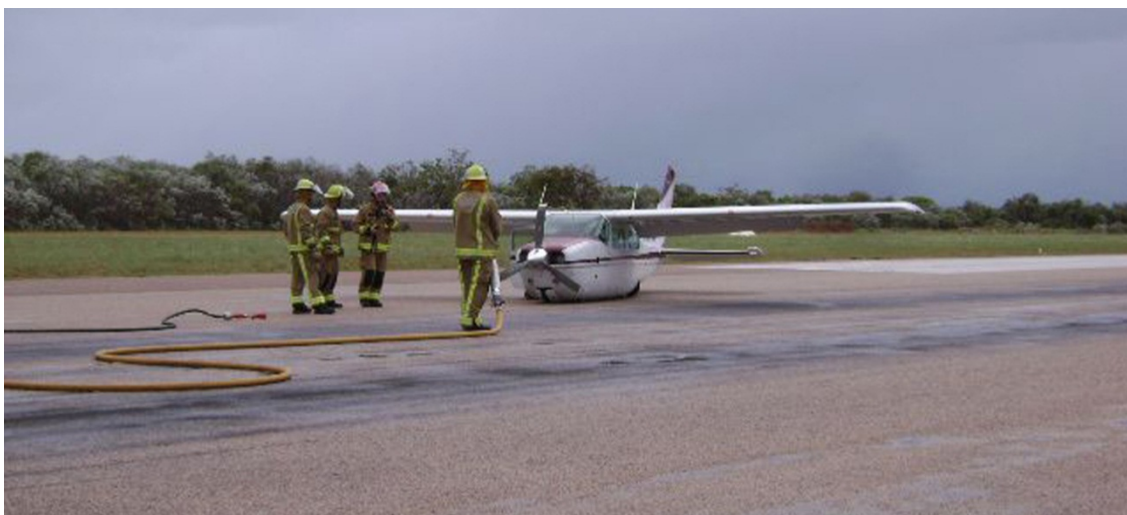
Collapsed landing gear involving a Cessna 210 Centurion (VH-PBV), at Broome Airport, Western Australia (ATSB investigation AO-2013-039)

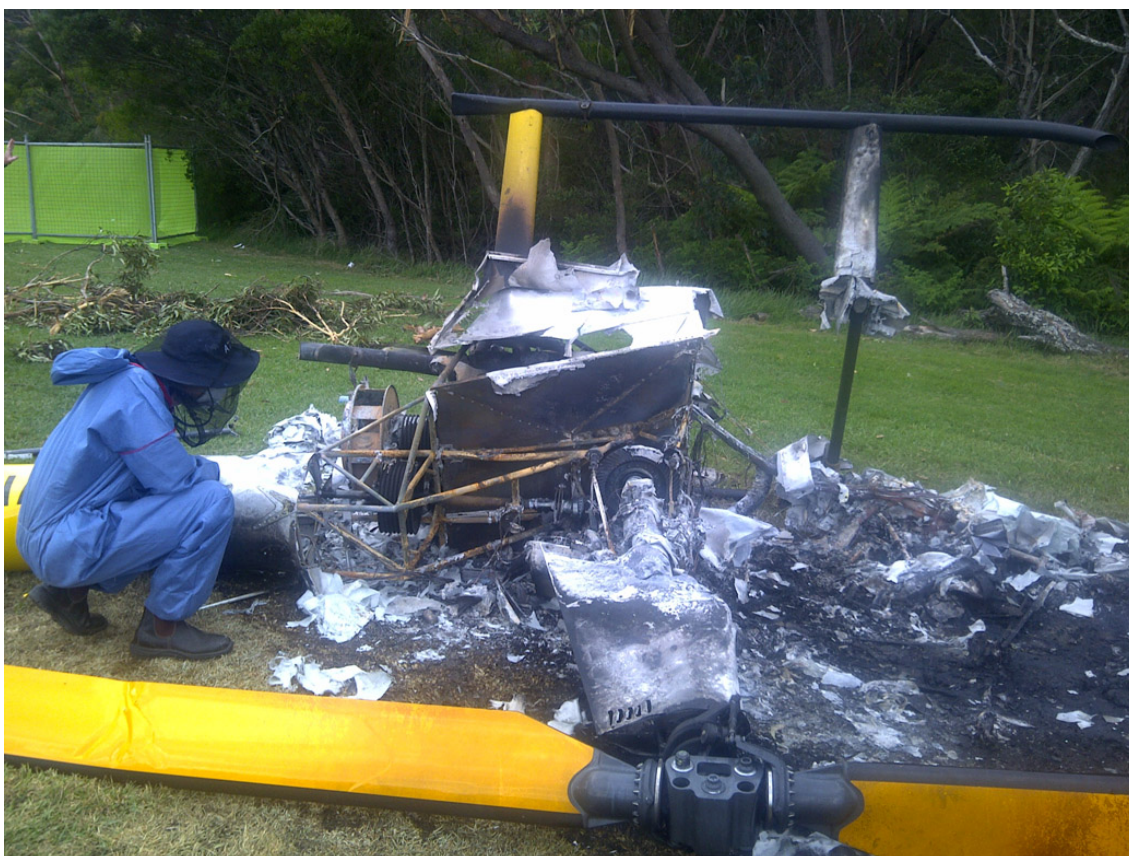
Collision with terrain involving a Robinson R44 helicopter (VH-HWQ), at Bulli Tops, New South Wales (ATSB investigation AO-2013-055)

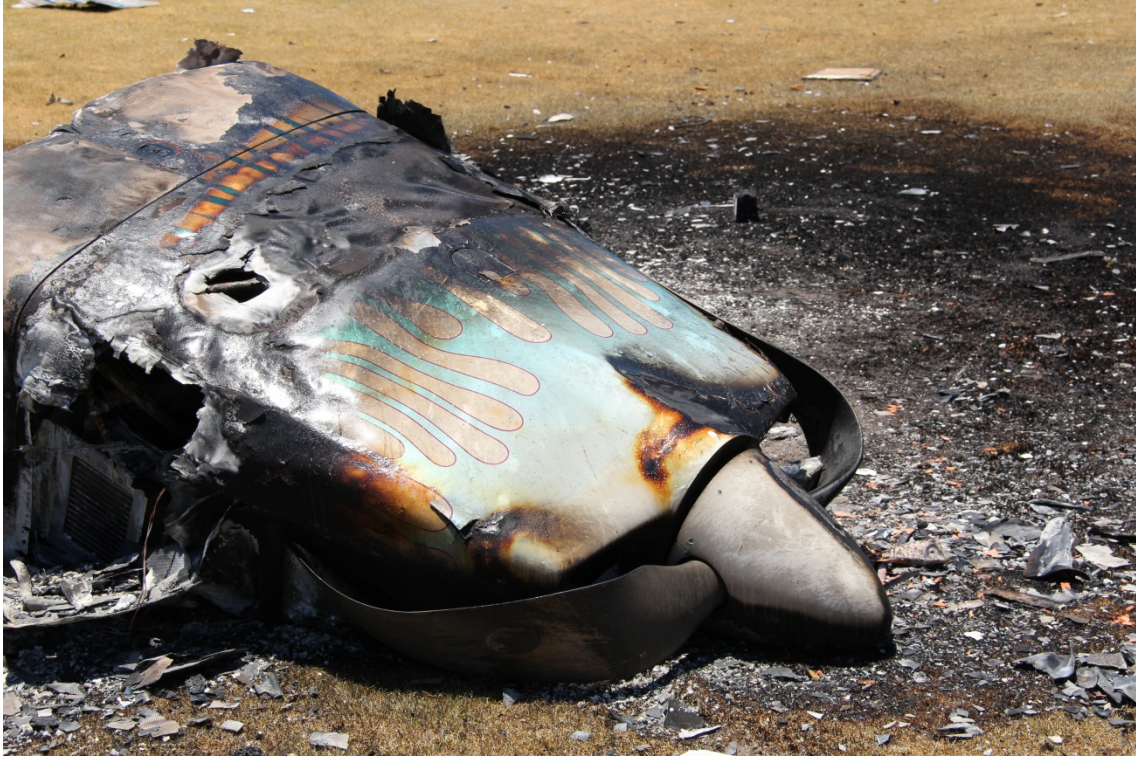
Collision with terrain involving a Glasair III (VH-USW), near Jandakot, Western Australia (ATSB investigation AO-2013-221)
