Collision between V/Line train 8280 and MTM train 6502

Altona, Victoria, 22 August 2014

ATSB Transport Safety Report
Rail Occurrence Investigation
RO-2014-016
Preliminary – 13 November 2014

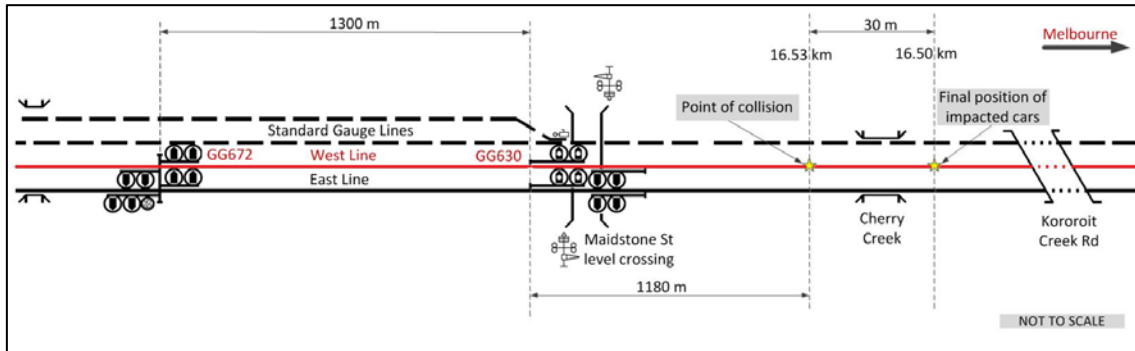
Figure 2 – Collision location and signals

The train departed Laverton Railway Station and all signal aspects from Laverton were at clear normal speed (Green over Red). At about 1855, the train achieved a maximum speed of 115 km/h — the maximum authorised line speed for this section of track. The train then passed signal GG630 (Figure 2) that was also indicating a clear normal speed aspect, and had just crossed over Cherry Creek, when the driver heard a ‘loud bang’ from under the train. He noted that the brake pipe pressure had decreased and the brake cylinder pressure had increased. There was an immediate reduction in speed and the driver placed the brake handle to the full service braking position. When the train came to a stop, he placed the Reverser to the off position, which

After passing signal GG630 the V/Line train reached a speed of 43 km/h and collided at this speed with the rear of the stationary MTM service 6502 at about 1901. The MTM train was shunted about 30 metres due to the impact and the impacted cars stopped at about the 16.5 rail km mark, approximately 1210 m from signal GG630. The driver of the MTM train was thrown onto the cab floor by the impact. The V/Line driver was trapped between the train control console and the seat but managed to extricate himself by lowering the seat. He got out of his cab, walked towards the MTM train and spoke to passengers to inquire as to their wellbeing and then spoke to the MTM driver who was still in the cab of his train.

The track infrastructure in this section consisted of a Broad Gauge East Line, a West Line and an independent parallel Standard Gauge line (Figure 2). Both trains were operating on the West Line. From the Maidstone Street level crossing the track is tangent with a slight downhill gradient towards Cherry Creek and Kororoit Creek level crossing. Clear sighting is available up to and beyond Cherry Creek from the Maidstone Street level crossing. The weather conditions were fine and it was a clear night with light winds.

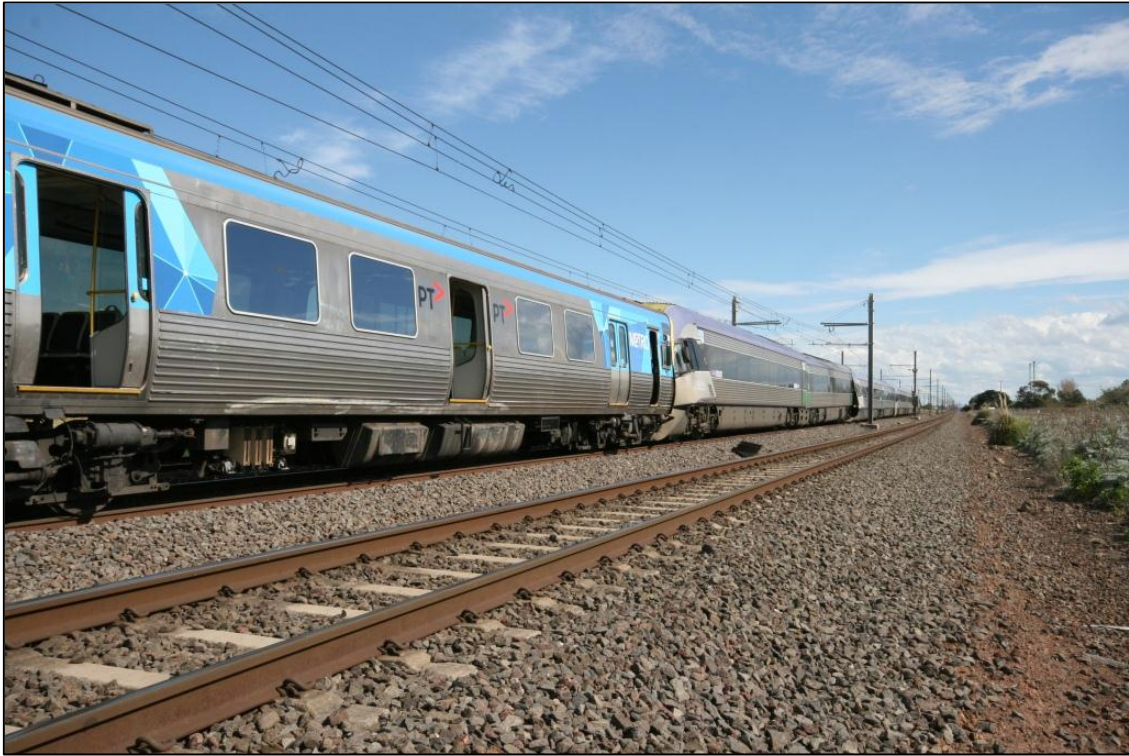
Figure 3 – Impacted trains

The driver and conductor on the V/Line train, the driver of the MTM train and four passengers from the MTM train sustained minor injuries in the incident. Both trains sustained significant damage (Figure 3 & 4).

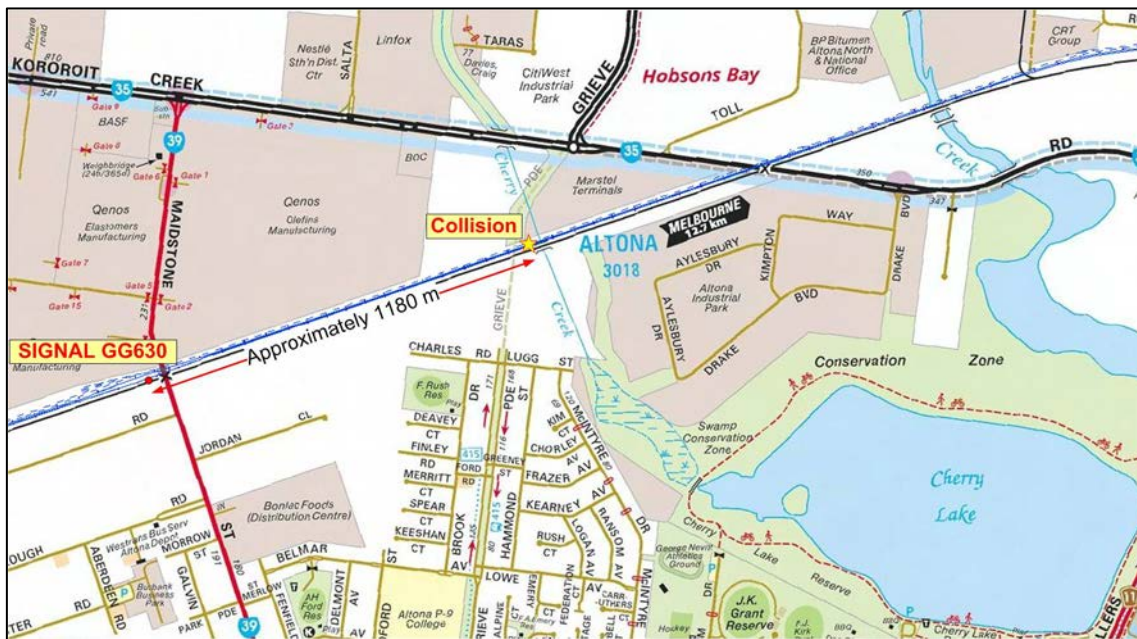
Figure 5 - Location of collision

The collision occurred on the MTM rail network between the Maidstone Street and Kororoit Creek Road level crossings in Altona.
