Aviation Short Investigations Bulletin

Issue 36

ATSB Transport Safety Report
Aviation Short Investigations
AB-2014-158
Final – 3 December 2014

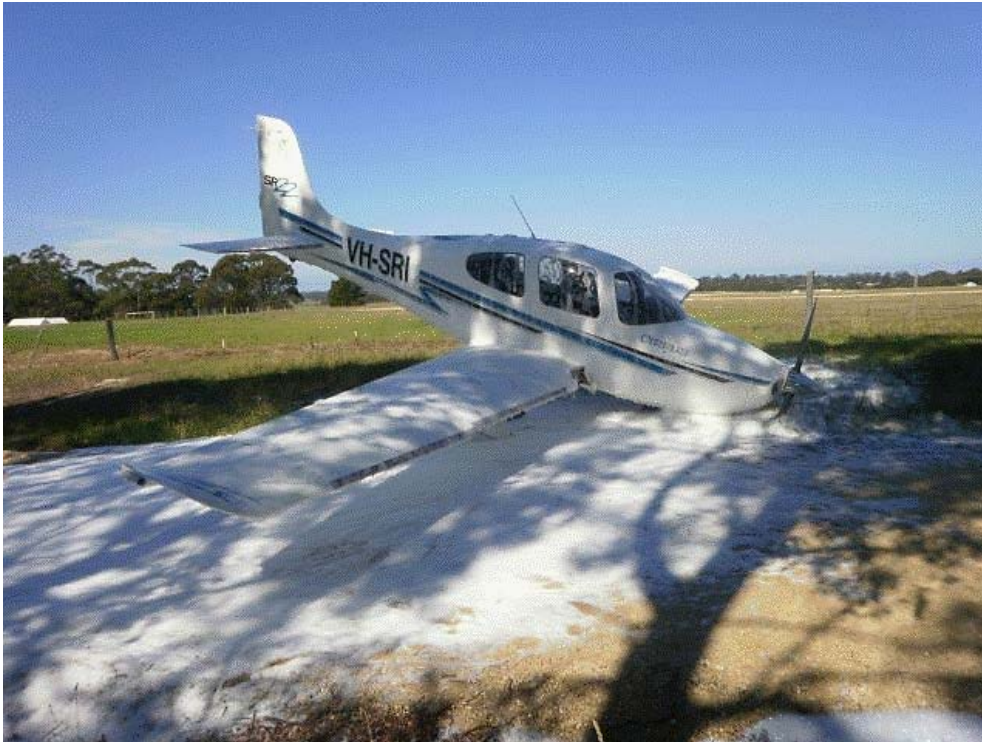
Figure 2: Accident site

The pilot reported that the approach and landing was normal. The aircraft touched down on the runway at the first white gable marker (Figure 1) at about 1320 Eastern Daylight-saving Time. As the aircraft passed the intersection with runway 26/08, the pilot realised that the aircraft was not slowing quick enough to stop in the remaining runway available and so applied the brakes harder. The aircraft departed the end of the runway, went through the airport boundary fence and came to rest on a road. The pilot turned off the fuel and all switches and exited the aircraft with the passenger. The pilot and passenger were uninjured and the aircraft was substantially damaged (Figure 2).

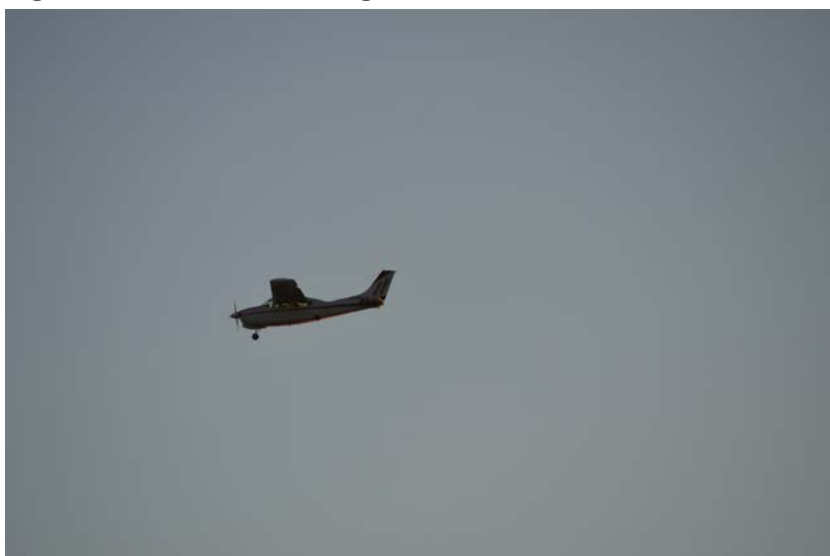
Figure 1: Aircraft on base leg

A witness observed the aircraft on the base leg, with the nose landing gear extended and the main landing gear retracted (Figure 1).

An engineering inspection found that a faulty nose gear up lock switch resulted in the nose gear extending during flight. This resulted in the main landing gear failing to extend.

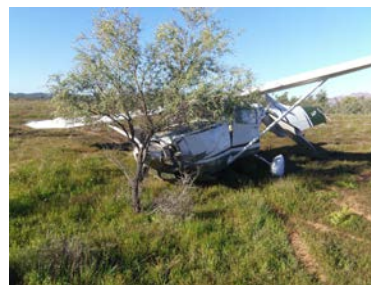
VH-TND accident site

The male passenger sustained serious injuries, and the female passenger minor injuries. The pilot was not injured; however the aircraft was substantially damaged.

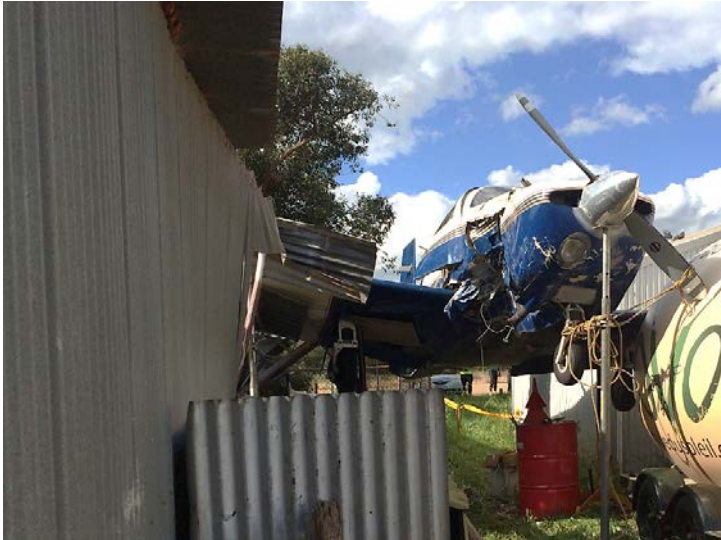
Figure 1: Accident site and damage to VH-JDY

The pilot reported initially adopting a normal climb attitude after take-off. When at about 50 ft above ground level, the pilot observed that the aircraft had drifted to the right of the runway centreline and attempted to correct the drift by slightly reducing the right rudder input. The aircraft wings remained level, however shortly after the pilot corrected the direction of the aircraft, the nose pitched up. The stall warning sounded and the pilot applied full right rudder and pushed forward on the control column in an attempt to level the wings and recover from the stall.³ The left wing dropped as the aircraft stalled, and it descended and collided with a hangar. The aircraft pivoted about the left wing and came to rest wedged between two hangars resulting in substantial damage (Figures 1 and 2).

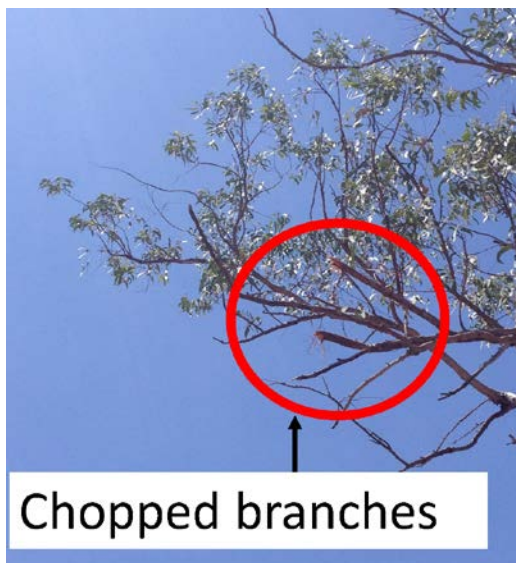
Figure 1: Tree damage following helicopter strike

At about 1218 Central Standard Time, the pilot conducted an approach and, when at about tree-top height, completed a final appraisal of the site and elected to continue the approach to land. The pilot then conducted a vertical descent into the selected landing site. When at about 1 ft AGL, the passenger seated in the left front seat alerted the pilot to the tree stump on the left, observing that he thought it may be tall enough to strike the main rotor. Due to the sense of urgency in the passenger's voice, the pilot immediately manoeuvred the helicopter up and to the right. During this manoeuvre, the pilot heard the helicopter strike a tall tree (Figure 1).

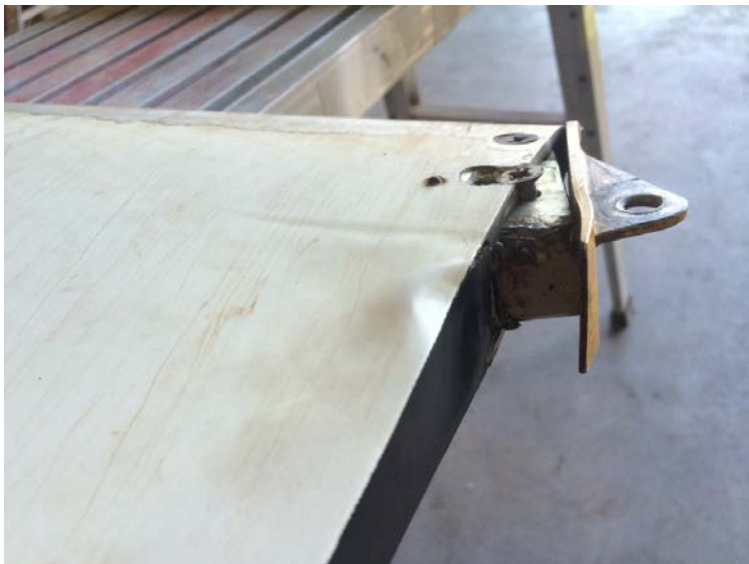
Figure 2: Damage to main rotor blade tip

About 20 minutes later, after landing at Jabiru, the pilot inspected the helicopter and found the damage to the main rotor blade had worsened significantly (Figure 2). The pilot then assessed the

helicopter as unserviceable and contacted the senior base engineer. The engineer subsequently determined that the main rotor blade and tail rotor blade had sustained substantial damage and required replacement.
