# Derailment of train 9614S

near Port Augusta, South Australia | 17 February 2013

**ATSB Transport Safety Report**  
Rail Occurrence Investigation  
RO-2013-007  
Final – 14 January 2015

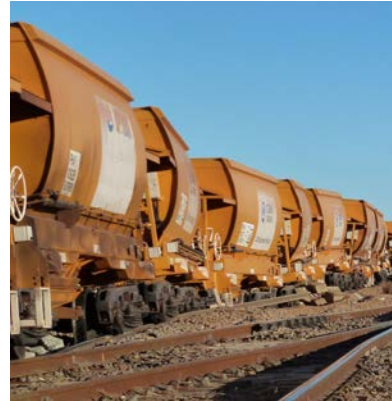
**Derailed ore wagons**

On 17 February 2013, ore train 9614S was departing Spencer Junction en route to Whyalla, South Australia. While the train was traversing 38A points at the northern end of Spencer Junction, the driver noticed a change in the train's dynamic behaviour and immediately reduced the throttle. The train then quickly came to a stop due to the automatic application of the electronically controlled pneumatic train brake. Upon inspection of the train, the second driver discovered five ore wagons were derailed.

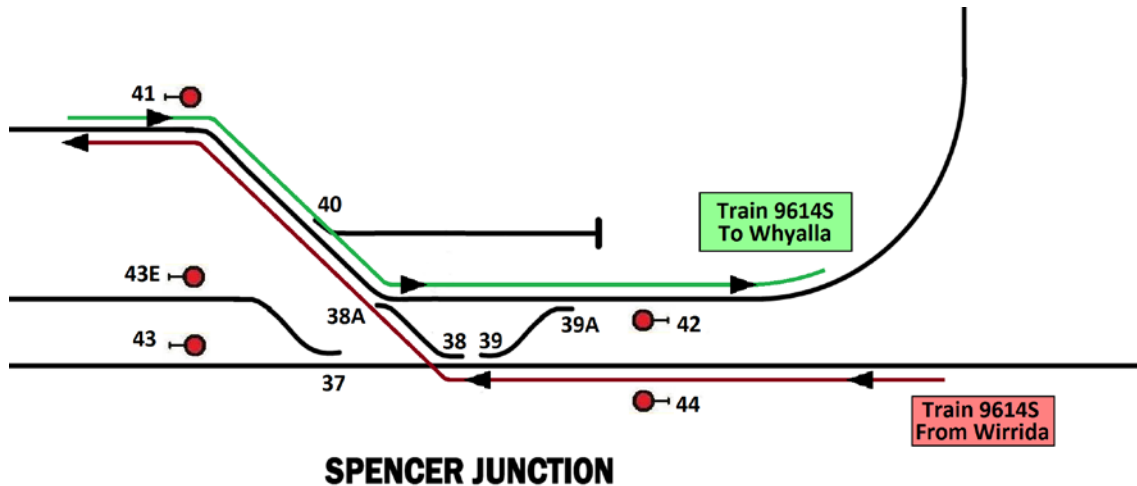
**Figure 1: The path of train 9614S at Spencer Junction, South Australia**

At 1939<sup>1</sup> on 17 February 2013, Genesee Wyoming Australia (GWA) ore train 9614S arrived at Spencer Junction, South Australia, on a return trip to Whyalla from Wirrida (about 137 km north of Tarcoola). Since there was no track available for south bound trains to travel directly to Whyalla via Spencer Junction, train 9614S was required to enter the marshalling yard before reversing direction to continue its journey towards Whyalla via 38A points (Figure 1).

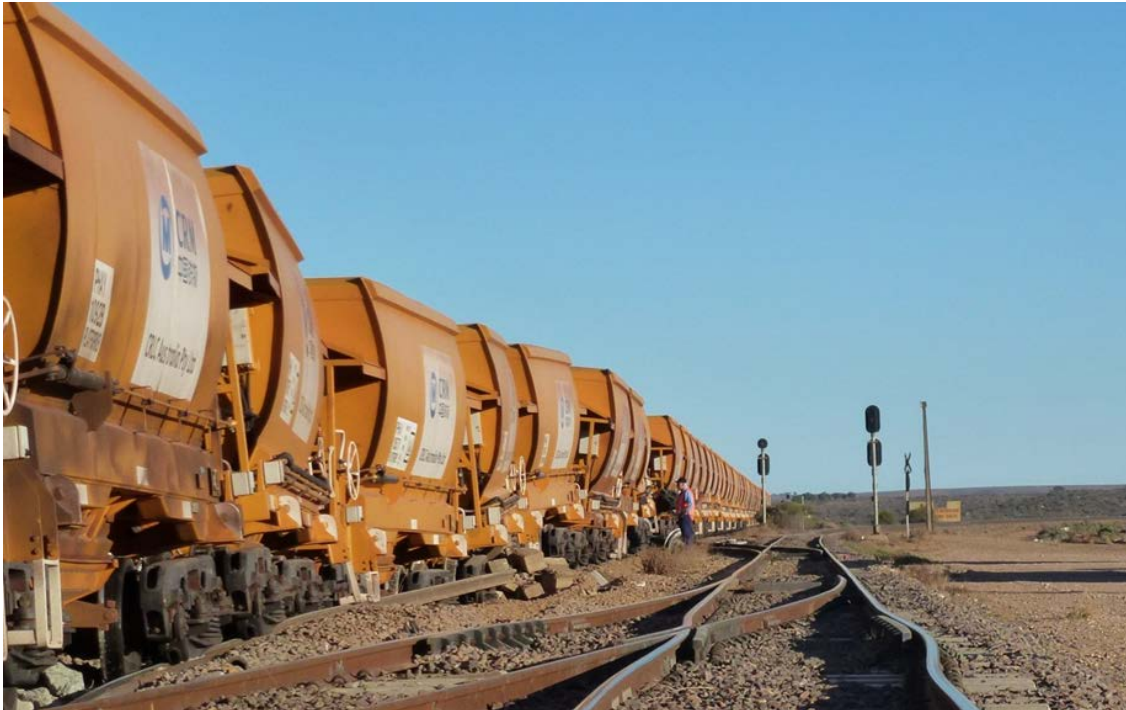
**Figure 2: Derailment Inspection at Spencer Junction, Port Augusta, South Australia**

Both the train crew and the car driver began assessing the number of wagons that had derailed and inspecting the damage. In total, five 2-unit<sup>6</sup> wagons had derailed and about 100 m of track, including 38A points, had been damaged (Figure 2).

The derailment caused significant damage to the Whyalla mainline and minor damage to the East-West mainline and the connected points. Repairs began at 1130 on 18 February 2013, and at 1916 that same day, the area was reopened for traffic.

On 25 February 2013, a new turnout which comprised of 60 kg rail laid on concrete bearers was installed to replace the repaired turnout.

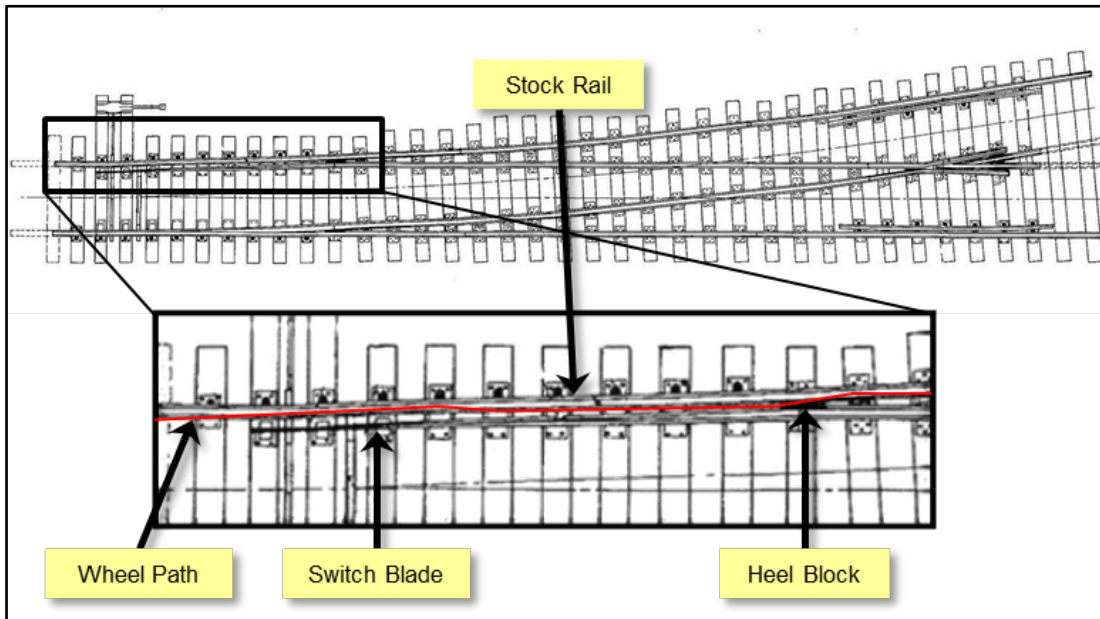
**Figure 3: Wheel path over 38A points, Whyalla crossover, Spencer Junction**

On 8 January 2013, ARTC staff attended Spencer Junction as part of their routine maintenance programme. While onsite, the Works Group Manager (manager) inspected the Whyalla crossover and noticed damage to 38A points. The manager advised that the points had suffered significant damage as a result of a transient derailment event, where the wheel of a wagon had 'dropped' in between the left hand blade and stock rail of 38A points, and then re-railed at the heel block (Figure 3). The derailment had not been reported by any of the train operators who utilise Spencer Junction, and as such it could not be established which train was involved.

The manager surmised that the derailment may have resulted from a number of factors, including wear to the point blade at 38A points, and/or a *suspect wheel*<sup>11</sup>. It was evident that only one wheel had derailed, but without knowledge of what train was involved, the manager was unable to identify the wagon and wheel-set involved.

The manager and his maintenance crew conducted works to temporarily rectify some of the damage sustained and faults identified. Records indicate that this work included the removal of the damaged left hand point blade and the fitting of a new blade assembly. The manager also recommended that the entire turnout be upgraded concurrently with the yard upgrade program which was already underway.

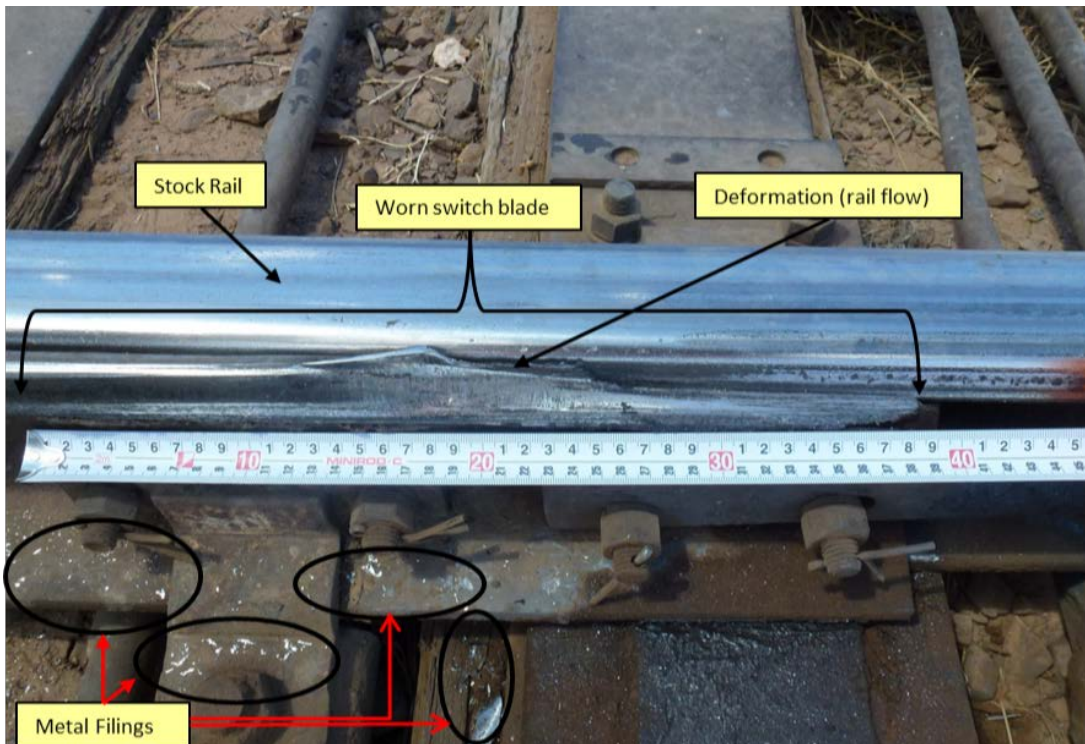
**Figure 4: 38A Points, Whyalla crossover, Spencer Junction SA**

Following this occurrence, a post-derailment inspection of 38A points by ATSB investigators identified a slight misalignment through the turnout, and observed that 290 mm of the leading

edge of the right point blade was worn and damaged. The tip of the blade showed signs of plastic deformation (rail flow) and tearing damage from wheel flanges that had been attacking it.

This wear resulted in wheels encountering the blade beyond the tip, where the blade head was quite wide. This created a ramping angle, where a wheel could ride up and over the blade rather than following the set route.

Metal filings were also found near the area of wear on the point blade (Figure 4). These filings further indicated that wagon movements through 38A points were tracking hard against the right hand rail and the point blade. The force of the wheels tracking against the point blade would accelerate wear, causing further damage and degradation.

It is likely that the curvature of the turnout, including the slight track misalignment, provided sufficient lateral force that the right side wheel on the lead bogie of wagon PHAY 1058A was forced up against the damaged point blade and subsequently rode up and over the head of the rail. It was evident that the derailed wheels then impacted the concrete sleepers, which ultimately failed to maintain track gauge and allowed further wagons to derail.

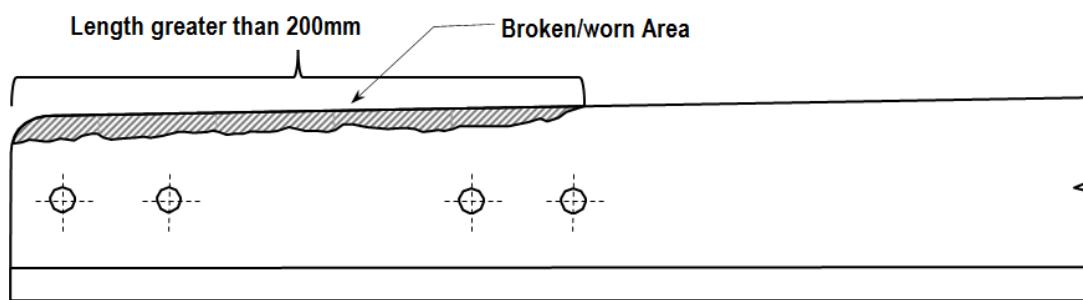
**Figure 5: 38A Points, Switch Tip Measurement**

The ARTC Code of Practice<sup>14</sup> describes the parameters and classification for assessing the damage to a point blade (Figure 5). Under this regime, point blade damage over a length of greater than 200 mm (as observed on 38A points) was classified as an A1 defect. The maintenance response defined for an A1 defect required a temporary speed restriction of 10 km/h under the guidance of a pilot, or for the defect to be repaired prior to the passage of the next train.

It was evident that the damage to the right hand 38A point blade had resulted from factors that had existed for some time, such as tight turnout curvature, slight track misalignment and increased traffic. Records indicate that the condition of the blade six weeks earlier, when two derailments had occurred within four days of each other, was similar to the condition observed following the derailment on 17 February 2013.

After the derailment on 8 January 2013, the ARTC had replaced the right hand blade on 38A points. However, evidence suggests that the blade continued to experience accelerated wear as wheels forcefully encountered the blade tip. After the derailment on 12 January 2013, records indicated that the left hand blade was also replaced (due to derailment damage), along with the replacement of every third bearer to stabilise the turnout. Despite replacement of both switch blades and the stabilisation works, the derailment of train 9614S about 1 month later was evidence that the rectification works had not effectively addressed all of the existing turnout issues.

While the ARTC had approved and scheduled an upgrade of 38A points to a 60 kg/m turnout, it was evident that the ongoing rate of wear was more aggressive than could be managed under the existing maintenance inspection schedule. The accelerated wear was visible and identifiable, but there was no evidence that the ARTC's inspection and maintenance regime had been adjusted sufficiently to monitor and manage the condition of 38A points at Spencer Junction, before the deterioration contributed to a further derailment.

The ARTC advised that works were planned for the upgrade of 38A points from 47 kg/m to 60 kg/m elements well prior to derailment of train 9614S, though installation did not occur until shortly after the derailment. Following the installation of the upgraded infrastructure, more frequent monitoring for wear rates of the point blade(s) was undertaken. After several months of condition monitoring it became evident that the track performance and wear rates could be managed as specified in the Code of Practice and the normal inspection schedule was reinstated.
