Aviation Short Investigations Bulletin

Issue 39

AB-2015-012

Final – 26 February 2015

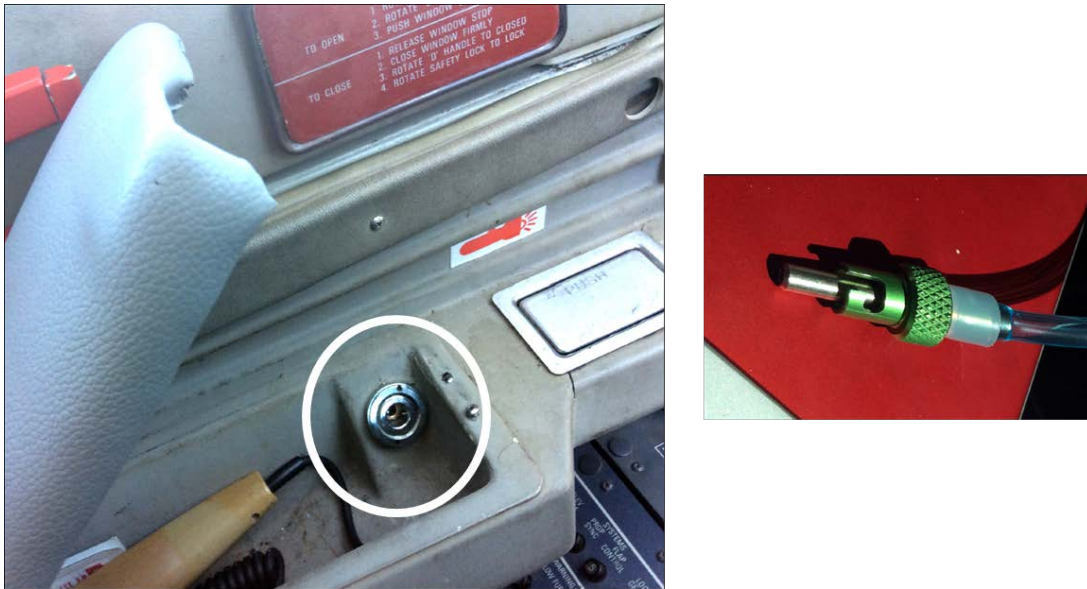
Figure 1: Oxygen port beneath pilot's armrest and associated oxygen fitting

- Despite his apparently hypoxic condition, the pilot was ultimately able to identify that an oxygen supply system fitting had become disconnected. The fitting was located beneath the pilot's armrest, and was the same fitting that the pilot had earlier connected during the climb (Figure 1). When he reconnected the fitting, he took a number of deep breaths and sensed almost immediate relief.

Consistent with the pilot's recollection of the event, the operator's investigation dealing with the incident found that the pilot's oxygen supply was interrupted when the fitting in the supply system beneath the pilot's armrest became disconnected. The investigation found that the bayonet fitting may not have been fully locked when connected by the pilot, noting that the connection could be in place but not necessarily properly locked. The investigation report added that the position of the port is such that some concentration and manipulation is required to ensure that the connection is seated correctly. The investigation also found that the supply tube may not have been correctly routed through an armrest cut-out, and that movement of the armrest may have dislodged the improperly secured bayonet fitting.

This incident highlights the importance of careful attention to aircraft oxygen systems, particularly with respect to connecting and monitoring oxygen system performance. An interruption in the supply of oxygen can quickly lead to hypoxia and crew incapacitation, particularly at higher altitudes. While the pilot was able to re-establish the flow of oxygen on this occasion and recover from his hypoxic condition, pilots are reminded that hypoxia is an insidious condition and the time of useful consciousness is often very limited. A prompt and decisive response to the first indication of an oxygen supply problem is imperative.

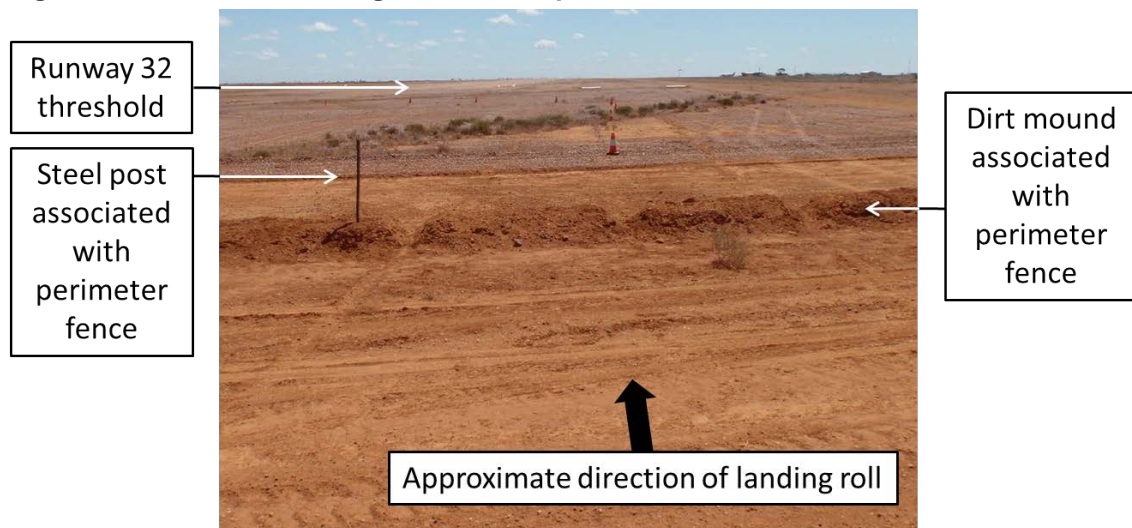
Figure 4: Aircraft track through aerodrome perimeter fence

The pilot reacted by pulling the control column back, in an effort to reduce the severity of what he felt was imminent ground impact. The aircraft touched down short of the runway threshold and to the right of the runway centre-line, on a firm surface that was once part of the runway strip. The aircraft passed through a wire aerodrome perimeter fence, and came to a stop after a ground roll of around 150 m (Figure 1). The aircraft also passed through a mound of loose dirt, and clipped a steel post, both associated with the wire fence (Figure 2).

Initial inspection of the aircraft following the flight identified that a micro-switch adjustment was required to address the nose landing gear indication problem. Closer inspection however revealed some damage in the area where the nose landing gear meets the aircraft structure, and scoring damage to the underside of the left wing and flap surface, just outboard from the left main landing gear. Scoring damage to the underside of the left wing and flap surface was probably the result of the wing and flap contacting the steel post visible to the left of the wheel track marks in Figure 2.

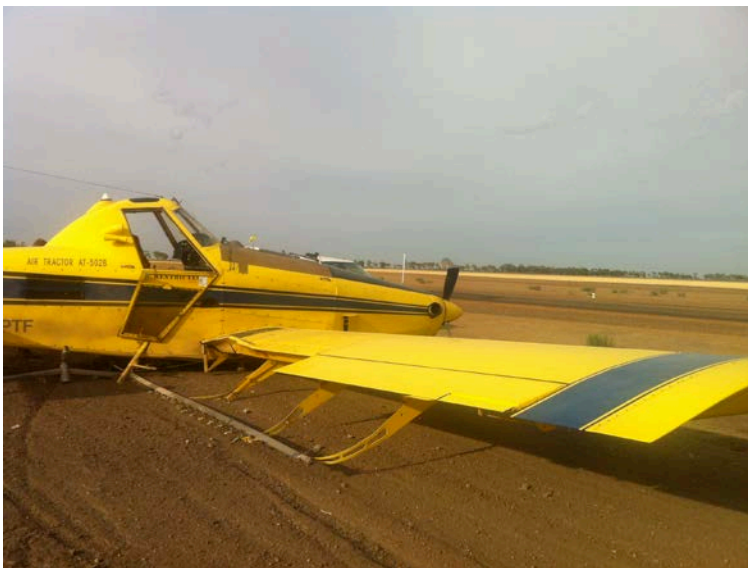
Figure 2: Damage to VH-PTF

At about 0704, PTF landed on a dirt road parallel to the airstrip. Both landing gear struts had been detached, which had then broken off the right flap, damaged the left flap and ruptured both fuel tanks. During the landing the propeller was damaged (Figure 2). The pilot was not injured.

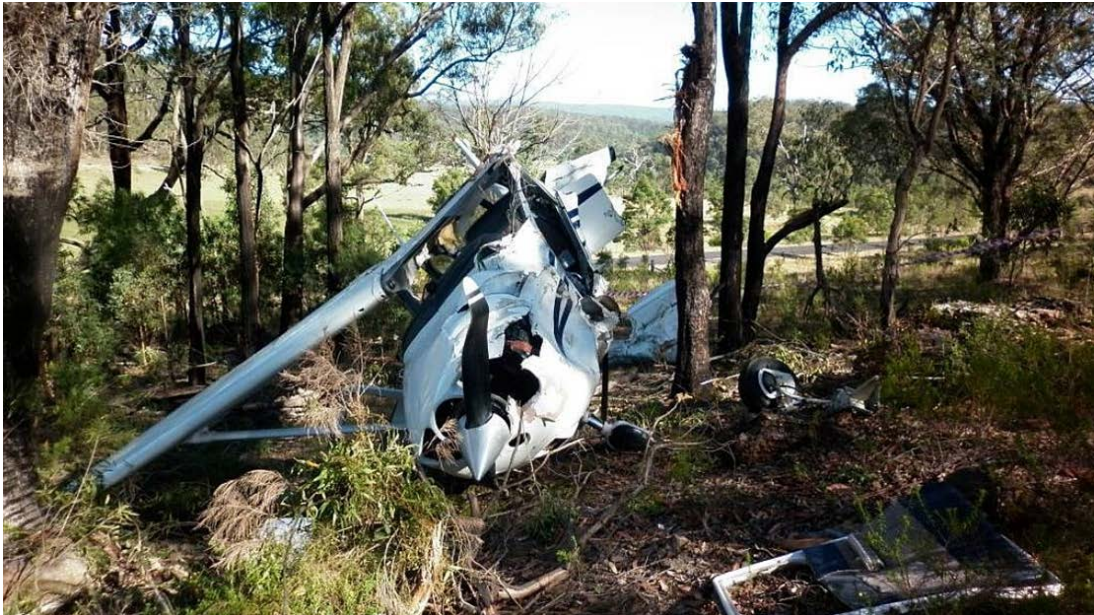
Figure 2: Aircraft wreckage

During his approach to land on the selected paddock, with full flap selected, the pilot found himself overshooting the selected aim point. He endeavoured to recover the profile, but had increasing difficulty maintaining the preferred aim point. Concerned that he would not be able to land safely, the pilot elected to discontinue the approach and commenced a go-around. As the go-around proceeded however, the pilot found that he was unable to climb over trees ahead of the aircraft on rising terrain beyond the far end of the selected paddock. He was able to manoeuvre around a small number of individual trees, but collided with a line of trees, slightly further on. The aircraft was substantially damaged in the collision (Figure 2) and the pilot received serious injuries.

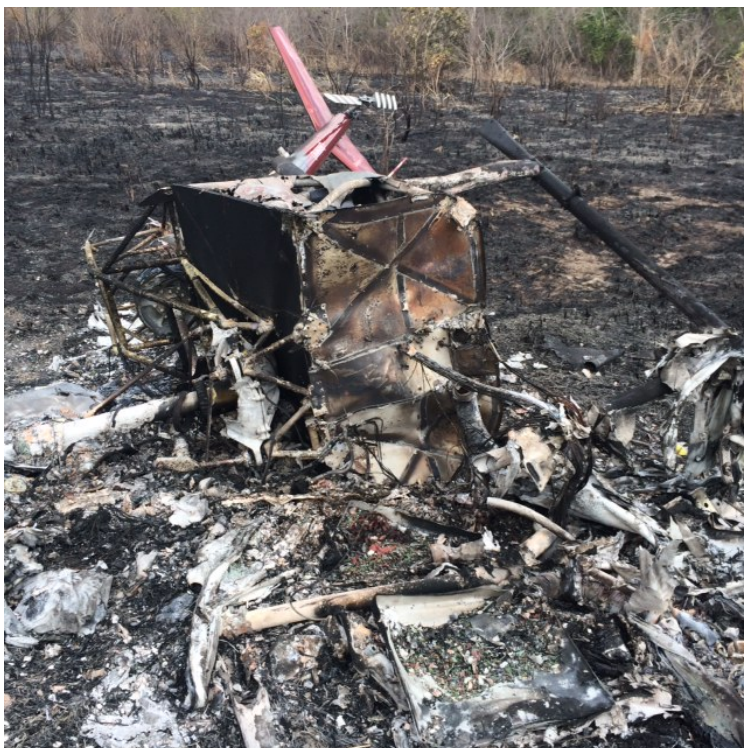
Figure 2: Accident site

As the helicopter neared the ground, the pilot saw that they were landing into tall guinea grass. As soon as the helicopter landed, the pilot locked the cyclic off, retrieved the emergency beacon and he and the passenger quickly exited the helicopter. The pilot observed smoke billowing from the rear of the helicopter, where heat from the helicopter's exhaust ignited a grass fire. They ran away from the helicopter and grassed area towards trees and within seconds the helicopter was engulfed by fire. The helicopter was subsequently destroyed and the pilot and passenger were uninjured (Figure 2). The helicopter had been fitted with bladder fuel tanks.
