Descent below approach path involving Boeing 777, VH-VPF

Melbourne Airport, Victoria | 15 August 2013

ATSB Transport Safety Report
Aviation Occurrence Investigation
AO-2013-130
Final – 15 July 2015

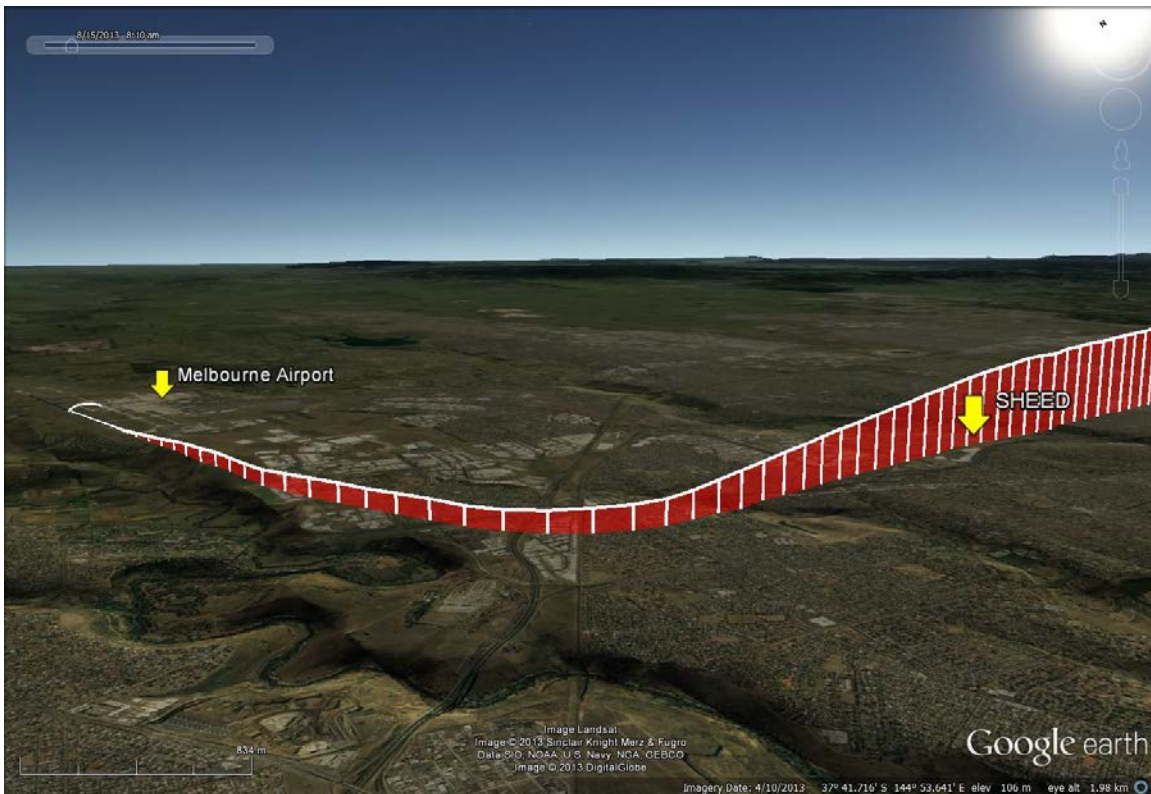
Figure 2: Approach flight path into Melbourne Airport

The aircraft was flown level until re-established on the correct glide path for a normal approach and landing. Figure 2 shows the aircraft's flight path during the approach and landing.

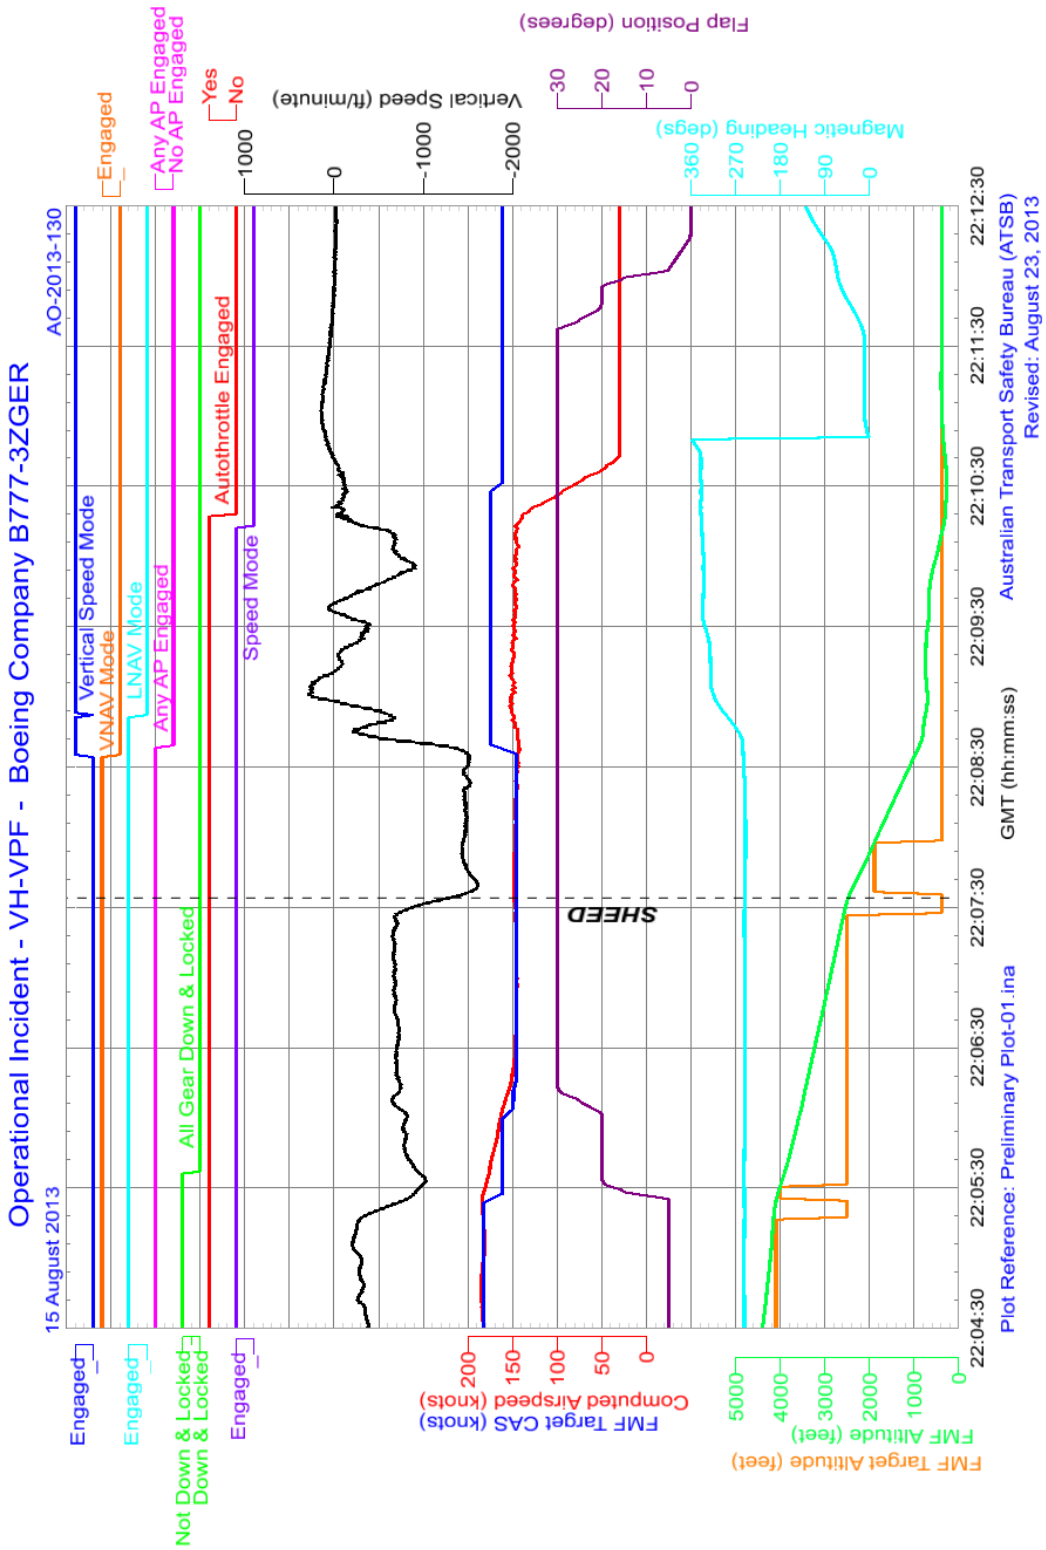
Figure 5: Selected QAR data showing the occurrence after passing SHEED

The ATSB obtained a copy of the data recorded on the aircraft's quick access recorder (QAR), including of the occurrence flight. Selected parameters from that data are provided in Figure 5.
