# Air Safety Investigations

## Recently completed investigations

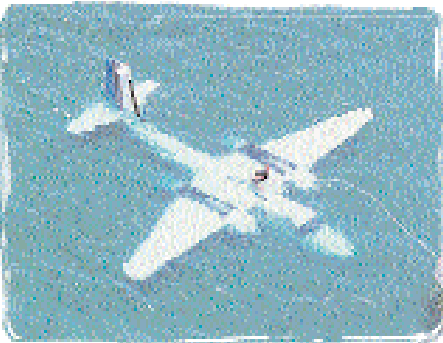
Occurrence Brief 199804432

The engines of a Shrike Commander lost power and the pilot had to ditch the aircraft into the sea 400 metres short of the threshold of runway 14 at Horn Island Aerodrome on 21 October 1998. The aircraft was substantially damaged and its five occupants received minor injuries.

The investigation found that both the engines had stopped because of fuel exhaustion. The findings included inaccuracies in the management of the fuel system that led to an incorrect understanding of the quantity of fuel remaining in the aircraft.

The fuel quantity indicator was unserviceable and the right engine fuel control unit was worn which allowed up to six litres an hour of extra fuel through. Inappropriate fuel consumption rates were used for flight planning and the fuel log contained inaccuracies that resulted in a substantial underestimation of the fuel used.

A number of organisational and management deficiencies were also identified. One was in the adequacy of assessing chief pilots for their ability to manage charter operations safely. The Civil Aviation Safety Authority will be amending the Air Operator Certification Manual to more adequately address system safety management issues. The ATSB will continue to monitor the progress of that amendment. ■

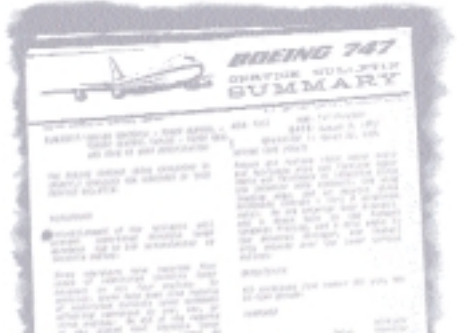
Occurrence report 199901894

While cruising at FL370 the crew of a Boeing 747 found that they were unable to move any of the throttle levers. The aircraft was put into a descent and within 15 minutes the levers became operable. The aircraft had been operating in light icing conditions for 20 minutes.

An ATSB investigation established that there was a known problem associated with restricted movement of throttle levers believed to be a result of moisture on the throttle cables freezing to seals and fairleads.

The aircraft involved in the occurrence had been fitted with the modified flexible seals and fairleads during its manufacture. The manufacturer requested that the operator carry out further inspections of the throttle cable seals, fairleads and drain holes. The operator subsequently advised that these inspections did not identify any anomalies that could have contributed to the restricted throttle movement.

The aircraft manufacturer had issued Service Bulletin 747-76-2060 which urged aircraft operators to replace rigid throttle vapour seals and fairleads with new flexible seals and fairleads. This action was expected to prevent restricted throttle lever movement due to moisture freezing on throttle cables.

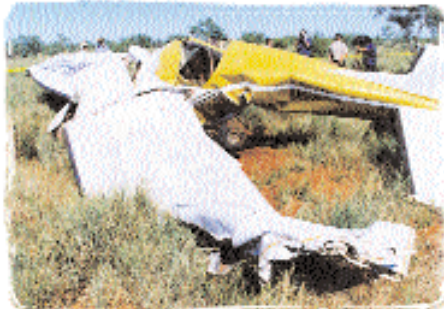
The Cessna 172 after the accident at Mindaroo Station

Pilot fatigue, inadequate rest and inexperience were the main findings of an investigation into an aerial sheep mustering accident on 16 July last year in which the Cessna 172 aircraft was destroyed and the pilot fatally injured.

The pilot was positioning the aircraft to cut off a mob of sheep that had broken away from the group when the aircraft impacted the ground in a near vertical attitude at low forward speed. No evidence of any mechanical defect was found.

The pilot had not received any low flying training and was not qualified to conduct mustering operations. Without these qualifications the pilot was legally required to operate no lower than 500 ft above ground level. At this height the aircraft may have been of some use in spotting sheep but probably would have been ineffective at mustering.

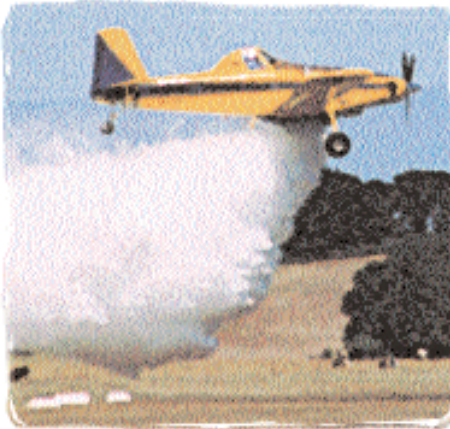
Occurrence report 199800640

A pilot was fatally injured on 1 March 1998 when his Air Tractor 802A impacted the ground at an airshow following a water drop in a firefighting demonstration.

The aircraft approached the drop site ten knots faster than recommended, and during the water release, the nose pitched up and the aircraft entered a climb. The nose continued to pitch up with an increasing climb angle. There was no evidence that the pilot had made any elevator input to reduce the steepness of the climb.

The aircraft climbed straight ahead for a short distance before starting to yaw and roll to the left. The bank angle increased to about 90 degrees and the nose attitude dropped to almost horizontal.

At about 450 ft and at low speed the aircraft rolled inverted and entered the incipient stages of an inverted spin. The aircraft impacted the ground inverted in a wings level attitude at a nose down angle of approximately 45 degrees.
