Air Safety Investigations

Recently completed investigations

Chieftain investigation leads to safety recommendations

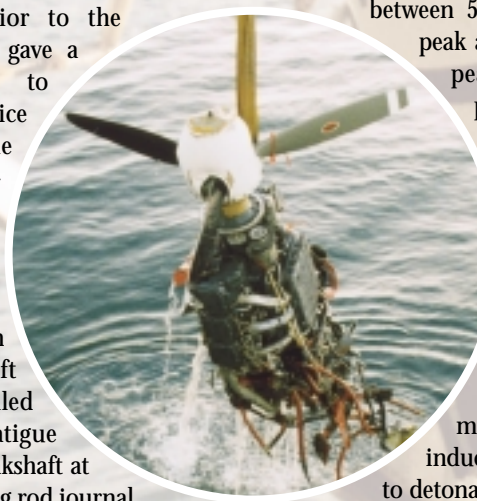
Immediately prior to the accident the pilot gave a MAYDAY report to Flight Service indicating that the aircraft had experienced two engine failures. The investigation found mechanical damage to both engines. The left engine had failed following a fatigue fracture of the crankshaft at the No. 6 connecting rod journal.

Cracks of this type are created by the generation of thermal stresses in the journal surface.

The No. 6 connecting rod "big end" bearing had failed and it was evident that engine operation had continued after the bearing shells had been broken down. The surface of the journal, and the journal radii, had been damaged extensively by the rotation of the journal against the connecting rod. Extensive thermal cracking was evident over the entire journal surface.

In the right engine a hole had developed near the top of the No. 6 piston, allowing combustion gases to bypass the piston rings. The hole had been created by an exposure to temperatures within the melting range of the piston material. There

- the Civil Aviation Safety Authority alert operators of aircraft equipped with turbo-charged engines to the potential risks of engine damage associated with detonation, and encourage the adoption of conservative fuel mixture leaning practices. (R20000250)
- the Civil Aviation Safety Authority amend Civil Aviation Order section 20.11 paragraph 5.1.2 to remove the restriction that it only applies to aircraft authorised to carry more than nine passengers. (R20000248)
- the Civil Aviation Safety Authority ensures that Civil Aviation Orders provide for adequate emergency and life saving equipment for the protection of fare-paying passengers during over-water flights where an aircraft is operating beyond the distance from which it could reach the shore with all engines inoperative. (R20000249)

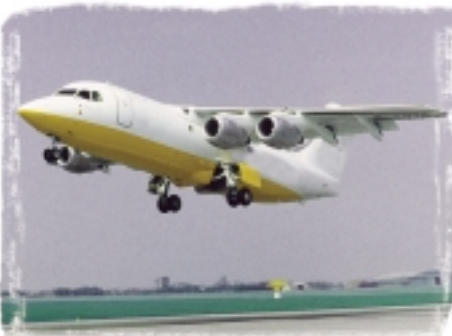
The fire started after the RCCB failed, leading to the failure of the AC power supply. The ATSB examined the RCCB and found it had been subjected to excessive heat and current load. This had caused a catastrophic internal failure. The heat generated led to molten metal escaping from the RCCB main contactor compartment. The metal flowed across two energised power cables and short-circuited two AC power phases.

The RCCB was located in an equipment bay that was not monitored for fire or smoke detection. The crew was alerted to the fire by smoke in the cockpit and system failures at engine start-up.

The AC-powered hydraulic pump internal thermal switch wire was pinched between the impeller housing and the stator, effectively creating a short circuit. The effects of the short circuit would only be noticed when the pump has exceeded an operating temperature of 204 degrees Celsius. Although the pump did not exhibit outward signs of excessive heat it did exhibit a general state of deterioration commensurate with an extended time in service for this unit. ■

A small fire in the electrical equipment bay of a BAe 146 just prior to departure has led to a new inspection and monitoring procedure by its operator. New heat sensitive decals have been fitted to the remote control circuit breaker (RCCB) contactor chambers and operating temperatures will be recorded into a database at regular intervals.

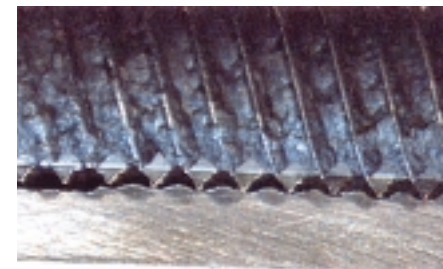
A cross section view of the Cessna 402 trim tab actuator.

The elevator trim tab actuator for the Cessna 402 aircraft has an internal jackscrew mechanism with a male-threaded rod and an internal female-threaded barrel. The practice of opting to replace only the less expensive male part has led to increased play and decreased thread engagement in the actuator.

Examination of the actuator revealed that the threads in the male and female screw assemblies were severely worn and the shaft was also bent. At the last overhaul only the male screw assembly had been replaced.

According to the ATSB investigation it was possible that the actuator had jumped threads when the pilot turned the trim wheel. The trim tab began to flutter, then the male end of the rod had bent and jammed.

The Cessna Aircraft Company and the US National Transportation Safety Board recommends that the actuator should be overhauled every 1,000 hours or three years and checked for security and condition at every 100-hour inspection, and included the recommendation that both internal screw assemblies be replaced as a set.

Cessna will supply the parts only as a set.
