Air Safety Investigations

Safety briefs

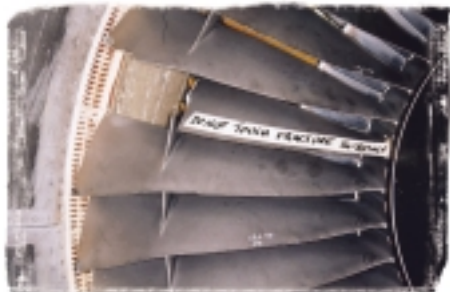
767 broken turbine blade

A Boeing 767 made an emergency landing at Sydney on 22 March 1999 after a portion of a fan blade in the right engine broke away.

The blade had fractured about 470 mm above the blade platform just inboard of the mid-span shroud. About one-quarter of the blade had been liberated. The fan blade had fractured as a result of fatigue crack growth.

The failure had originated at a foreign object damage impact site 2.54 mm aft of the blade leading edge on the rear (concave) face of the blade. Traces of mineral debris were detected at the crack origin, indicating that the foreign object damage was the result of stone ingestion. Fatigue crack growth, from a crack depth of 1.5 mm, probably occurred during 35 flight cycles. The blade had no material abnormalities at the fracture site. ■

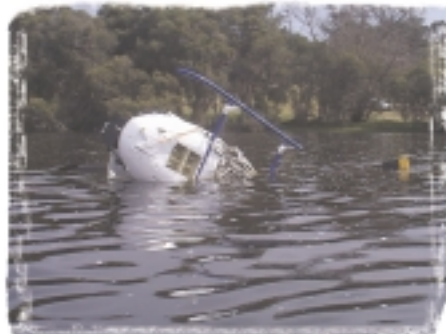
Helicopter spraying ends in lake

Two people survived serious injury when their helicopter impacted shallow water in Lake Joondalup in Perth on 19 October 1999 during a low-level turn in adverse wind conditions. The helicopter was being used to spray larvicide to control mosquitoes. During

a bank to right the helicopter unexpectedly lost height which the investigation concluded was consistent with it entering an area of strong turbulence.

The reported power margin should have been sufficient to recover the helicopter in benign conditions but the investigation could not determine if the power margin was adequate to overcome the conditions encountered at the time. By the time the pilot realised that the helicopter was descending at an excessively high rate there was insufficient height available for him to recover the helicopter. ■

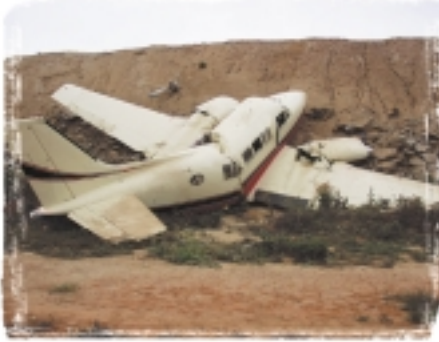
Multiple engine cowl accident factors

Limited time on the aircraft type and lack of experience may have contributed to a Beechcraft Queen Air pancaking into a hillside shortly after takeoff at Leonora in June last year leaving the six occupants seriously injured.

Although the accident occurred after the inboard cowl of the right engine had cleanly broken away during the takeoff roll, the ATSB investigation found that this would not have adversely affected flying capability.

During the takeoff roll the pilot and passengers heard a loud bang followed by the engine cowl opening as the aircraft left the ground. The cowl fell away without damaging the aircraft. It was later found that two top hinges had failed.
