Air Safety Investigations

Recently completed investigations

Safety briefs

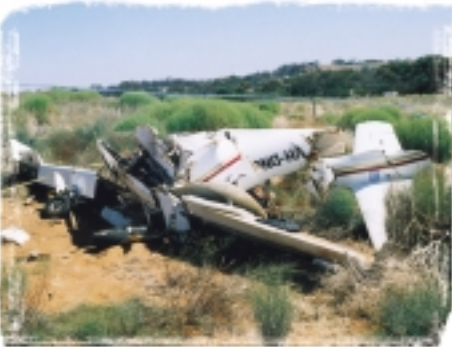
An amateur-built Lancair aircraft impacted the ground while recovering from a spin during a demonstration flight near Mildura on 12 March 2001. The pilot and passenger were fatally injured and the aircraft was destroyed.

An ATSB investigation established that the aircraft had impacted the ground with wings level at a steep nose-down angle at high speed. No indication was found of any pre-existing defect in the aircraft or the engine. The investigation determined that the circumstances of the accident were consistent with a loss of control during a demonstration of the handling characteristics of the aircraft at low airspeed.

It was determined that the aircraft entered a spin. The rotation of the spin was subsequently arrested, however the aircraft impacted the ground as it was accelerating during the pull out from a dive at the end of spin recovery. The landing gear and flaps were extended at the time of the accident.

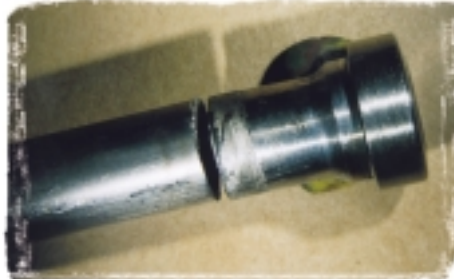
The BAe 146 was fitted with four Avco Lycoming ALF 502R-3s engines. A preliminary examination of the number three engine by the operator revealed that it had been subjected to extremely high temperatures around the bleed-band area and had a cracked fuel line between the flow divider and the fuel manifold assembly.

Subsequent examination of the cracked fuel line found that it had failed immediately inboard of the weld between the tube and the union on the flow divider end of the unit. A close examination of the fracture surfaces indicated that the cracking originated from a point on the inside bore of the tube. The cracking appeared consistent with a fatigue mechanism propagating under high frequency, low magnitude vibrating loads. The fatigue crack had extended along the outer boundary and covered approximately eighty percent of the cross-section. The remaining section failed in overload.

The ATSB's investigation found no evidence of any pre-existing physical defect or prior cracking and concluded that the material of the tube and the unions complied with the manufacturer's specifications.

Despite a thorough examination of the fuel line, the investigation was unable to conclude the reason for the fatigue cracking of the tube. ■

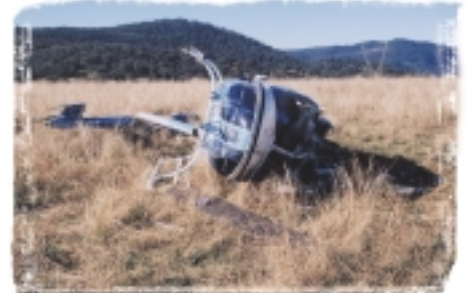
The controls were stiff and the helicopter descended at higher than normal speed. The helicopter landed heavily which caused the right skid crosstube support to fail and the helicopter rolled onto its side.

The investigation determined that the drive spline and coupling from the main gearbox to the hydraulic pump had failed due to lack of lubrication. This resulted in the loss of hydraulic power to the controls and the loss of main rotor RPM indication.

Up until January 1998 the maintenance requirement was to lubricate the splines every 1200 hours or 12 months. In January 1998 the manufacturer issued a new maintenance manual with combined requirements for the Bell 206 series helicopters. This change deleted the calendar requirements.

1. Bell Helicopter Textron P/L revise the maintenance manual for the Bell 206B III series helicopter to require the hydraulic pump spline be inspected and lubricated on a calendar basis.
2. CASA advise the Australian operators of the Bell 206B III series of the deficiency in the maintenance manual and revise the calendar requirement for the lubrication of the hydraulic pump splines.
3. The Federal Aviation Administration alert all operators of the Bell 206 B III series to a deficiency in the maintenance manual. ■
