# Air Safety Investigations

# Got the right fuel system fitting in your balloon?

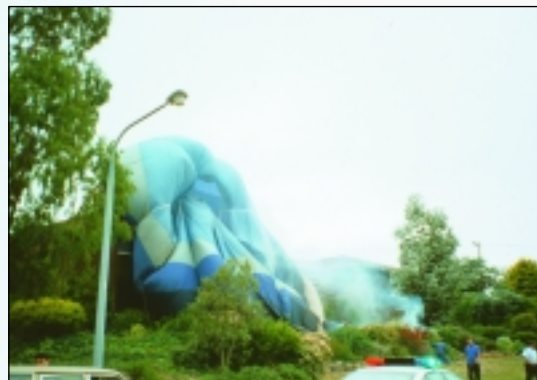
and both the liquid and vapour offtake valves on both fuel cylinders were on. A male connector fitting had broken off, flush with the top of the threaded portion of the body of the corresponding fuel cylinder liquid offtake valve.

Examination of the broken fitting showed that it had been partially fractured when the fire developed. The fracture was sufficiently large to allow the uncontrolled escape of LPG into the balloon's basket. The fracture surfaces indicated that the fire was no longer burning near the fracture at the time the fitting broke away completely. The fitting had fractured in a downward direction, and there was no evidence of fatigue or pre-existing defects.

The broken fitting consisted of a Rego 8101P5 service valve coupled to a 7141M check connector. With this configuration, the assembly extended outside the fuel cylinder guard ring.

The length of the broken fitting provided significant leverage that would have required only a relatively small force to be applied before the fitting broke. There was also limited protection for the fitting because it extended significantly beyond the fuel cylinder guard ring. While the Rego 8101P5/7141M combination liquid offtake valve may have been appropriate for some applications, it was not appropriate for aviation installations.
