# Air Safety Investigations

# Safety briefs

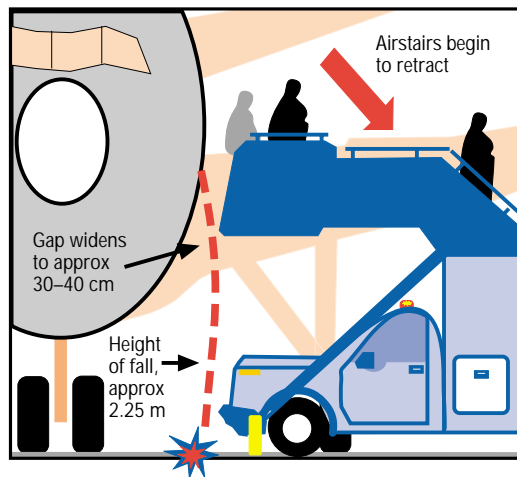
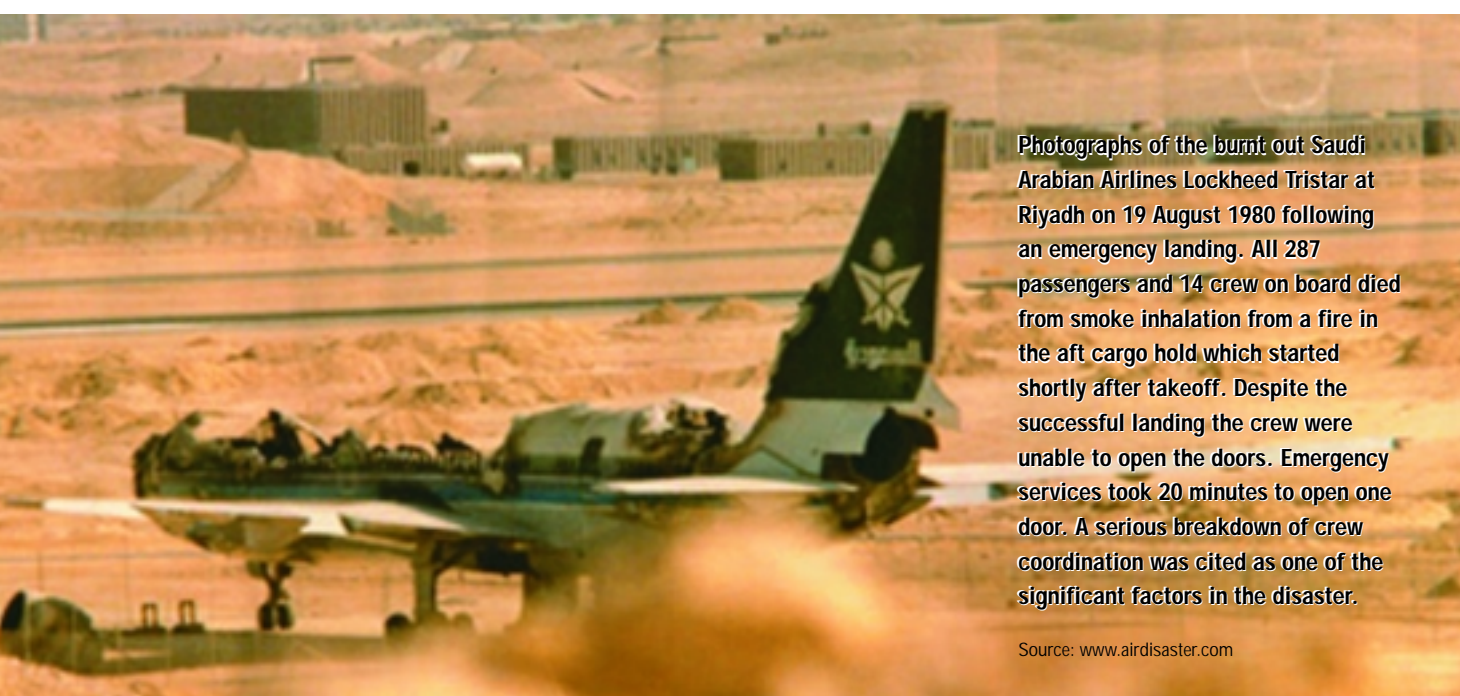
Photographs of the burnt out Saudi Arabian Airlines Lockheed Tristar at Riyadh on 19 August 1980 following an emergency landing. All 287 passengers and 14 crew on board died from smoke inhalation from a fire in the aft cargo hold which started shortly after takeoff. Despite the successful landing the crew were unable to open the doors. Emergency services took 20 minutes to open one door. A serious breakdown of crew coordination was cited as one of the significant factors in the disaster.
