Air Safety Investigations

Recently completed investigations

Twin mechanical failure linked to leaning

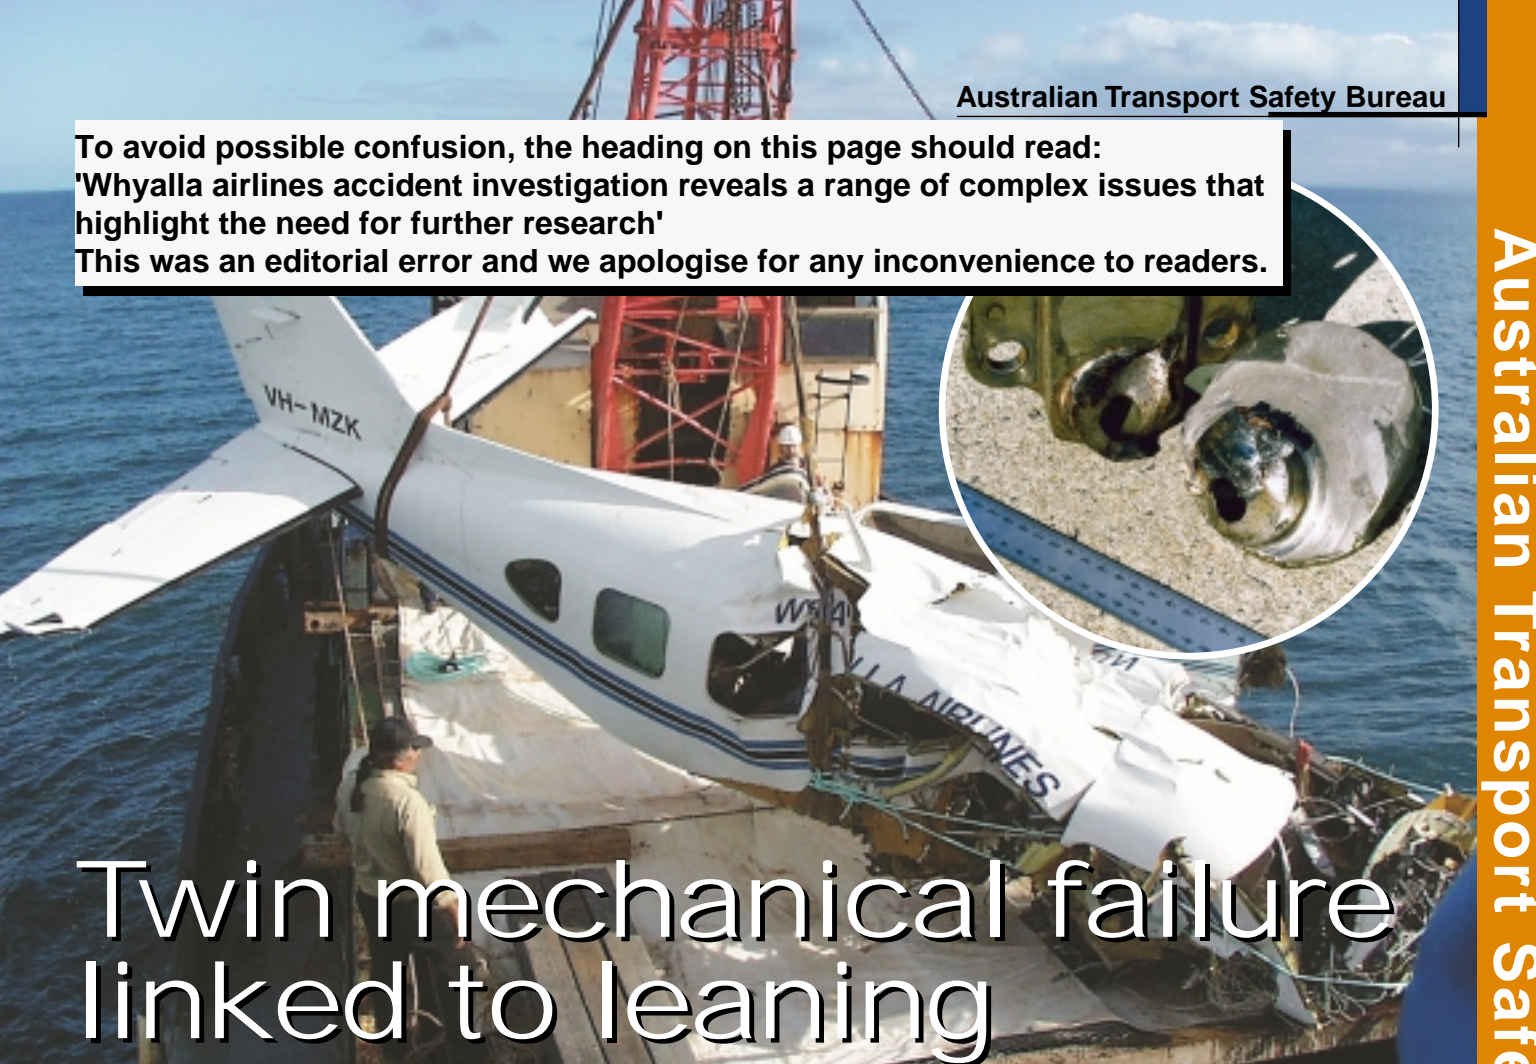
THE final report on the Whyalla Airlines Piper Chieftain VH-MZK accident on 31 May 2000, in which all eight occupants died, was released on 19 December 2001 by the Australian Transport Safety Bureau.

Based on careful analysis of the engine failures and recorded radar and audio data, it is likely that the left engine failed first as a result of a fatigue crack in the crankshaft. This was initiated about 50 flights before the accident flight due to the breakdown of a connecting rod bearing insert. The combined effects of high combustion gas pressures developed as a result of deposit-induced pre-ignition, and lowered bearing insert retention forces due to an 'anti-galling' lubricating compound used during engine assembly by the manufacturer, led to this breakdown.

It is likely that because of the increased power demanded of the right engine after the left engine failed, abnormal combustion (detonation) occurred and rapidly raised the temperature of the pistons and cylinder heads. As a result, a hole melted in the number 6 piston causing loss of engine power and erratic engine operation. The subsequent ditching involved great pilot skill.

- the US FAA in relation to engine deposits that may cause pre-ignition;
- the US FAA and the engine manufacturer on the use of anti-galling compounds between connecting rod bearing inserts and housings during engine assembly;
- CASA in relation to high power piston engine reliability more generally; and
- CASA in relation to providing guidance to pilots on ditching.

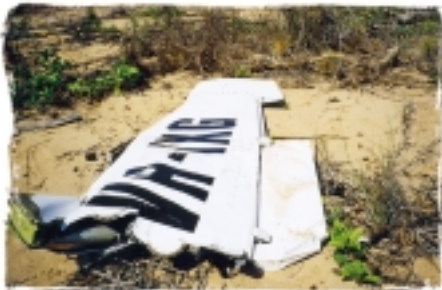
Occ Report 200003949

An Aerostar 600A pilot was fatally injured when he lost control of the aircraft on a dark night during the climb after takeoff from Port Keats, NT on 2 September 2000. The left wing had separated from the airframe in flight, which was consistent with aerodynamic loads in excess of the aircraft structural limit during a high speed or unusual attitude recovery manoeuvre.

The following morning a number of major structural components of the aircraft, including the outer left wing, were located at a position 24 km north-east of Port Keats aerodrome and close to the flight planned track. The main portion of the wreckage was found four days later and was destroyed by ground impact.

The investigation was unable to conclusively determine the circumstances that led to the loss of control and subsequent inflight airframe break-up. However, possible pilot distraction on a dark night with few visual clues and physiological factors could not be disregarded. ■

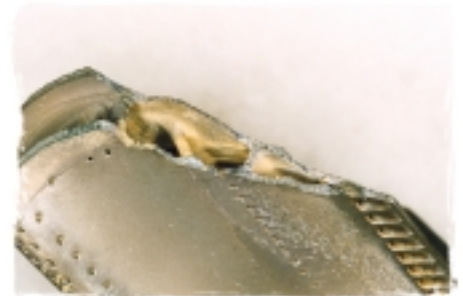
Occ Report 200004707

A Boeing 737 engine was shut down in flight after it was extensively damaged from a failed high-pressure turbine blade on 14 October 2000. The aircraft was on climb from Hobart and returned to land.

A 15 x 20 mm segment of the trailing edge of the blade had broken away, and passed through the engine causing extensive damage to all four stages of the low-pressure turbine assembly, rendering the engine inoperative.

Metallurgical examination of the failed blade (see ATSB Technical Analysis Report No. 3/01) indicated that the loss of the blade section was due to the progression of fatigue cracking into the blade section from an area of cracking and notching on the blade tip. The cracking had progressed into the blade parent Rene 125 material through an extensive Inconel 625 weld repair beneath the tip of the notching.

The ATSB concluded that the inferior Inconel 625 alloy was used in a tip repair in 1995, which had allowed the tip crack to continue rapidly through the region of the repair into the parent material below.

A number of safety recommendations were made to the manufacturer, General Electric Aircraft Engines, the US Federal Aviation Administration and CASA. The ATSB will publish responses to the recommendations on the web, www.atsb.gov.au ■

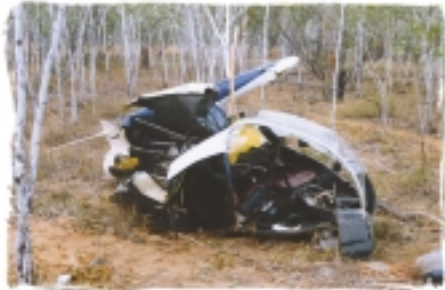
Occ Report 200003267

It is believed that exceeding the published service life of a helicopter main rotor blade led to its catastrophic failure on 29 July 2000.

The Robinson R22 Beta helicopter was engaged in mustering operations and developed a lateral shudder during the transition to flight at an altitude of approximately 200ft above ground level. The shudder intensified, the helicopter shuffled to the right and the pilot lost directional control. The helicopter impacted the ground and was destroyed. The pilot and observer were found lying on the ground forward of the cockpit. The pilot died while enroute to hospital.

The main rotor blades had separated in flight and only one blade remained attached to the main rotor hub. The missing main rotor blade was found 105 metres from the accident site and had a fracture at the blade root fitting. The failure was identical to a previous Australian occurrence where the blade had exceeded the service life and the manufacturer's failure tests.

There was anecdotal evidence from witnesses familiar with the helicopter's operations that suggested it might have been operating more hours than was being documented. Other evidence suggested the helicopter operating hours were being under-reported and supported witness accounts.
