The Australian Air Safety Investigator is a regular eight-page feature in *Flight Safety Australia* produced with editorial independence by the ATSB. It aims to keep the industry informed of the latest findings and issues in air safety from the bureau's perspective.

Panel hooks not engaged

Occurrence: 200101776

The Australian Air Safety Investigator

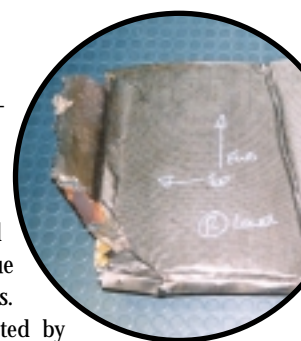
The parts were identified as engine combustion fairing components, originating from a B747-400 that had departed for Los Angeles. The aircraft had arrived safely, but with apparent engine and flap damage.

Technical examination of the fairing panels found that the items were released and ejected from the number-3 engine because of incorrect installation during maintenance activities before the flight. The examination found no evidence of deficiencies in the manufacture or maintenance of the panels that could have contributed to the release.

The design of the fairing panels allowed them to be fitted to the engine without the mounting hooks being engaged. Visual indications that the panels were incorrectly fitted were not obvious and the required inspections for correct panel installation failed to identify the problem. Maintenance documents for the number-three engine of the incident aircraft indicated that those inspections were first carried out after work was completed and again after the engine was ground run. However, neither inspection identified the problem.

A possible reason for the failure to identify the incorrect installation of the combustion fairings was the reluctance of the operator's maintenance staff to use the cold-stream duct access platforms. Without the platforms in place, inspection of the panel mounts for the signs of incorrect installation is difficult. Platforms have not been used because of instability within the duct, time taken in fitting and limits in access to the underside of the engine core.

1. The design of the engine combustion fairing allowed the individual panels to be installed onto the engine without the proper engagement of the upper mounting hooks.
2. During maintenance before the occurrence flight, the right side combustion fairing panel was fitted to the number-3 engine without the mounting hooks being engaged with the upper panel section.
3. Inspections following maintenance work and subsequently following engine ground running, failed to identify the incorrectly installed panel. ■

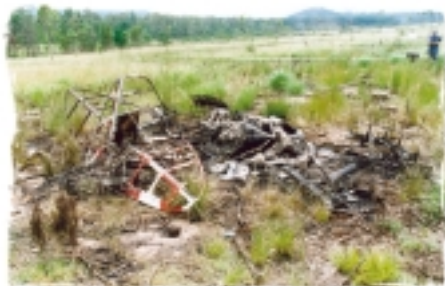
The pilot of another aircraft conducting aerobatic practice in the area subsequently located the burnt wreckage and notified air traffic control of the accident. The aircraft had struck the ground at about 100 kts while a wings-level 30 degree nose-down attitude. It was travelling in a direction opposite to that in which it was last seen. No witnesses observed the aircraft impact the ground.

The weather conditions were abnormally hot and humid during the period of the flight. The pilot normally did not wear a parachute, however he was wearing one on the accident flight. As a result, his body was positioned about 4 cm further forward than normal. That may have affected the pilot's perception of control positions when performing precision manoeuvres.

In the immediate vicinity of the crash site there were no prominent visual indicators for the pilot to judge the height of the aircraft above the ground.

Why the aircraft impacted the ground could not be established. ■

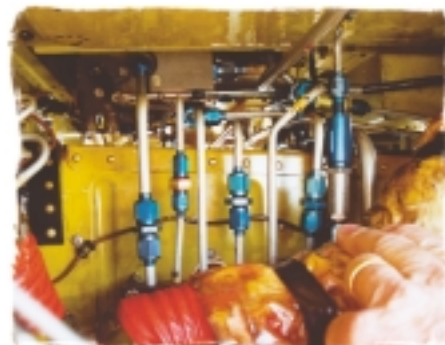
A flyby confirmed that the nose gear was not fully down. The nose landing gear collapsed on landing.

Subsequent engineering examination revealed that a rigid hydraulic pressure line had fractured. As a result, all the fluid from the hydraulic reservoir, including that portion in the power pack emergency sump, had drained out. The pilot was then unable to retract or extend the gear using either the normal or emergency systems.

Specialist engineering examination of the line confirmed that it failed due to fatigue cracking. The line was subjected to torsional or bending pre-loads causing the line to crack. The pre-loads were most likely introduced during assembly, where one fitting was tightened sufficiently to prevent free movement of the line, when the opposite end was brought into position. The maintenance documents did not reveal if the line was as fitted during aircraft manufacture or during a subsequent repair action. The aircraft had a total of 12,745 hours time in service at the time of the incident. ■

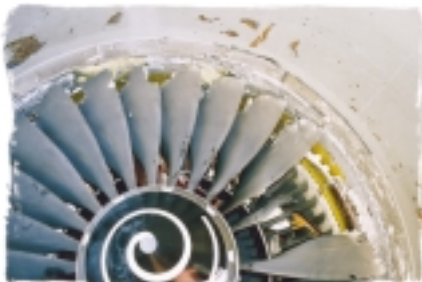
Preliminary inspection of the damaged engine revealed the complete liberation of one fan blade from the rotor disk, with the remaining fan blades experiencing severe damage of the outer length. Severe disruption of the fan shroud and acoustic linings occurred, with liberation of debris onto the runway. The blade failure was a contained event, with no perforation of the engine kevlar containment shroud having occurred in the initial impact area. A small amount of debris was ejected from the engine intake during a compressor surge that occurred at the time of the failure leading to minor damage to the forward fuselage. The right engine sustained minor damage, with one fan blade receiving a leading edge chip and some tearing of the aft acoustic insulation.

Metallurgical examination showed the fan blade to have released from the disk as a result of advanced fatigue cracking of the blade root. The development of fatigue cracking was attributed to the breakdown of the lubricant used to prevent galling between the blade root and the disk socket. The resulting galling produced irregularities in the stress distribution within the blade root, promoting the initiation of fatigue cracking. Physical defects, or other material or manufacturing anomalies, were not identified. ■

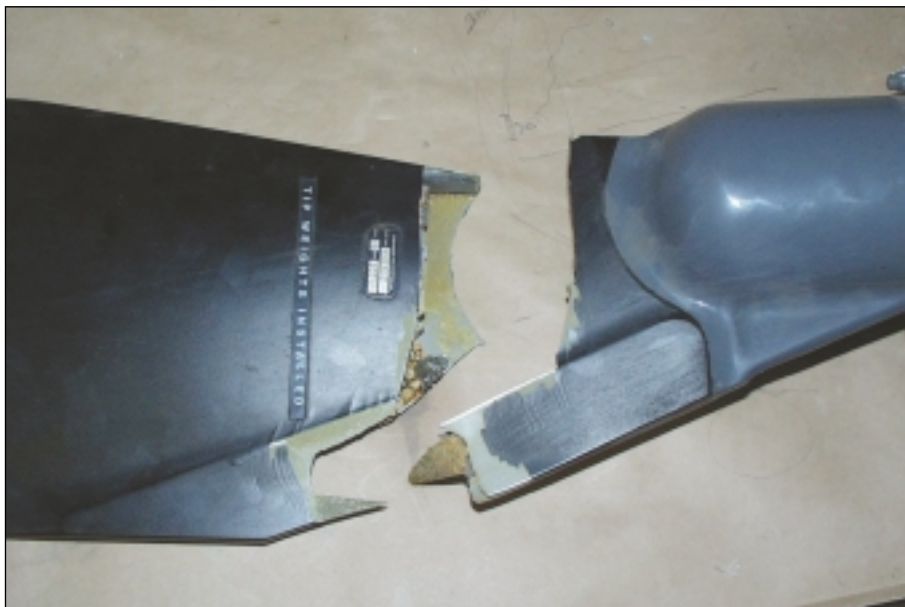
IN a recent Australian accident the main rotor blade of a Robinson R22 Beta helicopter separated in flight resulting in fatal injuries to the pilot and moderate injuries to the passenger. The resulting ATSB investigation found that the failure mode of the main rotor blade was identical to the failure mode documented in a 1990 occurrence and on manufacturer tested-to-failure blades.

The report concluded that under-reporting of the helicopter flight time probably resulted in an actual service life of the failed main rotor blade in excess of the manufacturers stated limits. This information was gleaned following a review of the helicopter logbooks versus company invoices and parts, and fuel usage.

Figure 1: The broken rotor blade
