The Australian Air Safety Investigator is a regular eight-page feature in *Flight Safety Australia* produced with editorial independence by the ATSB. It aims to keep the industry informed of the latest findings and issues in air safety from the bureau's perspective.

Main landing gear door separation

Occurrence 200105518

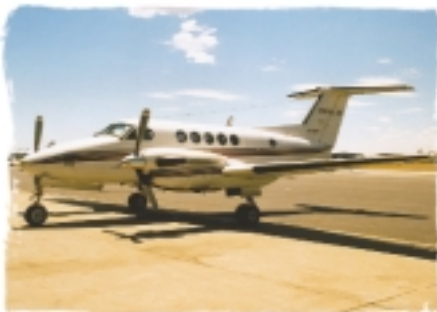
For the first 12 minutes of the flight, the operation of the aircraft and the communications with the pilot appeared normal. However, shortly after the aircraft had climbed through its assigned altitude, the pilot's speech became significantly impaired and he appeared unable to respond to ATS instructions. Several open microphone transmissions over the next 10-minute period revealed the progressive deterioration of the pilot towards unconsciousness and the absence of any sounds of passenger activity in the aircraft. Five hours after taking off from Perth, the aircraft collided with the ground near Burketown, Queensland, and was destroyed. There were no survivors.

The investigation concluded that the incapacitation of the pilot and passengers was probably a result of hypobaric hypoxia due to the aircraft being fully or partially unpressurised and their not receiving supplemental oxygen. Due to the extensive damage to the aircraft the investigation could not determine the reason for the aircraft being unpressurised, or why the pilot and passengers did not receive supplemental oxygen. ■

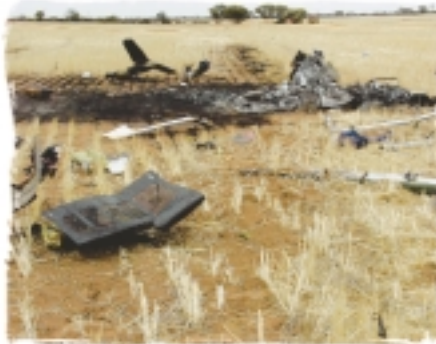
The pilot of the Bell 206 helicopter had been tasked to conduct a powerline inspection for the local electricity power company, with two power company employees on board as observer and inspector. After inspecting an anomaly on a structure the pilot transitioned the helicopter from the hover to forward flight. The pilot and front seat observer received fatal injuries and the rear seat inspector received serious injuries in the crash that followed.

The investigation found that the only published guidance and operating standard in Australia for helicopter powerline work, was the Electricity Supply Association of Australia Ltd (ESAA) document "Guidelines for use of helicopters for live line work", August 1995. Neither the power company sub-division or the helicopter operator involved with the accident was aware of this document. Consequently their procedures were inadequate for the task.
