The Australian Air Safety Investigator is a regular eight-page feature in *Flight Safety Australia* produced with editorial independence by the ATSB. It aims to keep the industry informed of the latest findings and issues in air safety from the bureau's perspective.

Recently completed investigations

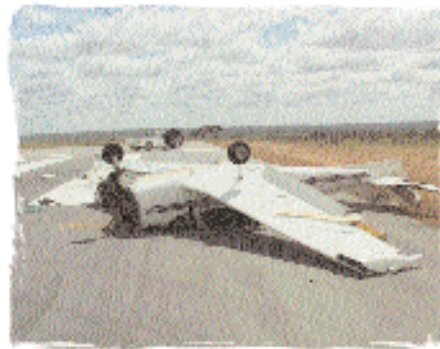
Two Grob G115-C aircraft, VH-ZIR and VH-ZIB collided at low altitude while on short-final approach to runway 18 at Merredin, WA. Each aircraft was being flown by a student pilot on a solo training exercise. Following the collision, neither of the pilots was able to maintain control of their aircraft.

The nose of ZIR pitched steeply upwards and the aircraft became inverted, striking the runway in a nose low attitude while the nose of ZIB pitched downwards with the aircraft landing heavily on its nose wheel. Both aircraft came to rest on the runway.

Witnesses reported that they saw the two aircraft converging on short final, with the lower aircraft being approached from above and behind by the higher aircraft, which was travelling slightly faster. It is likely that the relative positions of the two aircraft on final approach had prevented the pilot of the higher aircraft from seeing the lower aircraft ahead. Neither pilot had seen the other aircraft prior to the collision occurring. The investigation could not positively determine the sequence of impact between the two aircraft. The physical evidence was consistent with ZIR being struck from above and behind by ZIB, and prior to becoming inverted as a result of the collision. ■
