The Australian Air Safety Investigator

Disorientation during night operations

Occurrence 200101929

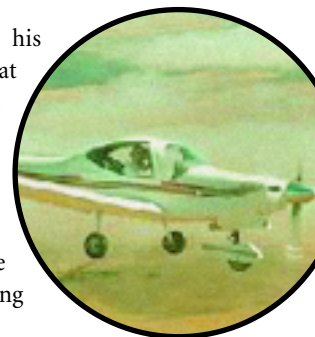
THE student pilot was authorised by his instructor to conduct solo night circuits at Merredin, WA in a Grob 115 aircraft. Shortly after take-off from runway 28, and as the student commenced his after take-off checks, he noted that the aircraft was becoming difficult to control. Scanning the aircraft's flight instruments he concluded the attitude indicator was unreliable and noted that the directional indicator was turning quickly to the left.

Despite applying back-pressure to the control column and maintaining the pitch attitude for a climb, the aircraft continued to lose height and impacted the ground beyond the aerodrome boundary. Immediately following the ground impact, the aircraft became airborne and the student recalled applying full power and commencing a climb. An instructor on the ground established radio communication and provided instructions to assist the student to complete the subsequent circuit and landing. As the nose was lowered to the runway during the landing roll the propeller struck the runway and stopped. Examination of the aircraft indicated that the nose wheel and oleo had been damaged on contact with the ground and had detached from the aircraft prior to the landing. The student was not injured and vacated the aircraft without assistance.

Post-accident examination of the aircraft flight instruments, engine driven vacuum pump and other associated systems did not reveal any pre-existing defect. The student was relatively inexperienced in dark night operations and had not completed the training specified in the operator's syllabus prior to commencing night operations.

The circumstances of the accident were consistent with the student becoming disorientated, possibly associated with the change in aircraft configuration during completion of the after take-off checklist. Because he had not completed the training required for night operations, the student had most probably not developed his instrument flying skills to the standard normally required. The pilot had completed a dual navigation exercise prior to departing on the accident flight. At the time of the accident he had been in attendance at the aerodrome for 10 hours. Accordingly, it was possible that his performance during the accident flight was also affected by fatigue. ■

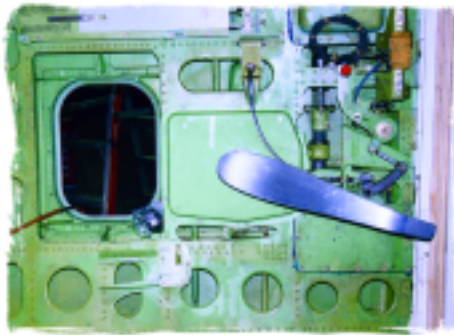
While en-route to Japan, the crew of the Boeing 747-300 aircraft noticed the number-5 left main entry door warning light illuminate. The flight engineer went to investigate and found the door handle had moved from its fully locked 4-o'clock position to an unlocked 3-o'clock position.

The flight engineer, with the assistance of one of the cabin crew, attempted to move the handle back to the fully locked position but were unable to do so. It was determined that the door would not be able to come open in flight due to the cabin being pressurised, so the flight continued on to destination.

Shortly before landing, following a normal approach, the door handle again started to move towards the open position. As the handle reached the 2-o'clock position, loud wind noise could be heard. The flight attendant, with the aid of a passenger, forced the handle down holding it there until the aircraft had landed and taxied to the terminal.

Minor adjustments were made to the door but the handle movement re-occurred over the next few flights. On returning to the operator's main base, the door was removed and inspected with no faults found. The door was refitted and a rigging check carried out. ■

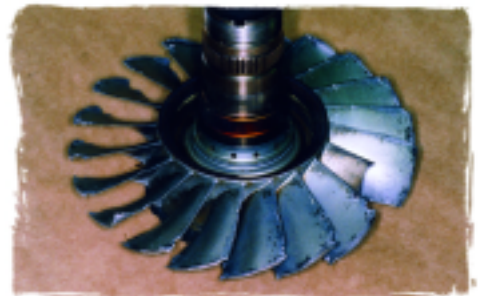
During the take-off roll, as the Saab 340 aircraft reached about 100 kts, the crew heard a loud bang that was followed by loss of power from the right engine.

An internal boroscopic examination revealed that about one half of a single first-stage compressor blisk (bladed disk) blade had separated, and that the compressor and turbine blades sustained varying degrees of damage on the leading and trailing edges.

The blade separation was found to have occurred as a result of fatigue cracking that initiated from corresponding transverse mid-span locations on both sides of the blade. The initial development and growth of the crack had been slow, extending over numerous hours and flight cycles. At approximately nine cycles before failure, the crack began to advance much more rapidly. The crack grew to a critical size and final overload fracture of the remaining section allowed separation of the outer blade section.

No anomalies were found within the blisk material and manufacture. ■

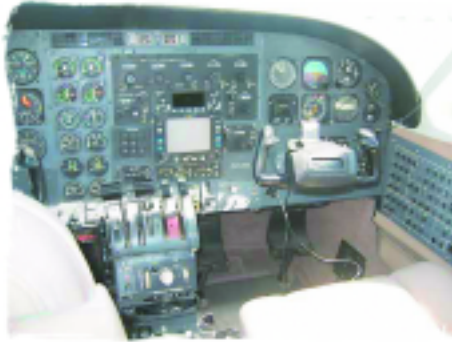
Shortly after commencing descent from flight level (FL) 310, the pilot of the Cessna Conquest noticed the cabin altitude indication rising. When passing through FL270, the cabin rate of climb rose to 3,000 ft/min with an accompanying

decrease in cabin differential pressure and both master warning and 'ALT' annunciators illuminating. When the annunciator lights illuminated the pilot observed that the cabin oxygen masks had failed to auto-deploy as required. As the patients were already on oxygen and the flight nurse had donned a spare mask, he did not deploy them manually. The pilot donned his own oxygen mask and commenced a rapid descent to 10,000 ft.

The pilot reported that the cabin altitude indication climbed to a peak of 17,000 ft before decreasing during the descent. A subsequent maintenance inspection found water contamination present in the cabin door seal pressurisation solenoid valve and it was suspected that this water froze preventing the correct operation of the valve.

The failure of the oxygen mask auto-deployment system was also investigated and the wiring to the barometric activation switch was found to have a high resistance. This wiring was replaced. As a precaution, the wiring to the barometric switch that activated the cabin altitude annunciator warning light was also replaced. During these rectifications, the maintenance personnel discovered there was no procedure published by the manufacturer to correctly adjust and test either barometric switch set-point after maintenance. The company has since introduced an engineering order that details the appropriate adjustment and test procedures to be carried out prior to return to service for these barometric switches. ■

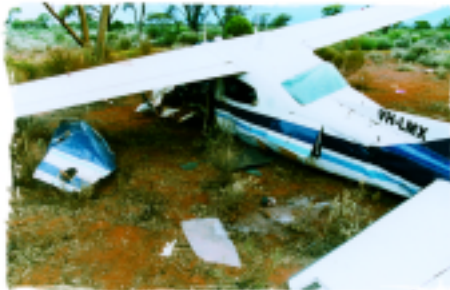
The pilot of the Cessna 210 declared a MAYDAY and stated that he had lost engine power and was attempting a landing on a road. A short time later, the aircraft impacted heavily in a left wing low, nose-down attitude on lightly wooded scrub ground to the south of the road. The pilot received fatal injuries. The three passengers were removed from the aircraft by emergency services personnel and transported to hospital with serious injuries.

The afternoon before the flight, the operator requested fuel for the aircraft (160L in each of two tanks) but later amended the requirement to fill the fuel tanks to a new quantity of 120L in each tank. The trip fuel log found in the aircraft revealed that the pilot had entered the incorrect fuel total with annotations of 160L per fuel tank instead of the actual 120L per fuel tank.

Because of the initial fuel total error, the pilot would have expected to have 40L more remaining in each tank at the time the engine lost power.

In the absence of evidence of a mechanical failure leading to engine loss of power, the most likely cause of the engine loss of power was associated with fuel supply starvation or interruption. ■
