Safety Investigator

Recently completed **investigations**

Safety briefs

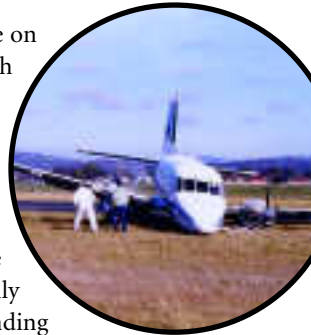
In-flight engine fire

Occurrence 200102710

Technical investigation revealed that vibration from the worn armature shaft of the right engine starter generator initiated a fatigue crack in the fuel return line. Fuel leaked from the fractured line during the flight, and was ignited by sparks or frictional heat generated by the failed generator after the armature shaft failed.

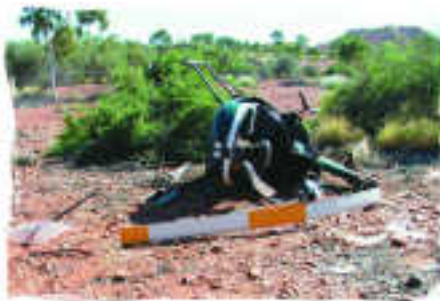
Collision with powerline

Occurrence 200201723

The powerline was aligned approximately east to west at right angles to the helicopter's flight path. It spanned a distance in excess of 500m from a pole in a saddle on a ridge east of the fence, to another pole set among trees in the timbered paddock. Strike marks on the wire showed the helicopter had struck the powerline at approximately mid-span. There were no markers on the powerline, nor were they required. The height of the wire, at the point of contact, was about 20m above ground level. ■

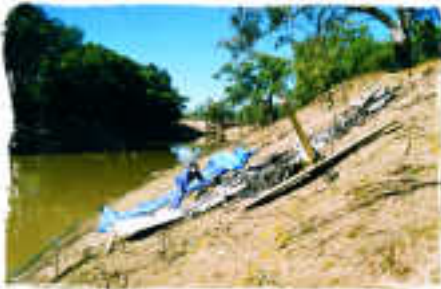
Rough running engine

Occurrence 200102289

The aircraft had incorrect heat range spark plugs fitted in the top positions in all of the engine cylinders. The aircraft and engine manufacturers indicated that the use of these spark plugs can result in detonation and pre-ignition. Engine rough running and backfiring typifies detonation and pre-ignition.

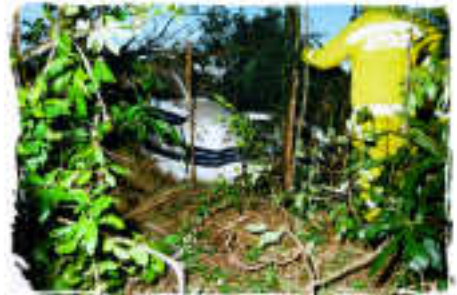
Erratic fuel flow indicator

Occurrence 200200885

As the aircraft descended, the pilot observed that one of the fuel flow gauges was indicating zero, while at the same time, one or both engines began to surge and run roughly. He immediately informed the controller, who asked if he was familiar with a local airstrip, (Greenhill, which is 10NM to the southeast of Cairns airport). The pilot replied that he wasn't. After conducting a number of steep turns, saw a cleared strip in a field and decided that he had to land, but found that he was too high and attempted a 360-degree steep turn onto final to reposition the aircraft. However, the airspeed was rapidly decreasing and there was insufficient height to complete the approach. At 1729 EST, the aircraft impacted the ground short of the strip and slid for about 20 metres.
