# The Australian Air Safety

# Safety Investigator

# Recently completed investigations

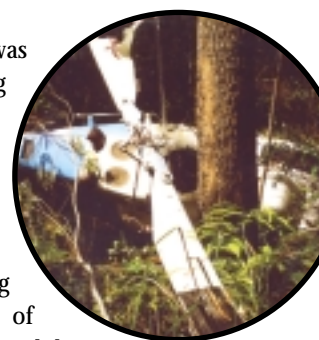
Occurrence 200104604

The pilot's left shoulder harness had broken and separated at a point just forward of and below the pilot's shoulder. The pilot's left shoulder harness was sent for testing by an independent belt and harness testing and repairs organisation. The webbing was identified as MIL-T-50368 Type IV, 2 inch Nylon Webbing, rated at 2,000 pounds strength. The rated assembly strength of the harness assembly was 1,500 pounds. Testing revealed that the webbing failed at a value of 391 pounds, or less than 20 per cent of the original strength of the material. Factors contributing to the loss of original strength were ageing related to ultraviolet light exposure, abrasion damage and contamination by turbine oil.

The investigation determined that fuel supply to the helicopter engine was interrupted, resulting in engine surging and subsequent flameout. ■

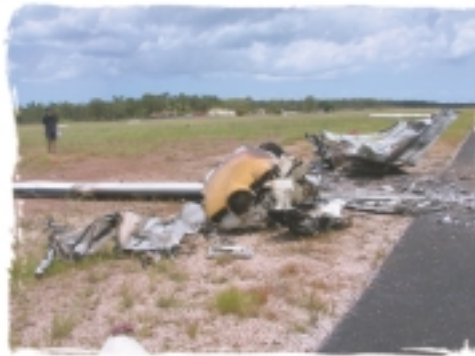
Occurrence 200201100

Witnesses reported that shortly after the aircraft took off from runway 10, it diverged to the right of the runway and in level flight at about 20 ft above the ground tracked towards the operator's ticketing office. The aircraft subsequently struck a floodlight, a VHF aerial and two palm trees. It then hit the ground approximately 150 m beyond the aerial and was destroyed by fire and impact forces. Although the pilot was able to exit the aircraft unaided, he later died from injuries received during the accident. Post-mortem and toxicological examination did not identify any factor, which may have impaired the pilot's ability to operate the aircraft safely.

The investigation was unable to establish why the aircraft diverged from the runway heading immediately after take-off. ■

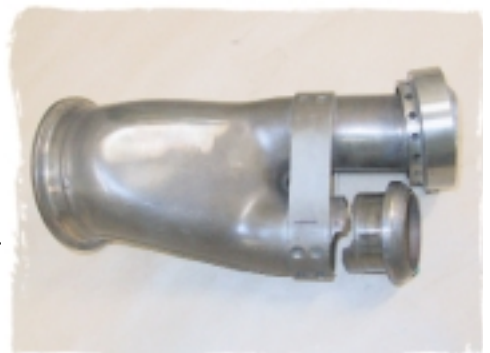
Occurrence 200105701

An examination by the operator revealed that a high pressure duct (Wye-Air Cooling Part No 1456M55G03) had fractured transversely through the shorter of two stub-sections. High-pressure, high-temperature air that had escaped from the cracked duct, impinged on wiring to the engine fire detection loop. The insulation of the wires was damaged and the wires disrupted. The duct that ruptured was part of the engine's stage 11 cooling system. Air is ducted from stage 11 of the high pressure compressor to cool the stage 2 high pressure turbine nozzles.

Examination of the duct by the ATSB determined that the duct rupture was a result of fatigue cracking consistent with high-cycle, vibratory loads. The crack initiated at the base of a reinforcing strap brazed to the duct neck. There was evidence of a mis-alignment of approximately 2 degrees in the connection of the fractured stub section to the adjoining section. There was no evidence of material or manufacturing defects. ■
