*The Australian Air Safety Investigator* is a regular six-page feature in *Flight Safety Australia* produced with editorial independence by the ATSB. It aims to keep the industry informed of the latest findings and issues in air safety from the bureau's perspective.

## Loss of control

# Safety briefs

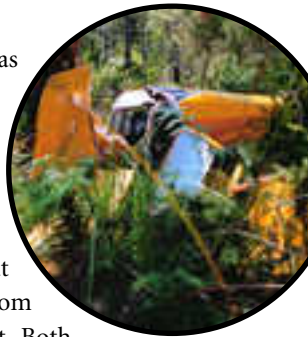
Occurrence 200200377

A de Havilland DH82A Tiger Moth aircraft was hired to undertake a pleasure flight. During the take-off, it was observed to strike and destroy two taxiway lights with the right wheel. The pilot continued the take-off and the aircraft departed the Williamstown circuit area at 1428 EST. The aircraft was airborne for about 50 minutes and crashed approximately 2 km from the aerodrome, shortly after joining the circuit. Both occupants were fatally injured. The witnesses reported observing either the left or the right wings fold up and an object separating from the aircraft.

The wreckage was contained within a small area at the foot of a tall tree, its distribution consistent with a steep nose-down attitude while rotating to the left. There was no evidence indicating that the right wheel destroying two taxiway lights during take-off damaged any major structural element or in any way contributed to the accident. No evidence was found supporting reported observations of the left or the right wings folding up or an object separating from the aircraft.

The wood was in good condition and free of decay. There was no evidence that a failure of the wood was a factor in the accident. Some laminated wing spar and propeller members failed at the glue line rather than in the wood. It was evident that the Casein adhesive had been subjected to attack by micro-organisms. The attack would occur when the wood and the glue moisture content had risen above 18 per cent. The attack by micro-organisms was least evident in the areas close to the edges of the glued joints. The joints were further secured by nails, bolts and screws, preventing easy detection of the deterioration in the glue. The detection of delaminated propeller members was also hindered by a covering of 'Irish linen' on the blades and a thick coat of paint. However, there was no indication that glue failure may have resulted in a catastrophic failure of a major structural element.

Current inspection procedures do not allow detection of delaminated Casein glued joints. ■

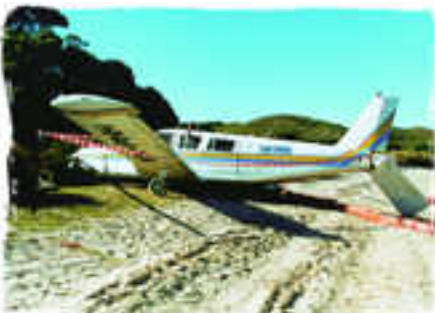
Occurrence 200105777

The pilot was unable to maintain directional control of the aircraft during the take-off roll. The aircraft diverged to the right of the runway centreline, and departed the runway strip, passing over a sealed taxiway and sandy scrub type terrain. The right main landing gear collided with a tree stump on the edge of a shallow salt-water lake adjacent to the aerodrome. The aircraft briefly became airborne, before coming to rest in the lake. The pilot and passengers were not injured and vacated the aircraft without assistance.

Examination of the aircraft did not reveal any defect that could have affected its normal operation.

The Rottneest Island AWS recorded wind gusts to 38 kts during the 5 minutes prior to the accident. The flight manual approved by the Civil Aviation Safety Authority stipulated a maximum permissible cross-wind component of 20 kts. ■

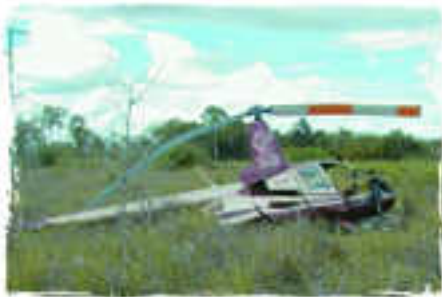
Occurrence 200300316

The violent vibration necessitated a landing. The pilot entered autorotation and selected a paddock for the forced landing. He reported that the helicopter was difficult to control during the descent. In particular, while cyclic inputs altered the attitude of the helicopter left and right it would not turn in the selected direction. The pilot also reported that it was difficult to control main rotor RPM during the autorotative descent and he relied upon the low rotor RPM horn and light as an indication of rotor RPM.

During the descent, the helicopter struck powerlines and was substantially damaged. The pilot reported that he was unable to avoid the powerlines because of the ineffective cyclic inputs. The pilot and passenger, the only occupants, suffered minor injuries.

A report from the accident site indicated significant main rotor blade skin disbonding 60 mm from the tip and extending 1070 mm inboard on one blade and the beginning of skin disbonding on the other blade. The ATSB conducted a preliminary investigation and it was apparent that the problem was a continuing airworthiness matter. ATSB released the main rotor blades to the Civil Aviation Safety Authority (CASA) for further examination as part of an airworthiness investigation. ■

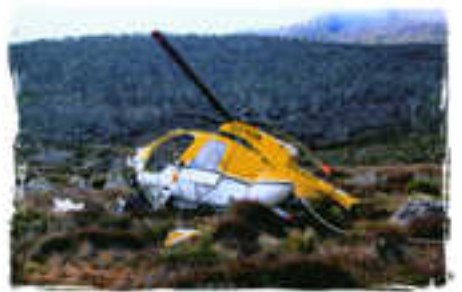
Occurrence 200202442

At 1524 hours, as the helicopter descended through about 200 ft above ground level (AGL), and at a speed of 70 kts, the main rotor speed decreased and the engine auto reignition advisory light illuminated. Assessing that the engine had lost power, the pilot reported that he initiated an autorotation to land. The helicopter impacted the ground heavily on the right rear skid landing gear, collapsing that gear and separating the left skid landing gear. The helicopter came to rest about 7 m from the initial impact point, facing back towards the direction of approach. Impact forces destroyed the helicopter. There was no fire. The pilot and three passengers sustained serious injuries.

The investigation found that the helicopter's engine had lost power at a critical stage of flight and that the pilot was unable to conduct a successful autorotation landing. ■
