The Australian Air Safety

Safety briefs

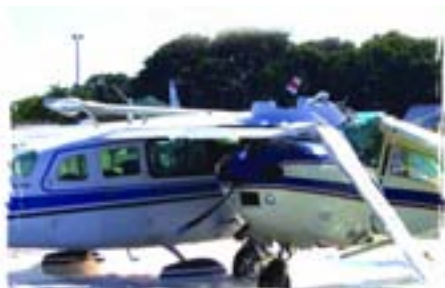
Occurrence 200203171

The pilot reported that he then applied the parking brake and set the engine controls. After instructing the passengers not to touch the aircraft controls, the pilot alighted and attempted to start the engine by swinging the propeller. When the engine started it accelerated to nearly full power and the aircraft moved forward and accelerated rapidly across the apron. The aircraft struck several parked aircraft before colliding with a Cessna 206. The pilot chased after the aircraft and although able to board the aircraft, he was unable to stop it before it collided with the C206 and a Metroliner, which were extensively damaged.

Maintenance personnel who had witnessed the collision came to the assistance of the C182 occupants. During the evacuation sequence, spilled fuel from the ruptured wing tanks soaked the aircraft occupants and rescuers. One passenger received minor injury and all the occupants and some of the rescuers received minor skin burns from contact with aviation fuel. ■

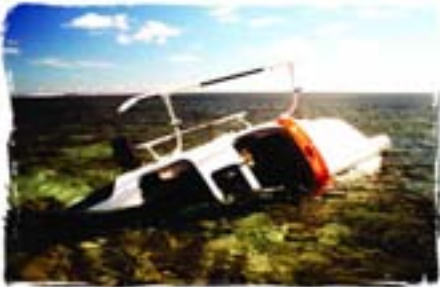
Occurrence 200102083

The crew of the Bell 407 rescue helicopter was tasked to drop a liferaft to the occupants of a sinking yacht at the southern end of the Great Barrier Reef. The pilot made a number of approaches to determine the best direction to approach the yacht and drop the liferaft. The weather conditions at the time were dark night with little or no celestial illumination. On the drop run the pilot intended overflying the yacht at about 20 kt and 50 ft, using the radar altimeter. As the helicopter approached the yacht at about 40 kts, and shortly after the crewman called 50 ft, the helicopter struck the water. Both occupants escaped from the upturned fuselage safely.

The circumstances of the accident were consistent with controlled flight into the water at night. The operator's documentation and associated lack of appropriate training, risk assessment tools, and published guidance inappropriately placed a large responsibility on the pilot to balance the safety of the aircraft and its crew with achieving life-saving missions that were the unit's function.

The decision to descend to 50 ft in black night conditions without the assistance of stabilisation, height hold, automatic pilot or coupled systems was questionable. The operator appeared to have an inadequate understanding of the risks associated with the flight as it was planned especially considering the limited equipment, procedures, training and experience that was available. The absence of clear organisational protocols for task acceptance or rejection may have influenced the crew in accepting a task that involved a high risk. ■

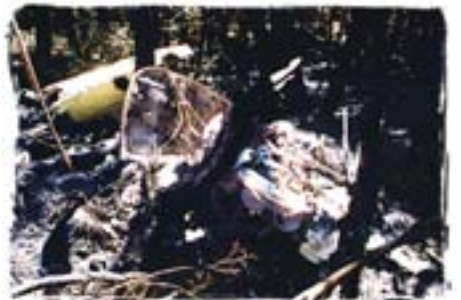
Occurrence 200205901

As the aircraft neared touchdown well down the strip, the pilot considered it to be a late landing, but still with sufficient length remaining for braking. The aircraft touched down and bounced twice into the air before the pilot applied power for the go-around.

The pilot reported that although he applied full power, the aircraft did not accelerate to take off speed and did not gain sufficient height to clear the trees beyond the end of the strip.

While the evacuation was taking place, the aircraft began to burn and was subsequently destroyed by the post-impact fire. The pilot reported that prior to the flight, he had thoroughly briefed the passengers on the emergency exits and the evacuation procedure. ■
