The Australian Air Safety

Safety **briefs**

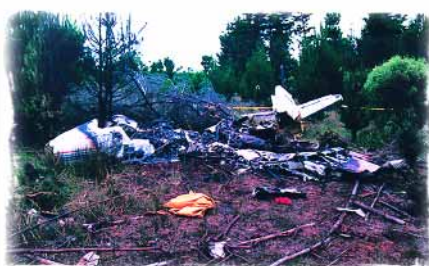
Occurrence 200105769

At approximately 2336 (56 minutes after departure), the aircraft impacted the ground at a position 3.1 nautical miles from the threshold of runway 18. ■

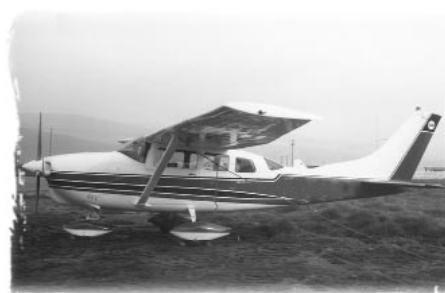
Occurrence 2003009713

On final approach, the aircraft undershot and contacted trees at the end of the field. The aircraft touched down on all three wheels in the cleared area just short of the strip, before the left wheel hit a log resulting in the aircraft flipping upside down. The pilot was uninjured and climbed clear of the aircraft through the left door.

An inspection of the aircraft by maintenance engineers found that the mixture cable had failed at its crimped fitting, allowing the mixture control to move to a lean setting. This resulted in the engine shutting down. A major defect report was submitted to the Civil Aviation Safety Authority. ■

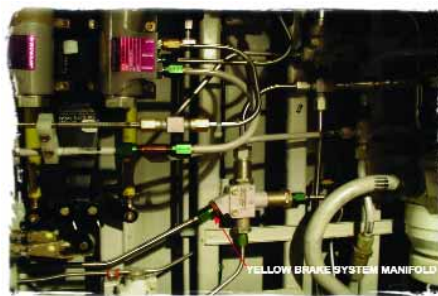
Occurrence 200203243

Two off-duty cabin crewmembers and some passengers reported a haze, or mist that was acrid and transparent, like light smoke, in the vicinity of Row 6. They also reported a burning sensation in the throat, difficulty swallowing and breathing and that many people were coughing.

Subsequent investigation by the operator determined that a leak in a hydraulic coupling connected to the yellow system brake manifold had allowed pressurised hydraulic fluid to escape as mist that entered the passenger cabin via gaps in the internal lining of the hydraulic bay.

The 'o' ring seal for the coupling was replaced and the leak stopped. After a number of subsequent flights the coupling leak re-occurred. On closer inspection it was found that the coupling had a crack along its threads. The coupling was replaced. ■
