Australian Transport Safety Bureau

The Australian Air Sa

Safety **briefs**

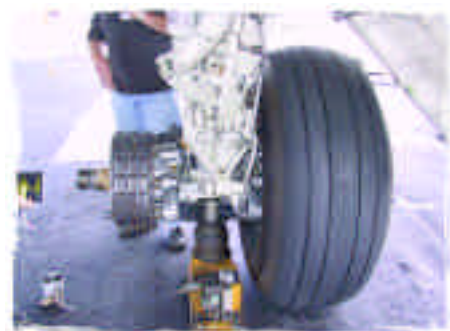
Occurrence 200204836

After parking the aircraft, the crew reported the loss of the inner left main wheel and requested RFFS to attend while the aircraft was secured. An inspection of the Perth runway did not find any debris.

A search conducted at Melbourne airport, the point of departure, resulted in the recovery of debris from runway 34. The wheel had impacted the perimeter fence past the overrun area of runway 34 and was recovered from that position.

Investigation revealed corrosion and rolling contact fatigue spalling of the bearings that probably resulted in failure of the bearing and the loss of the wheel from the aircraft.

The operator has amended maintenance procedures for re-inspection intervals of wheel bearings after long term storage. ■
