The Australian Air

Near crash from icing prompts call for better stall warning

Safety Investigator

Safety briefs

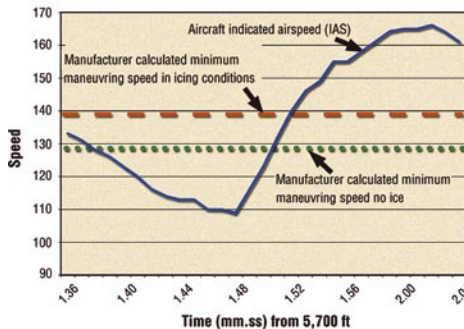
Recorded Aircraft Speed & Target Speeds

As captured by the flight data recorder, the airspeed prior to stall was significantly below the minimums recommended for both icing and non-icing conditions. Source: ATSB

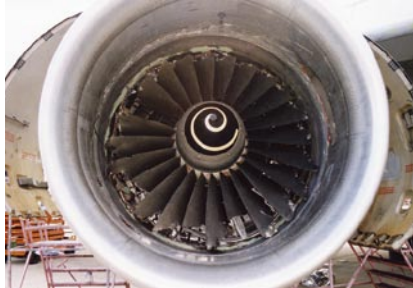
Approximately one hour after departing Sydney on a regular passenger transport flight to Bangkok, Thailand, the Boeing 747-436 aircraft, registration G-BNLD, sustained the failure of the right inboard (number-three) engine, necessitating a return to Sydney airport where an uneventful one-engine inoperative landing

Failure of the number-three engine resulted from the fracture and liberation of a single first-stage low-pressure compressor (fan) blade. The blade failed through the lower aerofoil section, immediately adjacent to the dovetail connection with the rotor disk. While the initial blade impact was fully contained by the fan casing, many fragments of the fractured blade and its damaged neighbours punctured the intake cowling or escaped forward of the nacelle, producing damage to the wing, control surfaces and the fuselage. Imbalance forces generated by the blade loss produced extensive damage to the engine accessory components and disrupted the primary load-bearing path between the engine fan case and the thrust reverser assembly.

Laboratory examination of the retained root section of the failed blade established that fatigue cracking had initiated and propagated from a pre-existing defect at the blade centreline. The defect was characterised as a 'lack of bond' feature at the interface between the two sandwiched titanium alloy panels used to form the blade. Fatigue cracking had initiated from the upper edge of the defect and propagated under operationally induced bending and centrifugal loads.

The lack of bond defect had formed during manufacture of the blade in 1991. ■
