Australian Transport Safety Bureau

# The Australian Air

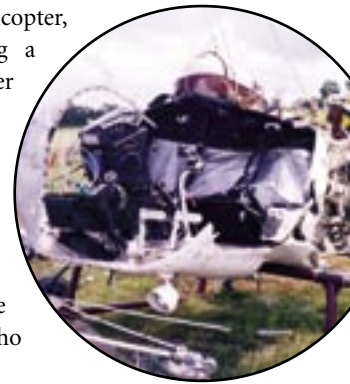
Occurrence 200300982

**A**T approximately 0830 EST, the pilot of the Bell 47G-4A turbine-powered (Soloy) helicopter, registered VH-MTX, was conducting a lift-off to the hover from a mobile helicopter landing site at Caboolture aerodrome, when the helicopter rolled onto its right side. Weather conditions at the time of the occurrence were reported to be '...little or no wind, warm and humid, some cloud but clearing'. The helicopter was substantially damaged, but there was no post-occurrence fire. The pilot, who occupied the left seat, was fatally injured and the passenger, who occupied the right seat, sustained minor injuries.

Post-occurrence technical examination of the helicopter did not reveal any evidence of a helicopter or system fault that could have contributed to the accident. In addition, examination of the mobile platform did not reveal any evidence of it having moved throughout the rollover sequence.

The circumstances of the accident are consistent with the phenomenon known as dynamic rollover. It is likely that the pilot's lack of recency in the helicopter type, combined with his not having flown a turbine-powered Bell 47 previously, contributed to his:

- not making sufficient flight control input to correct the right lateral movement during the lift-off to the hover
- not raising the helicopter to a hover height sufficient to prevent contact with the platform. ■

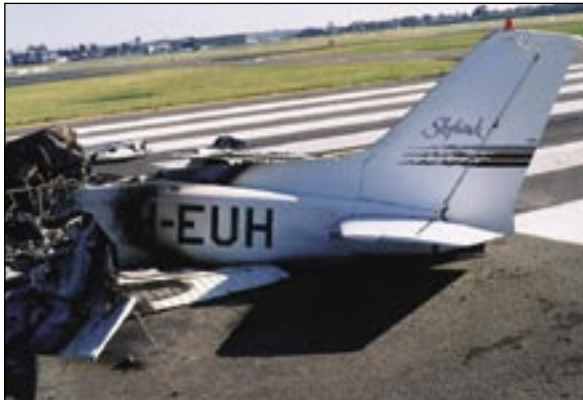
**A**T approximately 1840 Eastern Standard Time on Monday 29 July 2002, two Cessna Aircraft Company 172Rs, registered VH-CNW and VH-EUH, collided while on short final approach to runway 17 left (17L) at Moorabbin airport, Victoria. The two aircraft became entangled, with CNW on top of EUH. The entangled aircraft impacted the runway and came to rest after sliding a short distance along the runway.

The instructor and student pilot of EUH were conducting night circuit training and the pilot of CNW, the sole occupant, was conducting night circuits. Both aircraft were using runway 17L. The instructor and student pilot of EUH were able to exit their aircraft before fire engulfed both aircraft. The pilot of CNW was fatally injured.

to enable them to make a meaningful assessment of the location of other aircraft. The pilots of CNW and EUH made all the relevant mandatory broadcasts. They also made a discretionary broadcast at about the time they were established on the base leg of the circuit. Those broadcasts did not effectively alert either pilot to the collision potential with the other aircraft.

Even though the two aircraft were of the same type and were operating at similar speeds in the circuit, radar data indicated that the pilots of EUH conducted a wider circuit than the pilot of CNW. Both circuit dimensions were within the range of circuit dimensions that were being conducted by other pilots at the time, and were not considered by the investigation to be contrary to procedures. While the dimensions of the circuits flown by the two

accident aircraft were not unusual, the different circuit dimensions, and the consequent difference in the elapsed time, removed the natural spacing that would have typically resulted from the difference in take-off times. In the absence of any other defence or action, the different circuit dimensions led to the two aircraft converging on the final approach leg of the circuit. Neither of the pilots involved in the accident was aware of the impending collision.

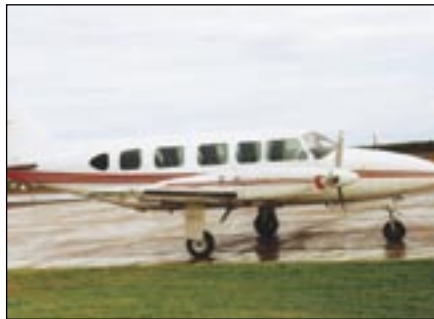
Occurrence 200303599

The Piper PA-31-350 Navajo Chieftain departed Albury with a pilot and six passengers. About 5 minutes into the flight, the pilot reported that the right fuel flow light illuminated and the right engine started surging. About a minute later the left fuel flow light illuminated and the left engine also started surging. Unable to restore power to the engines, the pilot carried out an emergency landing.

The investigation determined that there were 210 – 211 litres of fuel remaining in the inboard tanks, while their capacity was 212 litres. The right outboard tank contained approximately 25 litres and the left outboard tank approximately 1 litre of fuel.

Examination of the engines found that they were capable of normal operation. Detailed examination of the fuel tanks and the fuel system found no evidence of flow restriction or the presence of any foreign material inside the system. The fuel was of the correct type and grade for the aircraft.

The pilot reported that he had selected inboard tanks for the flight. The investigation was unable to reconcile the pilot's reported recollection of inboard tank selection and the evidence of the remaining fuel quantities in the inboard tanks.

The reason for the right engine losing power and surging first could not be determined. ■
