Australian Transport Safety Bureau

The Australian Air

Reflecting on the ATSB's outputs in 2003-04

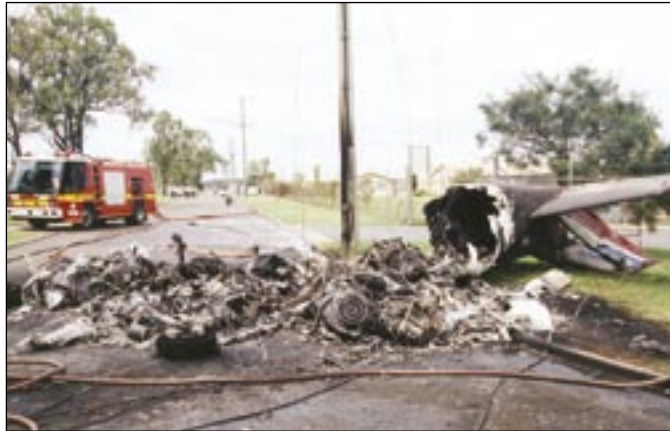
AT about 0836 Eastern Standard Time on 27 November 2001, a Raytheon Beech C90 King Air aircraft, registered VH-LQH, with a pilot and three passengers on-board, took off from runway 29 at Toowoomba aerodrome for an Instrument Flight Rules charter flight to Goondiwindi. As the aircraft became airborne, it lost power on the left engine. Following take-off, the landing gear was not retracted. Control of the aircraft was lost and it struck powerlines before impacting the ground inverted, in a steep nose-down attitude. An intense fuel-fueled fire erupted upon initial impact with the ground and all four occupants were fatally injured. At impact the left propeller was not feathered and the right engine was developing significant power.

Examination of the left engine showed internal damage consistent with the fracture and release of one or more compressor turbine blades, resulting in a significant reduction in power from the engine. Engine Condition Trend Monitoring (ECTM) Program data from the left engine indicated that a potentially safety-critical problem existed in that engine for several weeks prior to the accident. For a variety of reasons that evidence was not detected. The pattern of evidence suggests that temperature-related damage to the left engine's compressor turbine blades, probably due to a problem with the efficiency of the cold section of the

engine, resulted in the failure of one of the blades.

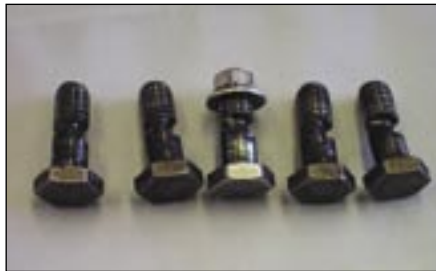
Although the engine was operating within the manufacturer's vibration limit, maintenance personnel continued to investigate the cause of the vibration. It was discovered that the six attachment bolts at the engine end of the Bendix driveshaft had worn through approximately 50 per cent of their thickness. There was evidence of fretting of the mating surfaces of the Bendix and engine coupling plates. The engine attachment plate for the Bendix also incurred severe elongation of the bolt holes. The Bendix shaft had completed approximately 380 hours in service since installation.

New Bendix attachment bolts, along with several of the damaged bolts were forwarded to the ATSB for laboratory analysis. The examination found no evidence of material deficiencies or other anomalous features of the bolt construction that would have rendered the items susceptible to the type of damage observed. The ATSB concluded that the damage sustained by the Bendix attachment bolts supplied was consistent with the effects of inadequate bolt tightness. The engine was shipped to the manufacturer in France for further testing. The damage to the engine, observed by the manufacturer and the BEA, in their opinion was consistent with the findings of the ATSB. ■
