Australian Government

Australian Transport Safety Bureau

# The Australian Air

## Drive shaft failure Robinson R22

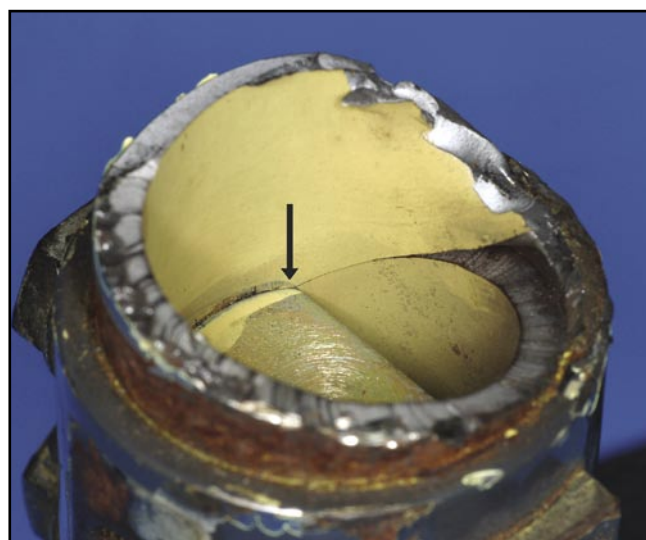
Examination of the shaft revealed that it had failed as a result of a fatigue crack that initiated at a bolt hole in the shaft. Inappropriate procedures, including use of an unapproved sealant, were used when the shaft was last assembled.

The clutch shaft had fractured at the point of connection to the main rotor gearbox flex-plate yoke. The fracture surface indicated pre-existing torsional fatigue cracking, which followed a spiral path from within the yoke connection, and extended around the shaft for approximately 340 degrees over an axial length of about 25 mm. Those crack propagation features were consistent with the initiation and progressive growth of the crack during multiple shaft load cycles prior to the accident flight.

Examination found that when the clutch shaft was assembled to the flex-plate yoke, paint was left on the surface

beneath the bearing blocks. That resulted in the applied bolt tension reducing over time. The examination also found that an unapproved jointing compound had been used when the shaft and yoke were last assembled.

The picture shows the fatigue crack with the initiation point arrowed.

On 6 November 2003 the ATSB issued recommendation R20030211 to the Civil Aviation Safety Authority (CASA). As a result of that recommendation, CASA issued airworthiness directive AD/R22/51, which mandated inspections of the A166 shaft to A907 yoke on all R22 helicopters operating in Australia. CASA issued AD/R44/019 on 28 November 2003, mandating the same inspection on those R44 helicopters that had had the C166 shaft to C907 yoke disassembled since installation at the factory.

The Robinson Helicopter Company subsequently advised that it would be revising the maintenance manuals and maintenance training courses for the R22 and R44 model helicopters to ensure that the instructions for the assembly of the shaft to yoke joint were clarified.

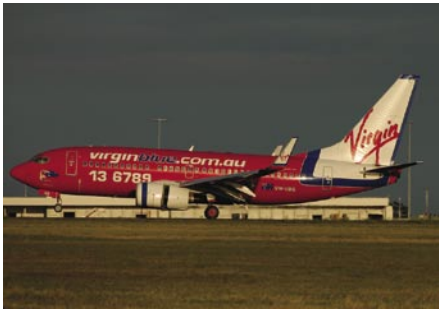
A subsequent engineering examination of the aircraft found a burned diode on the master dim and test module circuit board on the P6 panel, located behind the first officer's seat. The plastic cased diode was the only component damaged on the circuit board. Electrical tests conducted by the aircraft manufacturer determined that the mode of failure of the diode was due to excessive heating while under electrical load.

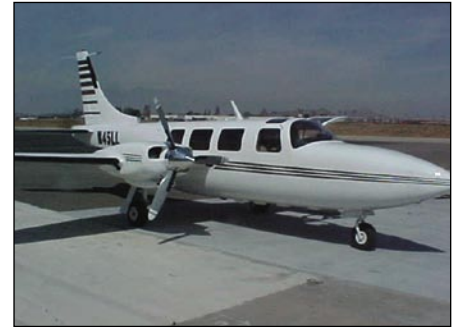
The purpose of the flight was to introduce the commercial pilot, who was undertaking initial multi-engine training, to asymmetric flight. At approximately 1445, the operator advised Australian Search and Rescue that the aircraft had not returned to Coolangatta, and that it was overdue. Recorded radar data indicated that contact with the aircraft was lost at approximately 1331 ESuT. A small amount of debris from the aircraft was recovered from the surface of the ocean.

Without the aircraft wreckage or more detailed information regarding the behaviour of the aircraft in the final stages of the flight, there was insufficient information available to allow any conclusion to be drawn about the development of the accident.
