Australian Transport Safety Bureau

# The Australian Air

## Executive Director's Message

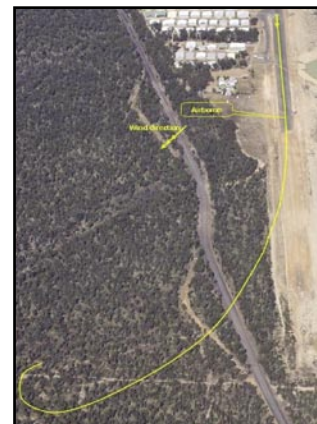
The investigation found that the aircraft had been descending steeply in a right turn when it impacted the ground in a westerly direction. Data recovered from a global positioning system found in the wreckage supported other evidence, which indicated that the aircraft entered a spin during a right turn after take-off.

Examination of the wreckage revealed no evidence of pre-existing mechanical defects that may have contributed to the accident. The wing flaps were in the 10 degrees extended position at the time of the accident. The aircraft stall warning system was recovered from the wreckage, tested and found serviceable. The aircraft had sufficient fuel onboard for the planned flight.

The aircraft was observed flying slowly during its climb after takeoff. If the aircraft's airspeed became sufficiently slow in a steady climb, the aircraft would stall. The circumstances were consistent with the aircraft having stalled in a right turn with insufficient height to recover before impacting the ground. The investigation identified a number of factors that may have contributed to the aircraft entering a stall. ■

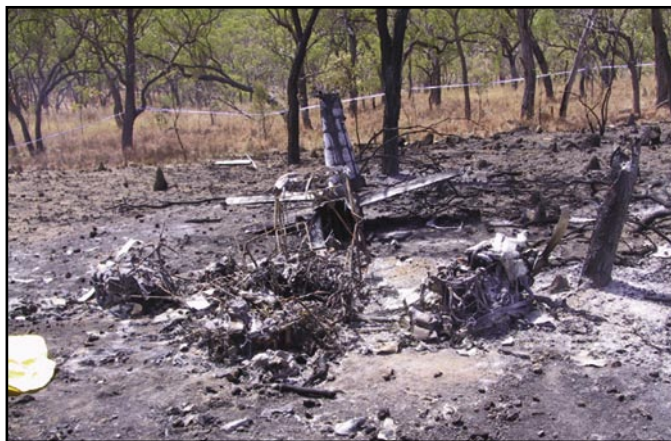
The accident site was 1.5 km west-south-west of Mareeba aerodrome. At the time of impact, the aircraft was inverted and in a nose-low, nearly vertical attitude. An intense post-impact fire resulted in significant melting and destruction of much of the aircraft structure and components. The examination of the wreckage by ATSB investigators did not identify any pre-existing defect that could have contributed to the accident.

Control of the aircraft was lost at a height from which recovery was not possible. The reason for the loss of control could not be conclusively established, however the circumstances of the accident and the available evidence was consistent with pilot incapacitation associated with coronary artery disease. Other possibilities, either individually or in conjunction with pilot incapacitation could not be excluded. ■

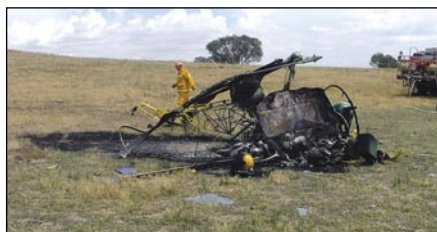
As the pilot air taxied abeam the loading area, the helicopter struck power cables that passed about 50 m from the airstrip, and at an estimated tree top height. The helicopter was destroyed by the resulting ground impact and post-impact fire. The pilot suffered minor injuries.

The power company owning the cables struck by the helicopter has installed overhead markers to the repaired power cables. In addition, that company is seeking to have input to the development of the Australian Standards affecting the mapping and marking of power cables and their supporting structures.

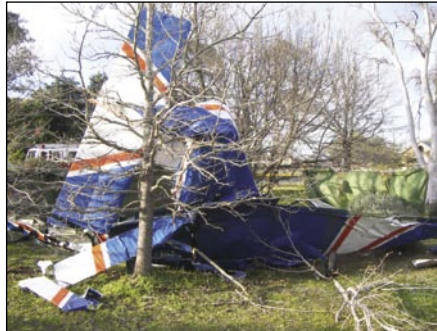
Examination of the aircraft fuselage, flight controls, engine and fuel components by the investigation found no explanation for the sudden loss of power observed by witnesses. Approximately 6.8L of fuel was removed from the aircraft fuel tank.

The investigation examined a similar model aircraft and fuel system. It was found that it is relatively easy to have the bottom (five imperial gallon) segment of the dipstick bend sideways, when the dipstick contacts the bottom of the tank, if the segments are not tensioned by releasing pressure on the tension button. This results in the dipstick over-reading by about 4–5 imperial gallons (18.2L–22.7L).

It is possible that the pilot's operation of the dipstick provided an erroneous reading which led the pilot to believe the aircraft's tank contained more fuel than it actually did. Additionally, an intermittent fuel gauge reading meant that the pilot may not have been able to check the fuel quantity by a secondary means.

In the takeoff climb the fuel pickup point in the tank was probably unported, interrupting the fuel flow to the engine thus causing it to lose power. After the loss of engine power, the pilot probably attempted a turn back to the runway with insufficient height to complete the manoeuvre. ■
