Australian Transport Safety Bureau

The Australian Air

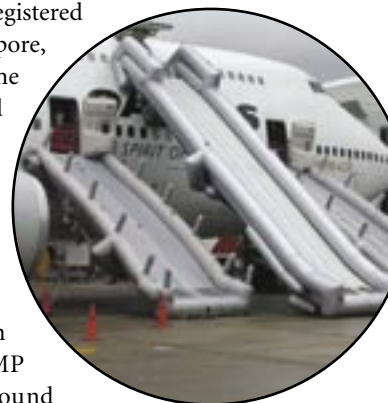
On arrival at the terminal, the pilot in command (PIC) observed a BRAKE TEMP advisory message and notified the ground engineers. At that point, a fire ignited on the right wing landing gear. The flight crew were advised and the PIC ordered an evacuation of the aircraft. On receiving the evacuation announcement, the cabin crew commenced the evacuation drill deploying the aircraft's escape slides. The upper deck left door and doors 2 left and 4 right escape slides, did not deploy. During the evacuation, the over-wing slide at door right 3 deflated while in use. As a result of the evacuation, one flight crew member and three passengers were seriously injured. Some passengers evacuated down the slides with their cabin baggage.

During the accident, an additional two brake fires ignited on the right body landing gear, one of which was extinguished by the Aerodrome Rescue and Fire Fighting Service (ARFFS). A subsequent inspection found that the aircraft's landing gear contained an excessive amount of grease with the presence of inappropriate grease on all of the landing gear axles. The three brake units that had caught fire were found to be serviceable but in a worn condition.

The investigation determined that slide door right 3 did not have any pre-existing defects that contributed to its failure. The nature of the failure was found to be overload of the fabric fibres during the evacuation. The inappropriate grease found on the landing gear axles was general purpose grease used on other components of the landing gear. The time and point of its application to the aircraft axles could not be determined.

The investigation found deficiencies in the operator's maintenance, flight crew and cabin crew procedures. As a result, the operator has issued maintenance memos to its engineering staff clarifying aircraft landing gear lubrication procedures, amended its Aircrew Emergency Procedures Manual, and reviewed cabin crew and flight crew emergency procedures.

As a result of this investigation, the ATSB is issuing safety recommendations to the operator and the Civil Aviation Safety Authority to review the use of over-wing slides during known brake fires. The reviews should take into consideration the visual cues used and potential risk to passengers of evacuating within close proximity of a fire zone. ■

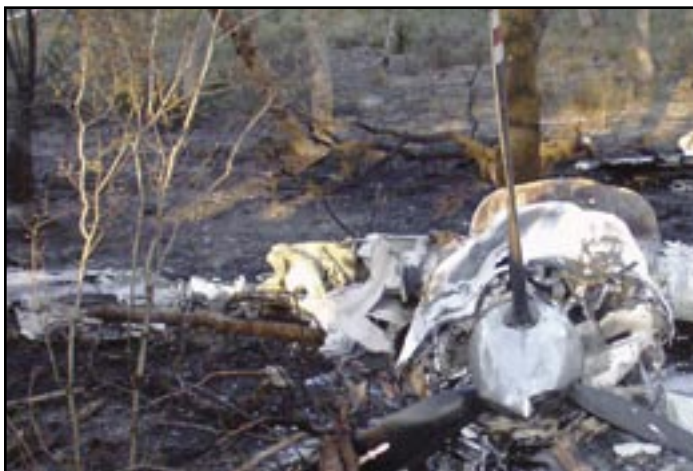
aircraft descended into an area of scrub-type terrain, moderately populated with trees. During the impact sequence at about 1537, the outboard portion of the left wing collided with a tree trunk and was sheared off. A significant quantity of fuel was spilled from the wing's fuel tank and ignited. An intense post-impact fire broke out in the vicinity of the wreckage and destroyed the aircraft.

The failure of the right engine was due to fuel starvation when the drive shaft to the right engine-driven fuel pump had sheared. Examination of the right engine revealed a material anomaly with the fuel pump sleeve bearing. That bearing exhibited evidence of localised adhesive wear (galling) that had restricted the rotation of the pump spindle shaft. The bearing had previously been replaced during the last engine

Analysis of the bearing revealed that it had been manufactured from material that possessed inferior galling resistance when compared with bearings from similar pumps. The investigation concluded that the specified material for the replacement sleeve bearing was inadequate with respect to its galling resistance. High torsional loads between the spindle shaft and the sleeve bearing had caused the pump's drive shaft to shear at a critical phase of flight. Associated with a loss of drive to the pump shaft was a reduction in fuel pressure, which was insufficient to sustain operation of the engine at take-off power.

Following the occurrence, the operator modified other C404 aircraft in its fleet to incorporate a warning light to indicate low fuel pressure. The ATSB has previously issued three recommendations (see ATSB report BO/200105618) relevant to pilot training for engine-out operations in multi-engine aircraft. Those recommendations are also relevant to the circumstances of this occurrence. ■

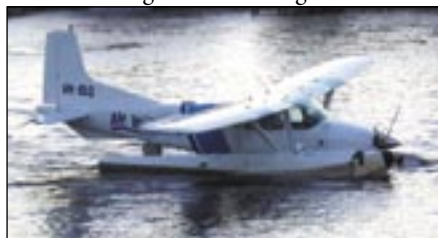
The pilot who was the company chief pilot, reported that he was conducting a 10 minute joy flight with three passengers on board the aircraft in the Gold Coast area. There was 45 L of fuel in the right wing tank and the left wing tank was empty. The flight proceeded normally and at the turning point the pilot flew a wide flat turn using rudder and opposite aileron to give the passengers the best view from the aircraft. After completing the turn, the engine lost power, so the pilot conducted a forced landing on the Nerang River.

The pilot said that after landing he checked the fuel and conducted a fuel drain. He then restarted the engine and noted that all instrument indications were normal. He said that, because there was no other company person available to assist the pilot with the logistics of looking after the aircraft and passengers, he elected to continue the flight. He reported that the takeoff was normal but that the engine lost power soon after the aircraft became airborne. At about the same time, he saw powerline markers directly ahead. He flew over the wires, and noted the aircraft speed had fallen to under 45 knots. The pilot lowered the nose and set the aircraft in the landing attitude. The engine surged but the aircraft impacted the water heavily, and was substantially damaged.

There was 37 L of fuel remaining in the left wing tank, with no evidence of any water. The fuel strainer contained a minor amount of brown residue, but all other filters and the fuel distributor were clean. ■

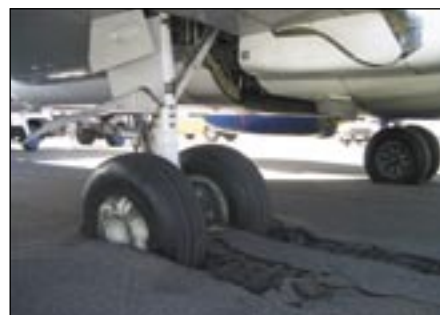
At 1940 EST, on 4 October 2004 a Boeing 737-300 was being taxied to runway 27 at Melbourne Airport for a scheduled international passenger service to Hamilton, New Zealand when its left main landing gear tyres penetrated the blast-protection surface adjacent to the shoulder of taxiway Papa.

The pilot in command then turned the aircraft left and began to enter the holding bay, thinking it was taxiway Papa. The crew realised that they were not on Papa, and turned the aircraft to the right to regain taxiway Echo and the lead-in to Papa. However, the pilot in command misidentified the double lines on the taxiway shoulder as being the taxiway centreline. Consequently, the aircraft was inadvertently steered onto the blast-protection surface adjacent to the taxiway shoulder, where it penetrated the blast-protection surface and became bogged. ■

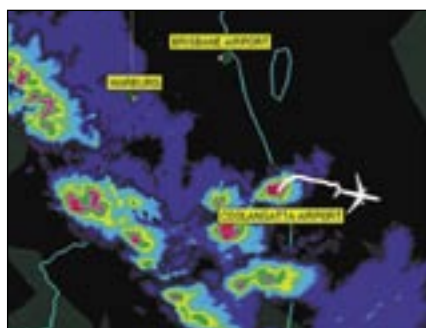
take-off, passing through an altitude of about 800 ft, the aircraft encountered heavy rain, hail and windshear, due to thunderstorm activity. During the windshear encounter, the aircraft descended about 130 ft and a ground proximity warning system Mode 3 aural alert 'DON'T SINK' sounded.

During the subsequent climb, the cabin crew reported to the flight crew that there was damage, in the form of dents, to the leading edges of the wings. The flight continued to Sydney where an uneventful landing was conducted.
