Australian Transport Safety Bureau

# The Australian Air

# Safety **briefs**

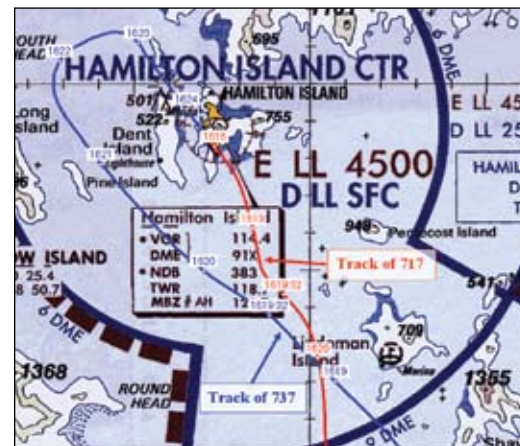
On 17 July 2004, at about 1619 EST, a Boeing Company 737-476 (737), registered VH-TJH, was inbound to Hamilton Island from the south-east for a landing on runway 14. The Hamilton Island Aerodrome Controller

The ADC instructed the crew of the 717 to maintain 3,000 ft, to make a right turn to track to Mackay and that they were clear for takeoff. After takeoff, at about 2,000 ft, the crew of the 717 received a TCAS traffic advisory and saw the 737 crossing from left to right on descent. The 717 crew's perception was that the expected track of the aircraft would place them on, or close to, a collision course so they turned left and descended to avoid the 737 by passing behind it.

Analysis of air traffic control recorder data and aircraft flight data revealed that at 1619:15 after the 717 had turned left, the lateral and vertical distance between the aircraft was 1,112 m and 700 ft (737 above the 717).

The occurrence highlighted the importance of using unambiguous radiotelephony phraseology to avoid misunderstandings and the need for pilots and controllers to remain vigilant at all times especially when the dynamics of a situation require action to be implemented early to ensure that aircraft safety is not compromised.

Airservices Australia advised several safety actions in place following the incident or planned for implementation. The Group Tower Manager responsible for Hamilton Island has reinforced the need, through the Tower Manager, to ensure that the automatic terminal information system strip matches the actual ATIS broadcast. Also a review of the visual separation requirements in the Manual of Air Traffic Services (MATS) was conducted to assure that all pertinent limitations were referenced and determined that no changes to MATS were required.

A further Airservices safety action will involve a performance check being completed every month for the first 3 months after an air traffic controller gets an initial rating, then at 6 months, and then the checking regime will be in accordance with the requirements in the Civil Air Traffic Services Operations Administration Manual. ■

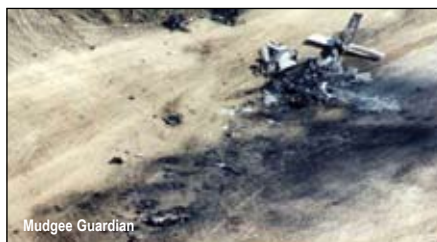
Occurrence 200304589

On 11 November 2003, at about 1240 EST, a student pilot undertaking multi-engine aircraft training was accompanied by an instructor pilot in a Piper PA-34-200 Seneca, VH-CTT. The flight was to include asymmetric flight training.

The flight departed and they were turning onto the final approach to runway 11 Right, for a fourth touch and go, when the aerodrome controller (ADC) saw that the aircraft's landing gear was not extended. Witnesses reported that when the aircraft was almost over the threshold to runway 11R it commenced to diverge right while maintaining a low height. They reported that when the aircraft was abeam the mid length of the runway, its nose lifted and the aircraft banked steeply to the right before impacting the ground in a near vertical nose-down attitude. A fire ignited after the impact. The instructor vacated the aircraft through the right door after the aircraft came to rest. The student was fatally injured. The instructor received severe burns and was treated in hospital for three and a half weeks before succumbing to those injuries.

The investigation found a number of engineering anomalies in the engines, but these were considered to not have affected the circumstances of the occurrence. The investigation found control of the aircraft was lost at a height from which recovery was not possible. The reason for the loss of control could not be determined. ■

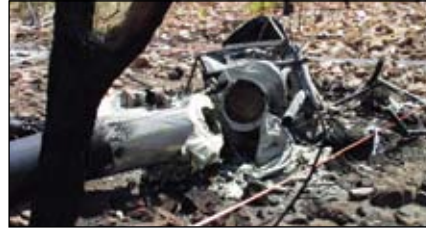
Occurrence 200304546

A Bell helicopter Company 206 (B206), registered VH-FHY, and a Robinson Helicopter Company R44, registered VH-YKL, were travelling in company returning to Kununurra WA from a fishing charter to the Cape Domett area of far north Western Australia.

during the journey, the pilot of the lead helicopter, the B206, received a broadcast from the pilot of the R44 stating that 'I'm going in hard'. The pilot of the B206 immediately turned his aircraft around in a tight right turn and after assuming a reciprocal heading, observed a mushroom cloud of smoke rising from a nearby ridge. The pilot of the B206 immediately broadcast a mayday to Brisbane Centre and began to orbit the site. Brisbane Centre asked the pilot of the B206 to look for people moving about around the wreckage; none could be seen.

The onsite investigation accounted for all major components of the helicopter at the crash site. The centre of gravity was found to be outside the forward limit, and the operating weight at the time of the occurrence was found to exceed the maximum allowable operating weight for that helicopter type.

The short radio transmission by the pilot of the R44 did not allude to a specific problem. In the absence of witness reports of the occurrence, and the lack of physical evidence due to post-impact fire, the reason(s) for the descent from cruise altitude, and the subsequent impact with terrain could not be established. ■
