Australian Transport Safety Bureau

Reflecting on the ATSB's aviation outputs in 2004-05

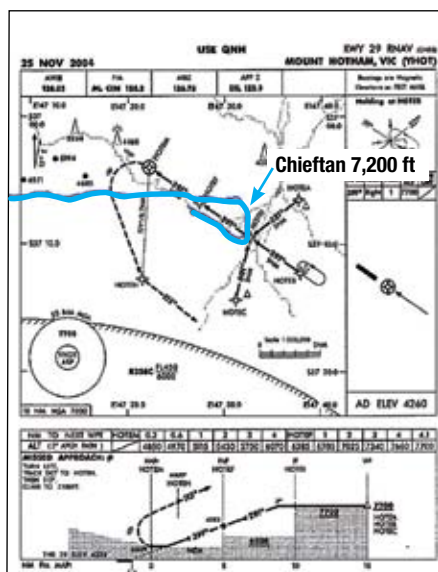
Due to hazardous weather conditions over the following two days, the search for the aircraft was primarily conducted on foot and on horseback. A helicopter engaged in the search for the aircraft located it at 1030 on 11 July. The Chieftain was found on a tree covered ridge, partially covered in snow, approximately 5 km south-east of the aerodrome at an elevation of 4,060 ft above mean sea level.

All occupants had been fatally injured and an intense post-impact fire destroyed most of the fuselage, including the instrument panel and avionics. Damage to the engines and propellers was consistent with both engines delivering power at the time of impact. The landing gear was extended, but its pre-impact position could not be confirmed. The wing flaps were fully retracted.

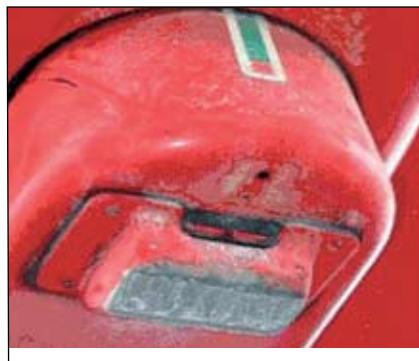
During the departure climb, the cabin crew alerted the flight crew to a possible tail strike during the takeoff. The pilot in command assumed control of the aircraft and elected to return to Perth. Engineering inspection confirmed that the aircraft had

sustained a tail strike during the takeoff.

The Perth automatic terminal information service advised the crew with of the existence of crosswind conditions on runway 03. The copilot initiated the rotation at V1 takeoff decision speed, which was 5 kts before the scheduled VR speed. There was a lack of change in airspeed at V1, which was indicative that the aircraft had encountered a wind gust, consistent with the crosswind conditions. The rotation was continued when the gust was encountered, and the aircraft was at a nose up pitch of 13.2 degrees at lift off. Despite the early rotation, it was conducted at a pitch rate of about 3 degrees per second.

The application of left control wheel during the takeoff was sufficient to deploy flight spoiler panels 3 and 4. That reduced the lift coefficient, and consequently, the tail clearance was reduced as the aircraft became airborne.
