Australian Transport Safety Bureau

# The Australian

## Final report on fatal helicopter accident near Camden

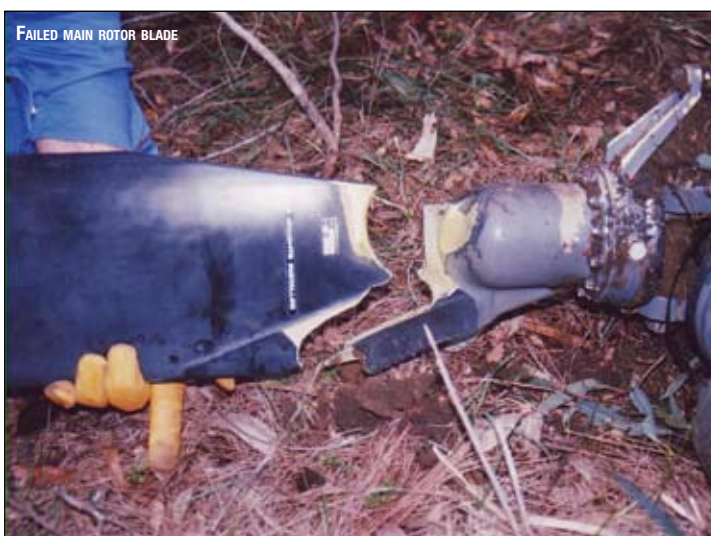
**O**n 20 June 2003, a Robinson R22 helicopter registration VH-OHA crashed near Camden NSW during a training flight from Bankstown airport. The instructor and student pilot onboard were both fatally injured. Examination of the accident site and helicopter wreckage confirmed that one main rotor blade had failed in-flight. Examination of the helicopter and its systems did not reveal any other abnormality that would have contributed to the loss of the main rotor blade.

An examination of the main rotor blade in the ATSB laboratories revealed that it had failed as a result of fatigue crack growth in the blade root fitting at rotor station 10.35. The fatigue crack initiated as a result of localised pitting corrosion in the counterbore of the inboard bolthole. The examination also revealed that while the fatigue failure was in a similar position to two previous main rotor blade failure accidents in Australia, in OHA's case, there was an area of adhesive disbonding between the main rotor blade skin and blade root fitting. The investigation found no evidence to support suggestions that the fatigue crack was the result of under-recording of time in service.

The material failure analysis found that the disbonding present on the failed main rotor blade was also present in a number of other main rotor blades that were examined. As a result, the ATSB issued

The manufacturer has issued a safety letter and a service bulletin relating to revised retirement lives for main rotor blades, and has introduced a redesigned main rotor blade into service. The manufacturer indicated that it intends to publish safety alerts and notices on

The R22 maintenance manual has also been amended by the manufacturer as a result of this investigation. The main rotor blade tracking and balancing section now contains information, which alerts maintenance personnel to the fact that a main rotor blade vibration may be the result of a developing crack.

Safety action taken by the CASA as a result of this accident was to amend an existing airworthiness directive to take into account the findings from the examination of the blade and to introduce additional amendments to the directive, when updated information became available from the manufacturer. They also introduced a discussion paper on the installation of mandatory time in service recorders for helicopters. As at October 2005, CASA was still evaluating the public comments on the discussion paper.

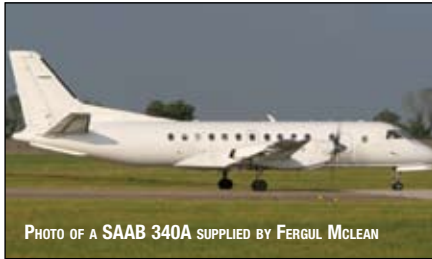
The PIC reported that the outside air temperature was minus 10 degrees while the indicated airspeed (IAS) was 145-150 knots. As the PIC increased the propeller RPM to aid with ice shedding, the IAS rapidly decreased to 137 knots. The PIC disconnected the autopilot and initiated a descent to 10,000 feet. During the autopilot disconnection, the stick shaker activated for about 1 to 2 seconds. Ice was still present on the aircraft radome after landing.

A manufacturer investigation reported that the wing partially stalled, probably due to a combination of significant ice accumulation on the airframe, and run-back ice accretion on the propeller blades.

The company decided that the current Crew Simulator programme, containing elements of unusual attitude recovery and flight in severe icing conditions, would be extended until the new flight proficiency simulator programme had been trialed and approved. During a visit, the manufacturer informed Australian operators about winter operations in icing conditions. ■

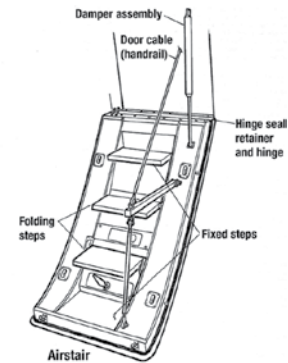
On 7 September 2004, at about 0710 Eastern Standard Time, while passing FL175, during a gradual descent from flight level (FL) 220, the pilot of the Raytheon B300 aircraft, registered VH-KJD, heard a loud muffled thud and then air noise. The pilot saw that the cabin door had separated from the aircraft fuselage.

The investigation found that the aft door latch hook sense switch terminal screw and the sense switch adjustment nut were located in very close proximity.

A circuit test of the three sense switches, located within the door (two switches for the two latch hooks and the other for the door handle position) determined that it was possible for the aft latch hook sense switch to produce an earth point through the sense switch earth loop wiring, resulting in the door handle position sense switch no longer providing an electrical signal for its position. Consequently, one of the systems to alert a pilot to a potential cabin door unsafe condition was not available.

The Australian Transport Safety Bureau recommends that the Civil Aviation Safety Authority advise operators of Beechcraft King Air and Raytheon King Air aircraft of the potential safety deficiency of the cabin door warning system becoming prematurely earthed, resulting in a sense switch or switches no longer providing an electrical signal for its or their position.
