Australian Transport Safety Bureau

Final report on fatal helicopter accident near Roma

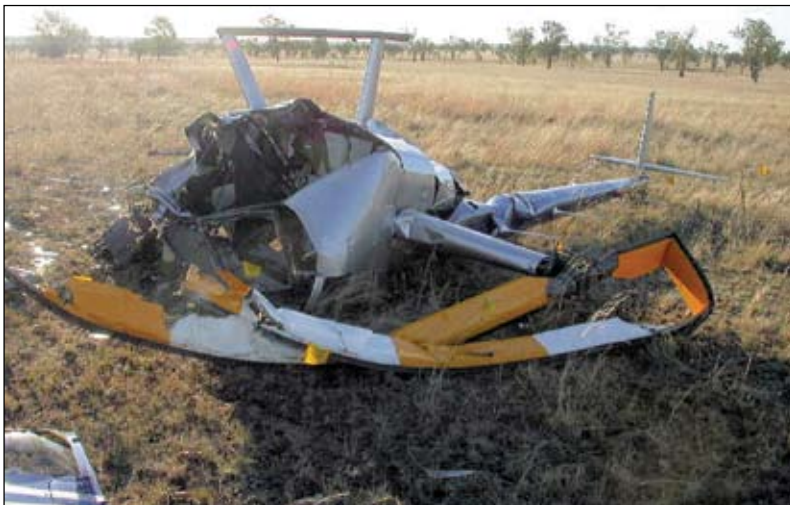
At 1725 EST on 8 September 2004, Robinson Helicopter Company R44 Raven II helicopter, registered VH-JWX, departed Eureka Station homestead, located approximately 54 km west of Roma, Qld, for a local flight. On board were the pilot and one passenger. The helicopter was seen operating about 7 kilometres north of the homestead before departing to the south at about 1830. Later, a person at Eureka homestead saw the lights of the helicopter apparently heading towards the homestead. When the helicopter did not arrive, search action was initiated. The wreckage was located the following morning 1.8 km west of the homestead. The helicopter had impacted the ground in a steep nose-down attitude. The impact was not survivable.

point source. There was a high probability of rain/showers in the area, and most likely greater than 5 oktas of cloud cover. These conditions meant that a natural horizon was probably not discernable and visual reference to surface features was unlikely. It is possible that rain and/or cloud thwarted the pilot's attempts to

fly towards the homestead and, in association with the dark conditions, ultimately contributed to him becoming disorientated and losing control of the helicopter.

The only abnormality found during the wreckage examination was that the clutch warning light globe filament was stretched. It is possible that clutch was activated during the impact sequence. It is also possible that activation occurred during normal flight in which case the warning

The helicopter manufacturer issued safety notices (SN) and included those in the aircraft flight manual. Two of the notices related to night flight—SN-18 Loss of Visibility Can Be Fatal, and SN-26 Night Flight Plus Bad Weather Can Be Deadly. The circumstances of the accident highlight the risk of spatial disorientation during night VFR operations and reinforce the significance of the cautions included in those safety notices. ■

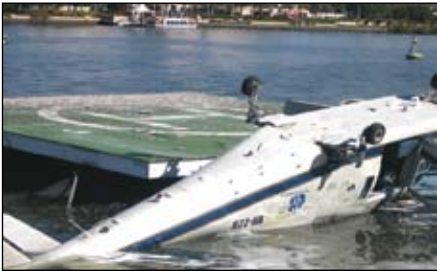
The pilot landed the helicopter on the Brisbane River Helipad to disembark a passenger. As the pilot prepared to lift off, the right main wheel penetrated the pontoon deck, causing the helicopter to capsize. The circumstances were consistent with dynamic rollover. The pilot did not lower the collective pitch control (the recommended response to dynamic rollover) when the helicopter began to roll.

mounted on a framework that formed a floating pontoon moored to the river bank. Prior to the flight the pilot had not checked the load bearing capability of the deck, but assumed that the helipad was capable of accepting the Agusta 109 helicopter. Examination revealed that the point load imposed by the main wheels of the helicopter was close to the tested strength of the plywood pontoon decking material. The additional dynamic load effects due to helicopter movement, and wind and water action, were likely to have increased the loads on the deck surface, causing failure of the plywood.

Documentation relating to the management and maintenance of the helipad revealed that the actual load bearing capability had never been established. Potential users of the helipad had been advised of a load limit of 2,000 kg, although the origin of that figure was unknown. The pilot claimed that he was not aware of that limit.

The engineering drawings for the deck called for plywood sheets that extended the full width of the deck. However, smaller sheets were used when the deck surface was last replaced. That had the effect of introducing weaker areas where sheet ends butted together but were unsupported. The deck failure occurred at one of the sheet ends. ■

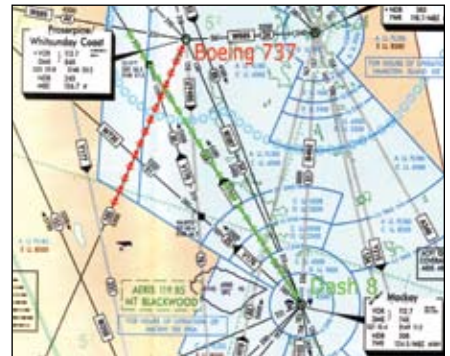
When the controller issued the crew of the 737 a clearance to enter control area (CTA) on climb to 5,000 ft the crew reported they were approaching 6,000 ft. The minimum vertical distance between the two aircraft reduced to 430 ft and there was an infringement of separation standards.

The radar that provided coverage in the area had been removed from service and a notice to airmen had been issued. The crew of the 737 had obtained pre-flight briefing material, however first became aware of the radar outage on the inbound descent to Proserpine. They believed that the base of CTA had changed to 9,000 ft and on departure set 8,000 ft as an initial level for climb outside CTA.

In issuing the crew of the 737 a clearance to climb to 5,000 ft, a level below the published lowest safe altitude of 5,500 ft on the departure track of the 737, the air traffic controller did not comply with the MATS and the potential existed for the 737 crew to not meet their responsibilities for minimum terrain clearance. ■
