Australian Transport Safety Bureau

The Australian

Aviation Safety Investigator

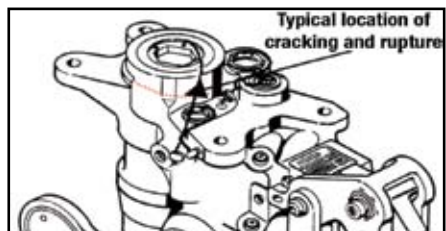
Loss of the hydraulic system was traced

to the ruptured left outboard roll spoiler actuator, which allowed uncontrolled release of hydraulic fluid and depletion of the system.

The ATSB's examination of the failed actuator and two other similarly unserviceable items from other Dash-8 aircraft found the actuator cylinders were susceptible to the initiation and growth of fatigue cracking. The cracking resulted in perforation and rupture of the cylinder base, with the consequent loss of the affected hydraulic system. Research found records of 15 other related failures in Dash-8 aircraft, all from actuators of the same design and with similar service lives.

Both the aircraft manufacturer and certifying authority reviewed the risks and probabilities of actuator failure. That review concluded that existing emergency procedures adequately addressed the loss of a hydraulic system stemming from actuator rupture and hence did not warrant any direct corrective or safety action. It was not evident however whether the review had considered the aircraft landing performance restrictions imposed by the loss of hydraulics, which could become problematic in areas where runway lengths are limited. From this perspective therefore, the ATSB issued a Safety Advisory Notice highlighting the risks associated with operating aircraft at risk of actuator failure into such areas. ■
