Australian Transport Safety Bureau

# Aviation Safety Investigator

### Interim Factual Report on fatal Cessna 310R crash near Tamworth

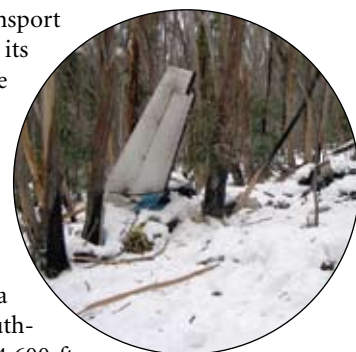
On 11 May 2006 the Australian Transport Safety Bureau (ATSB) released its Final Investigation Report on the fatal aviation accident near Mount Hotham airport on 8 July 2005 that claimed the lives of the pilot and two passengers on board. The accident involved a Piper Navajo Chieftain aircraft registered VH-OAO which was being operated on a charter flight. The Chieftain was found on a tree covered ridge, approximately 5km south-east of the aerodrome at an elevation of 4,600 ft above mean sea level. The aircraft had broken into several large sections and an intense fire had consumed most of the cabin.

The ATSB has reported that extreme weather and unsafe pilot attitudes and practices led to the 'controlled flight into terrain' accident at Mt Hotham in July 2005. The weather conditions included sleet and snow showers, and were conducive to visual illusions associated with a 'flat light' phenomenon. The aircraft was not equipped for flight in icing conditions. The ATSB in its final report was unable to determine why the pilot, after acknowledging that the weather was unsuitable, persisted with his attempt to land at Mt Hotham in accordance with neither the VFR nor proposed IFR procedures, but apparently seeking to follow the highway. However, it is possible that overconfidence as a result of previously avoiding accidents despite risk-taking, and commercial or family pressures, influenced the pilot's decision making.

As a result of this investigation, the ATSB has recommended that CASA publish educational material, to promote greater awareness of the flat light phenomenon for pilots operating in susceptible areas. The ATSB has also recommended that CASA review its surveillance methods, which may include cooperation with Airservices Australia, for the detection of patterns of unsafe practices and non-compliance with regulatory requirements. CASA has advised the ATSB that it is taking safety action including enhancing its operator risk assessment processes to enable it to more clearly identify and quantify operators presenting risks to aviation safety.

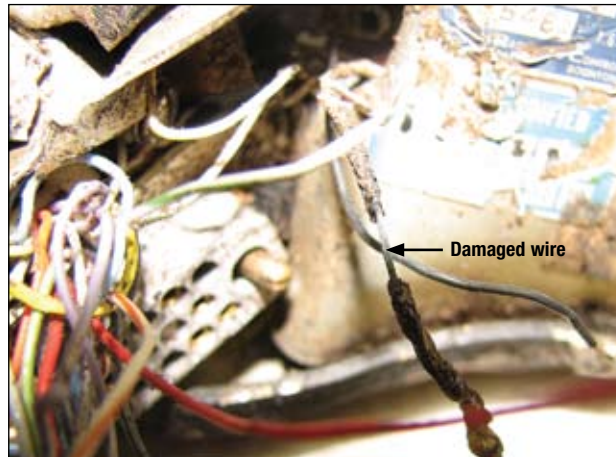
Figure 1: Damaged wire within the autopilot controller

The aircraft was equipped with a Cessna 400B Nav-O-Matic Autopilot System. The autopilot controller recovered from the site showed evidence of thermal damage to a wire within the controller, consistent with current overload (Figure 1). That damage was inconsistent with post-impact fire damage. The ATSB is awaiting data from the manufacturer and other specialist agencies regarding the effect of the damaged wire on autopilot operation.

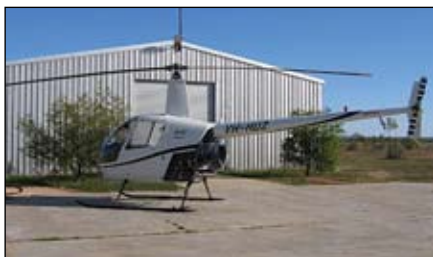
Witnesses at a number of properties along the route flown by the pilot reported that as the flight progressed, the pilot requested by radio for each of them to illuminate their external homestead lights. The owner of the property that included the accident site estimated that the helicopter was below 30 ft above ground level as it passed north of his property. Shortly after passing that property, the pilot commenced a climbing right U-turn before descending towards the ground at an estimated angle to the horizon of 20 to 30 degrees. The helicopter impacted the ground and was destroyed by impact forces and the post-impact fire. The pilot was fatally injured and the passenger suffered serious injuries.

The reported operating height of the helicopter minimised the time available for the pilot to recover from any disorientation in the dark night conditions before impacting the ground. In addition, it was likely that the climbing right U-turn eroded the already marginal outside references held by the pilot. The likely result was that the impact with the ground was almost inevitable. ■

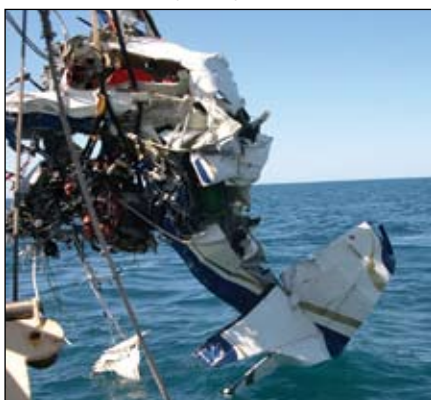
The wreckage was recovered 13 days after the accident. An examination revealed that at the time of impact; the engine was delivering high power, the instrument lights were receiving electrical power, and the gyroscopic instruments were receiving pneumatic power.

The circumstances of the accident are consistent with a loss of control due to the pilot becoming spatially disoriented after flying into an area of minimal surface and celestial illumination. Physiological and cognitive factors may have contributed to the development of the accident. However, the factors that contributed to the aircraft descending into the water could not be conclusively established.
