Australian Transport Safety Bureau

The Australian

Safety briefs

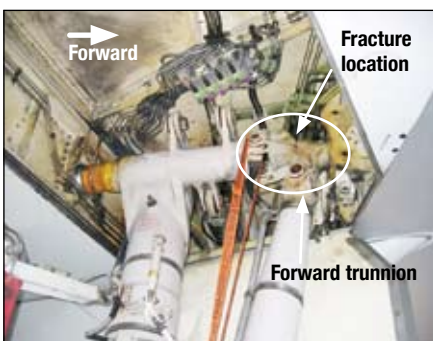
Fatigue cracking of trunnion fork

At about 1200 Eastern Standard Time on 30 May 2005, a Boeing Co 747-300, registered JA8184, was being pushed back from its gate at Sydney International Airport for a scheduled passenger flight to Osaka, Japan. During pushback, the ground staff heard a loud cracking noise. The pushback was stopped and an inspection by the ground crew identified a structural failure in the left wing landing gear forward trunnion fork.

Examination of the trunnion fork revealed that it had failed due to fatigue cracking that had originated on the inner surface of the trunnion fork bore. It was found that the wall thickness at the crack origin was below the minimum allowed by the design and that the inner surface of the bore did not meet the specifications of the design. These factors contributed to the formation and development of the fatigue crack, which lead to the final failure on pushback.

The trunnion fork had amassed a total of 25,095 landing cycles and had been overhauled by the operator on four occasions. During the overhaul the item was inspected for cracks and on each occasion the item was passed. The inspection procedure was general for the item and did not specifically indicate that the area where the cracking originated required particular attention. The surface finish of the inner surface of the bore may have masked indications of any cracks that may have been present.

As a result of this occurrence, the aircraft manufacturer and the aircraft operator have commenced actions to determine the extent of the problem in the remaining fleet and improvements in the inspection of items during maintenance. ■
