Aviation Short Investigations Bulletin

Issue 43

AB-2015-097

Final – 7 October 2015

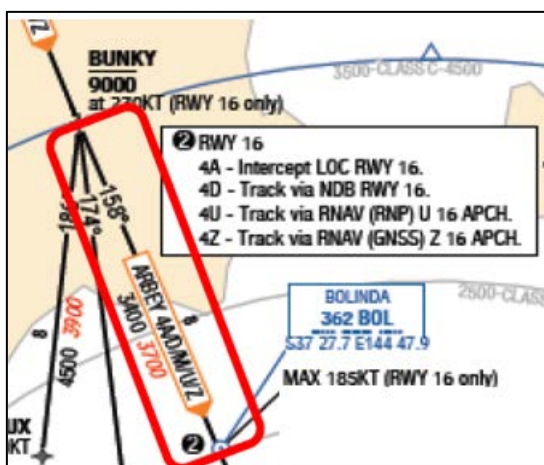
Figure 1: Excerpt from the ARBEY 4 STAR chart used by the operator depicting MEA (3400) and MTCA (3700)

Within the STAR, BOL had a coded speed restriction of a maximum 185 kt for approaches to runway 16, but did not specify a minimum crossing altitude. This allowed arrivals from other directions to cross BOL at a minimum altitude of 3,000 ft, instead of 4,000 ft as required via ARBEY. This conditional altitude restriction was specified in the approach charts only and not on the STAR chart. This procedure design did not protect the MEA of 3,400 ft on the arrival segment

CASA suggested a possible solution would be to include the altitude restriction in the STAR chart. This would then make the altitude obvious on the text and plan view, and the altitude restriction would be coded in the FMS. They also found that the overall complexity of the STAR chart did not aid pilots' awareness.

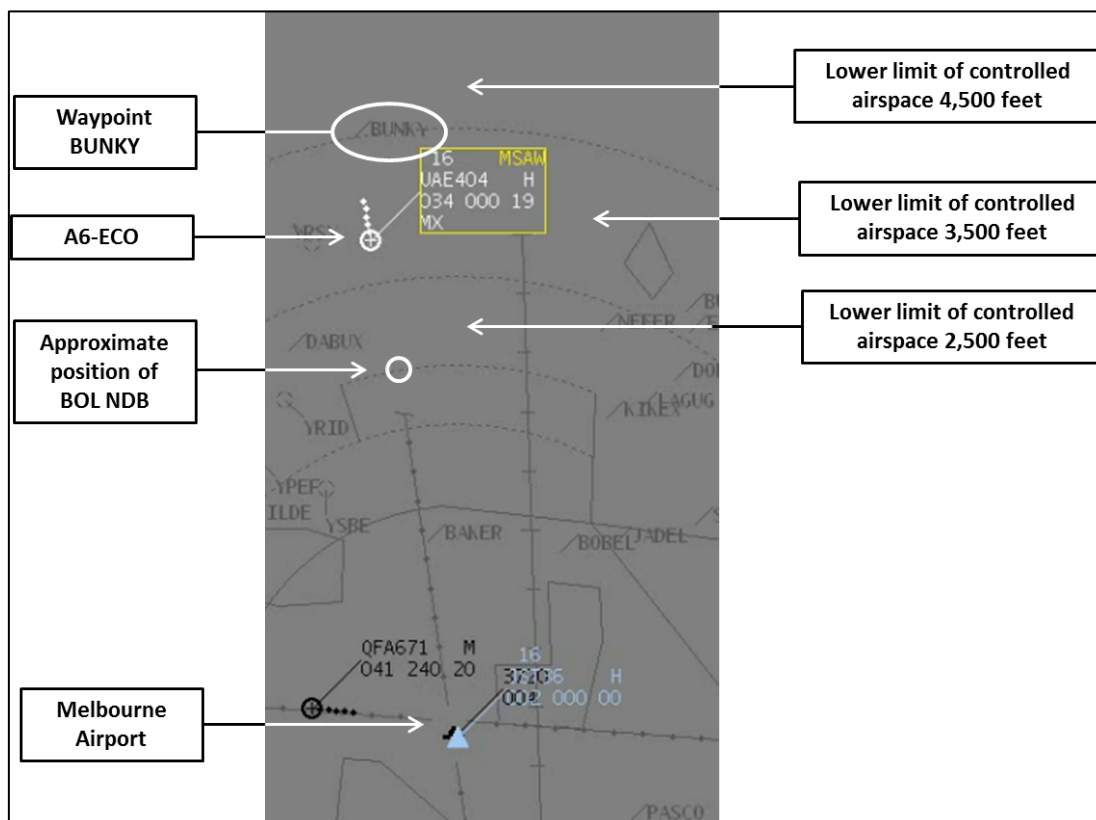
Figure 3: ATC radar image at the time the MSAW alert activated

The operator's investigation found that descent below the 4,000 ft altitude restriction at BOL occurred because the crew selected the 'hard altitude' of 3,000 ft for BOL. The potential for deviation below the 4,000 ft minimum altitude restriction at BOL was increased by factors related to aeronautical charts and the FMC navigation database. Some of these factors are discussed in the following paragraphs.

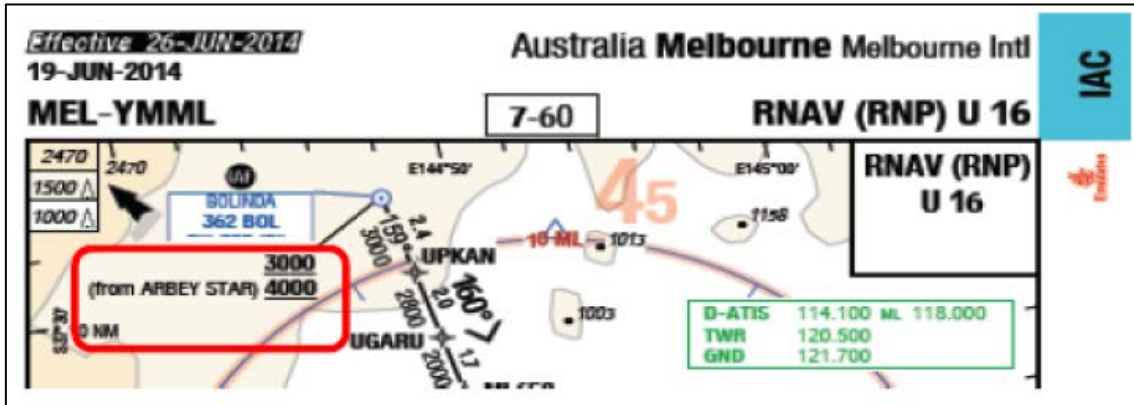
Figure 4a: RNAV (RNP) approach chart used by the crew

The following two figures show a comparison of two presentation options for multiple arrival altitudes. These altitudes are boxed in red.

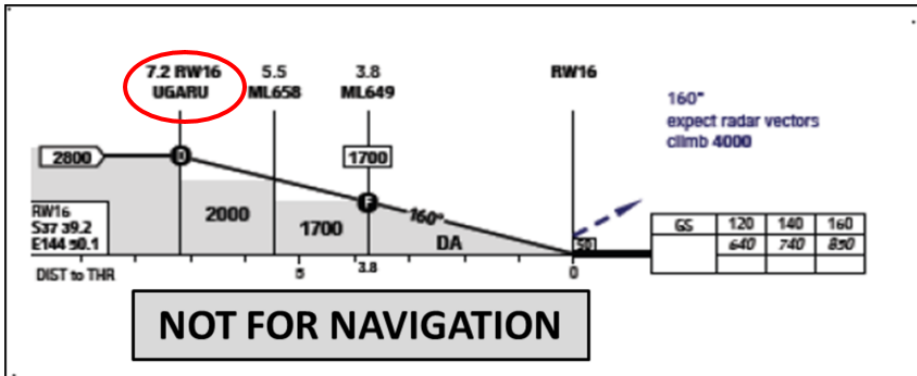
Figure 5a: Excerpt from the RNAV-U (RNP) runway 16 approach chart used by the operator showing vertical profile information

from the initial approach fix (IAF) BOL, to UGARU. Had this information been present in a vertical profile, it may have alerted the crew to the different altitude requirements at BOL, associated with the different STAR procedures.

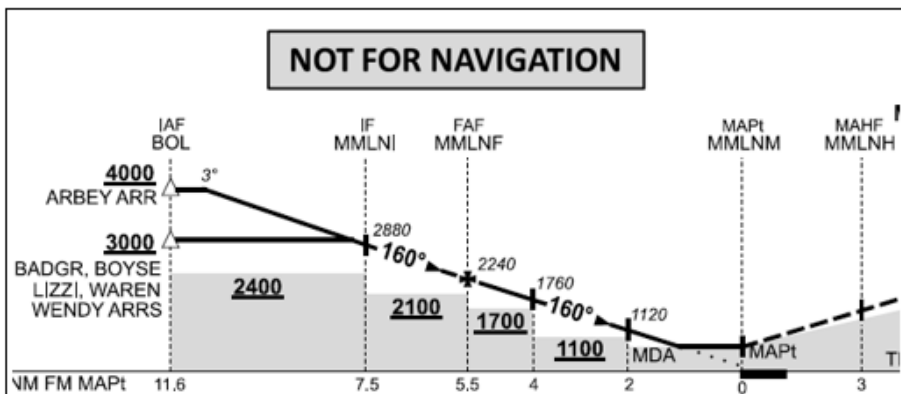
Figure 5b: Excerpt from the Airservices RNAV-Z (GNSS) runway 16 approach chart for comparison

The operator noted that the profile view of Naverus charts was inconsistent with similar Airservices Australia charts. For example, the RNAV-Z (GNSS) runway 16 approach chart, which was designed by Airservices Australia, provided the important hazard information of the different minimum crossing altitudes over BOL in the profile view (Figure 5b). However the RNAV-U (RNP) runway 16 approach chart, which was designed by Naverus, depicted these altitudes in the plan view only. The operator considered that extension of the profile view, as published on similar Airservices Australia charts, would assist flight crews to select the correct altitude for the IAF.

The operator suggested that the profile view of the Naverus charts should be amended to conform to that of the Airservices Australia charts.

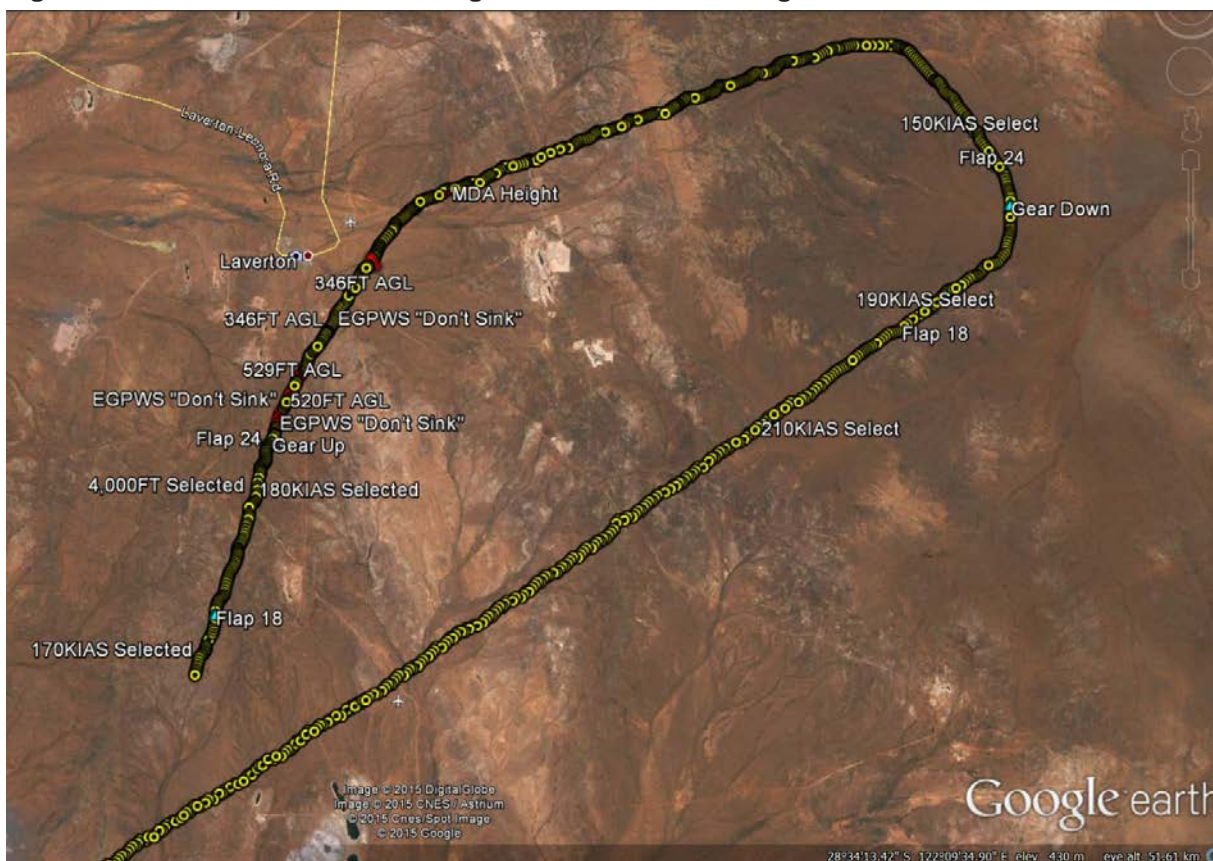
Figure 2: Plan view of the incident flight from the recorded flight data

The captain observed the radio altimeter (RADALT) indicating 500 ft and the electronic ground proximity warning system (EGPWS)⁴ called '500', both indicating the aircraft was 500 ft AGL. Shortly afterwards, the crew received an EGPWS 'DON'T SINK' warning. The first officer observed the RADALT indicating 380 ft and the vertical speed indicator showing about 100 ft per minute descent. The captain immediately applied nose-up pitch and increased the thrust, in accordance with the standard response. The aircraft climbed towards cloud and the captain levelled the aircraft off to remain clear of cloud. The crew then received a second 'DON'T SINK' warning (see 'Don't Sink' section below). The first officer noted the RADALT indicating 410 ft and the captain immediately initiated a go-around, climbing to 4,000 ft AMSL.

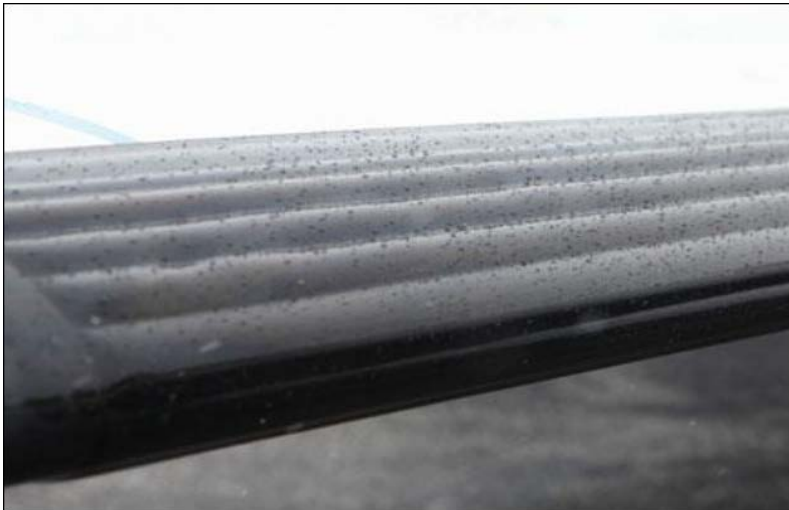
Figure 3: Inflated Raytheon B200 wing leading edge de-ice boot

Satisfied that the aircraft had reached a safe altitude, the pilot inspected the wings in an attempt to ascertain the reason for the poor take-off performance and stall warning. At that point, the pilot noticed that the right wing de-ice boots appeared to be inflated. Due to the position of the sun, the pilot was unable to immediately ascertain if the boots on the left wing were also inflated. Nonetheless, the pilot was confident that the inflated condition of the wing de-ice boot (or boots) explained the poor performance and stall warning. The pilot immediately cycled the wing and horizontal stabiliser de-ice system control switch in an attempt to deflate the boots, but cycling the switch appeared to have no effect.

Subsequent inspection by engineering staff found that the wing de-ice boots inflated again during an engine ground run, without having been selected. The boots returned to normal operation when the wing and horizontal stabiliser de-ice system control switch was cycled.⁶ Numerous subsequent system tests (in accordance with the relevant maintenance manual) found that the wing and horizontal stabiliser de-ice system functioned normally, and the aircraft was returned to service. The operator also advised CASA of the occurrence.

The pilot believed that the wing de-ice boots probably remained inflated following the wing and horizontal stabiliser de-ice system check, and that the inflated condition of the boots went unnoticed following the check. The pilot could recall completing the checklist procedures as normal, by monitoring the pneumatic pressure gauges and the status of the wing boots during the check, but not specifically confirming that the wing boots had deflated following the check. The pilot also noted that even though the checklist procedure did not specifically call for confirmation that the wing de-ice boots had deflated following the check, it was normal practise to check them.

Pilots operating Raytheon B200 or similar aircraft, fitted with pneumatic wing and horizontal stabiliser de-ice boots, are encouraged to take particular care when inspecting the boots during the system function check. Pilots are cautioned that the status of the boots may not be immediately obvious under some conditions, and that a concentrated inspection may be necessary. This may require the assistance of an external observer to assist with monitoring the status of the de-ice boots, particularly the boots fitted to the leading edge of the horizontal stabiliser which may not be visible from the cockpit.

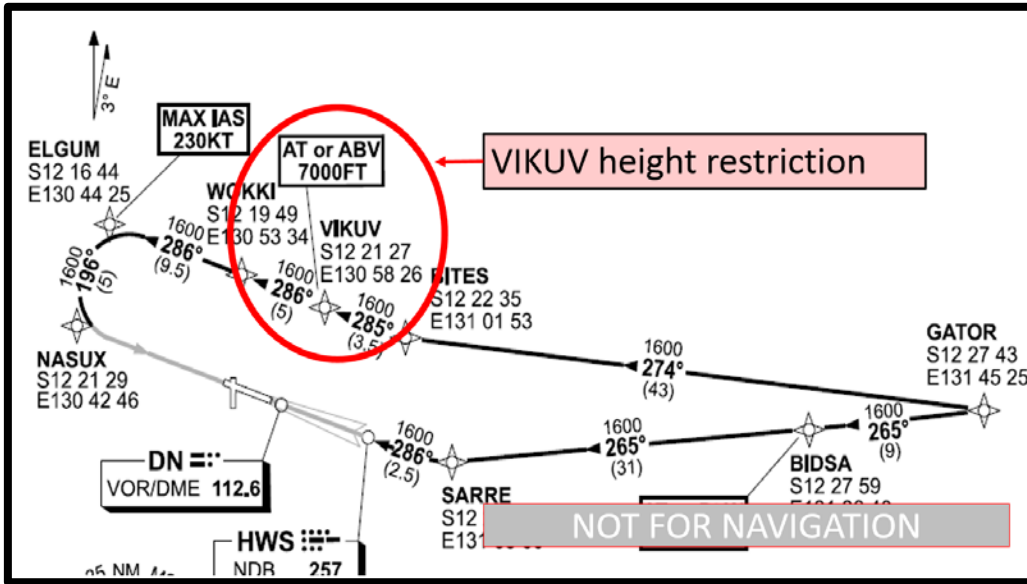
Figure 2: Extract of GATOR THREE A STAR

At 0901:00, the approach controller cleared ZCJ, which was then passing about 7,700 ft, to descend to 3,000 ft. In accordance with the STAR, that could only be complied with after passing waypoint VIKUV at or above the 7,000 ft height restriction published for that point on the STAR.

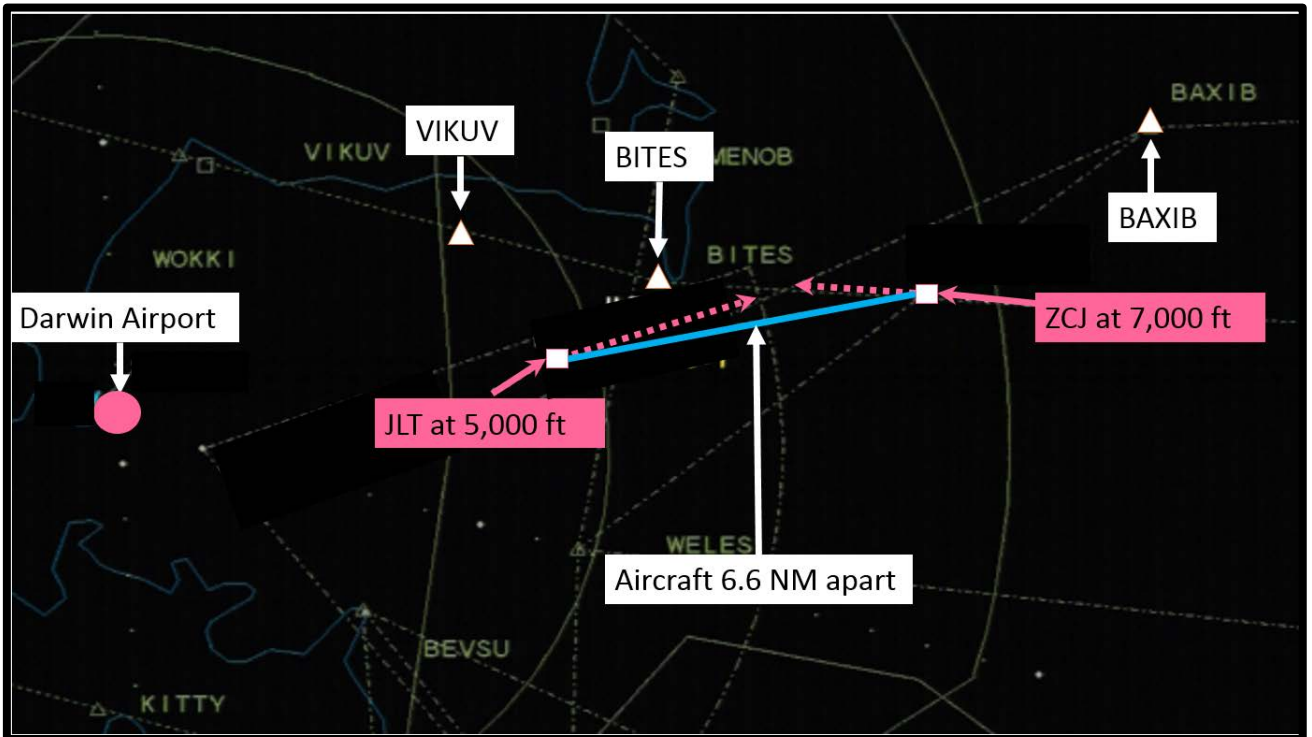
Figure 3: Situation display showing JLT at 5,000 ft and ZCJ at 7,000 ft

About 13 seconds later, the approach controller observed ZCJ approaching 7,000 ft. The controller asked the pilot of ZCJ to confirm they were aware that the level restriction at VIKUV still applied, and to expect track shortening after VIKUV. The pilot responded ‘roger’. The radar display indicated the aircraft then descended below 7,000 ft to 6,800 ft, which was still within the specified tolerances (+/- 200 ft) of the level restriction. At 0901:41, the radar display showed the ZCJ at 6,700 ft, and the controller asked the pilot to confirm they were maintaining 7,000 ft, and the pilot responded ‘affirm’.³ JLT was then about 11 NM away, and there was still about 3,100 ft vertical separation between the aircraft at that time.

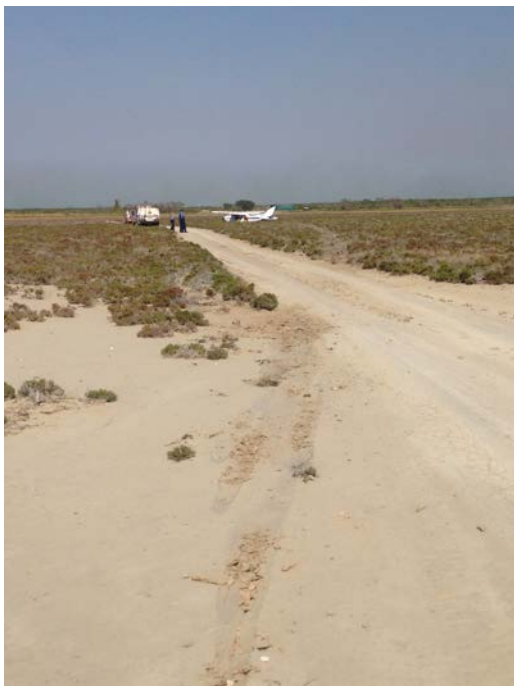
Figure 2: Initial contact point

The pilot was not injured; however, the aircraft propeller and engine sustained substantial damage.

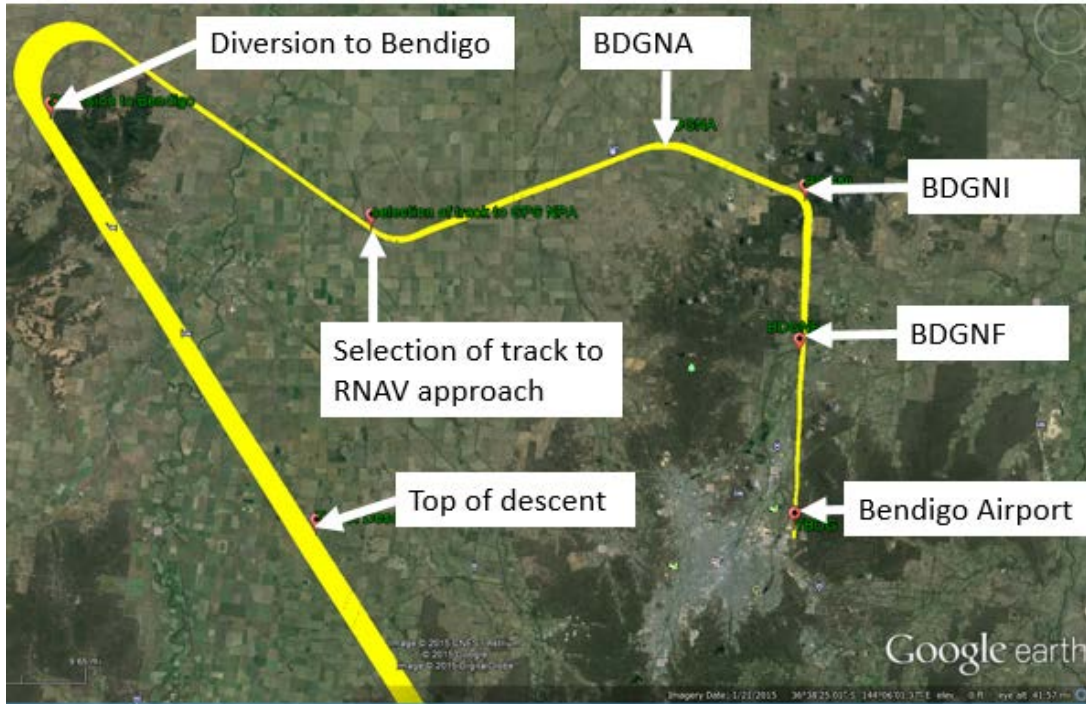
Figure 2: Aircraft track showing diversion to Bendigo and RNAV approach

When on final approach to runway 17, about 0.6 NM from the runway threshold, the pilot suddenly sighted a row of trees. The pilot immediately conducted a climb to avoid them, and estimated that the aircraft cleared the trees by a few feet. The pilot then landed the aircraft on the runway threshold. The pilot and passenger were uninjured and the aircraft was not damaged.

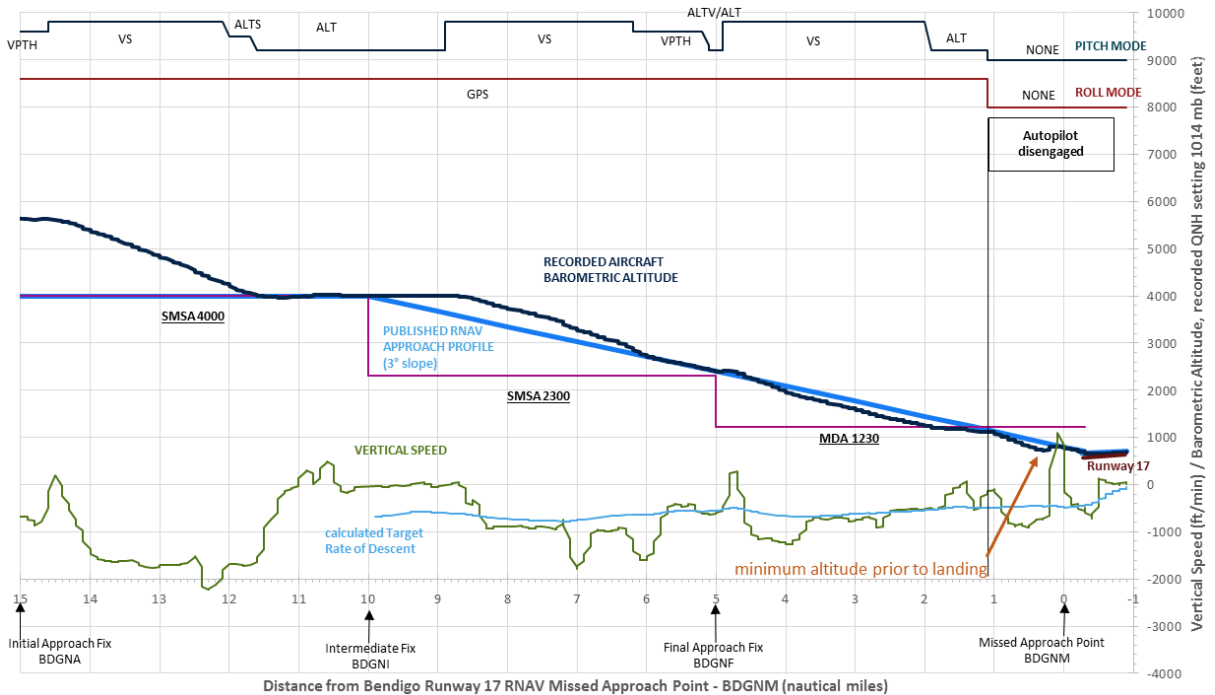
Figure 3: Comparison of recorded aircraft altitude and published approach procedure vertical profile

The autopilot was disengaged at 9:14:59, about 1.1 NM from the missed approach waypoint, 'BDGNM'. Following the autopilot disengaging, the rate of descent increased and the aircraft reached a barometric altitude of about 715 ft at 9:15:33, about 0.3 NM from 'BDGNM'. The aircraft then proceeded to pitch up, to about 15°, and climbed to about 810 ft. The aircraft regained the published approach path angle and continued the approach to land at Bendigo Airport. The estimated touchdown was about 9:15:57, on the runway threshold – about 0.3 NM beyond the missed approach point), and the barometric altitude recorded was about 670 ft.

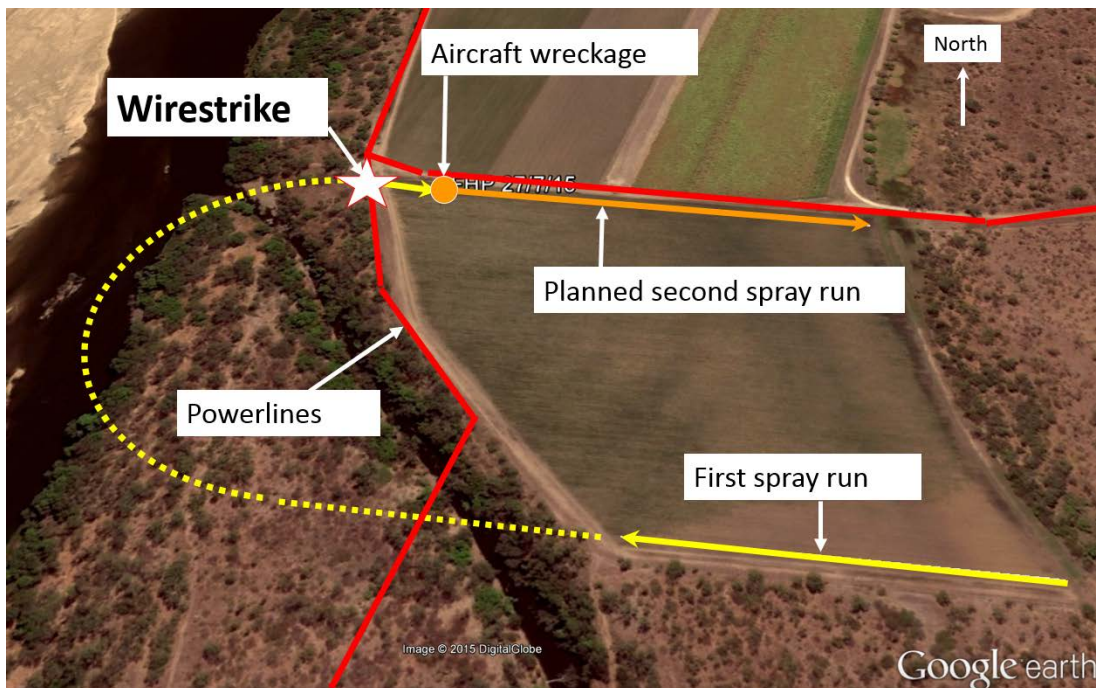
Figure 1: Paddock to be sprayed showing powerlines and wirestrike location

The pilot completed the first spray run towards the western powerline, overflowed it, and then turned to line up for the second spray run (Figure 1). A small area of about 30 m of trees had been cleared for a pump installation and the clearing was in line with the start of the second spray run. The pilot noted the powerline ahead, but then diverted their attention to the other powerline, running parallel to the direction of flight, and about 5 m off the left wingtip. The pilot also looked inside at the GPS to check the aircraft's line for the spray run.

The pilot commenced the descent into the paddock through the clearing in the trees and did not see the powerline at that time. As the aircraft descended, the pilot looked up and suddenly sighted the powerline. The pilot elected to push forwards on the controls to make the aircraft descend. The aircraft then struck the powerline above the propeller on the wing struts.

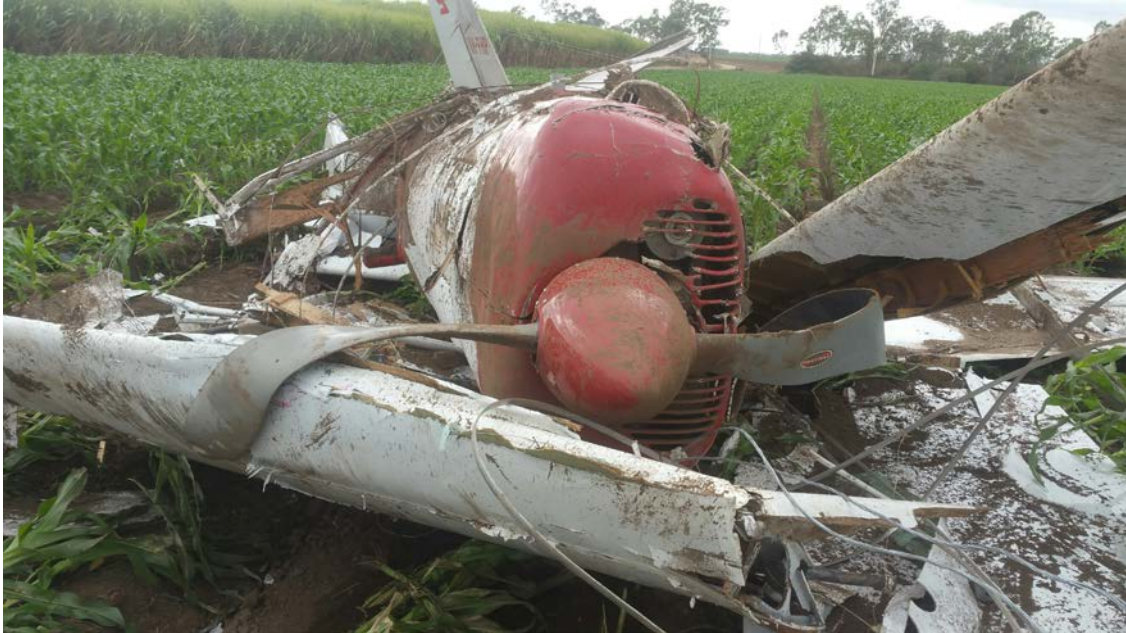
Figure 2: Photo of VH-FHP at the accident site showing damage to the aircraft and wires

The aircraft decelerated rapidly and the wires pulled the aircraft towards the ground. The pilot landed the aircraft with the wings level. The landing gear sheared off, the propeller struck the ground and the aircraft ground-looped, coming to rest facing the opposite direction. The pilot sustained minor injuries and the aircraft was destroyed (Figure 2).
