Australian Transport Safety Bureau

The Australian

Loss of control 7km WSW of Tamworth Airport

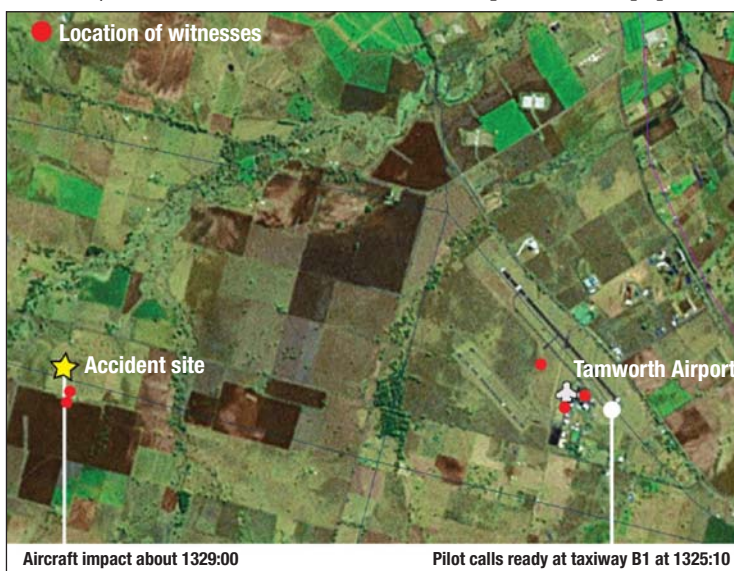
At about 1326 on 7 March 2005, the pilot of a Cessna Aircraft Company 310R, registered VH-FIN, took off from runway 30 Right (30R) at Tamworth Airport, for Scone, NSW. Approximately 1 minute after becoming airborne, the pilot reported flight control difficulties. At about 1329, the aircraft impacted the ground in a cleared paddock about 7 km west-south-west of the airport, in a nearly wings-level attitude at high speed and at a nose-down angle of between 35 and 40 degrees. The pilot was fatally injured and the aircraft was destroyed by the impact forces and post-impact fire.

Examination of the aircraft's mechanical flight control systems, autopilot and electric trim system did not reveal any evidence of pre-impact malfunction. Those results, however, were inconclusive due to the extensive impact and fire damage. Metallurgical analysis of a bent hand tool found in the wreckage indicated that it was not implicated in the development of the accident. A periodic maintenance inspection carried out in the days before the flight resulted in the rudder trim tab being set at the full right position and possibly aileron and elevator trim tabs being set at non-neutral positions prior to the flight.

The investigation found that the pilot probably overlooked the rudder and aileron trim tab settings during the pre-takeoff phase of the flight due to significant time pressure and the relatively obscure location of the rudder and aileron trim tab indicators. Before taxi, the rudder

trim tab was in the full right position (nose left tendency) and the aileron trim tab was probably at, or close to the 12 degrees down position (left roll tendency). The pilot experienced flight control difficulties shortly after takeoff from runway 30R at Tamworth Airport and was not able to identify the source of the problem. He subsequently lost control of the aircraft at a position corresponding to an early left downwind for runway 30R, probably as a result of heavy control loads produced by a combination of abnormal trim tab position

Following the accident, the aircraft operator advised that it had incorporated the emergency procedures relating to autopilot and electric trim from their flight manual supplements into their aircraft-specific operating procedures. The maintenance provider advised that they had reviewed and amended some procedures. The Civil Aviation Safety Authority advised that

a Civil Aviation Advisory Publication titled Multi-engine Aeroplane Operations and Training will be issued by July 2007. In addition, issues relating to tool and equipment control, aircraft configuration after maintenance and operator's aircraft operating procedures and checklists have been forwarded to the Safety Promotion Branch for consideration/action. ■

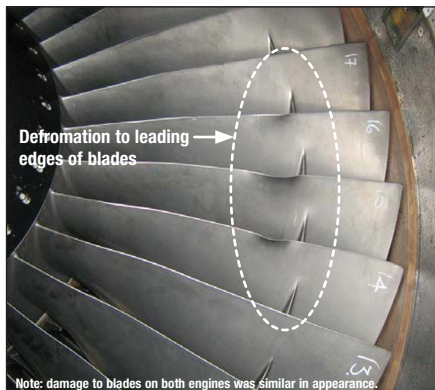
During rotation of the aircraft, the crew noticed a large flock of birds (estimated between 20 and 50 birds) converging with the aircraft's flight path. With no evasive manoeuvre available to the crew at this stage of flight, the aircraft encountered the flock and sustained multiple strikes on many parts of the aircraft. Immediately following the strikes, the crew checked the engine instruments and noticed that the left engine vibration indicator had risen to about 4.5 units. The crew reduced power on the left engine and that reduced the vibration levels. The crew reported that, based on the stable EGT and the vibration level on the left engine being below the limit provided by maintenance watch, they elected to continue the flight to Sydney rather than return to Melbourne.

The investigation found that the decision to continue the flight did not fully take into account the potential effect of the birdstrike on the durability of the left engine, nor did it account for the performance of the aircraft if the right engine ceased operating during the flight.

Following the occurrence, the operator implemented a policy for their twin engine fleet that if a birdstrike to an engine is known to have occurred and there is obvious sign of engine damage, then a landing at the nearest suitable airport should be made. ■
