Australian Transport Safety Bureau

Is an uninterrupted continued flight?

Safety briefs

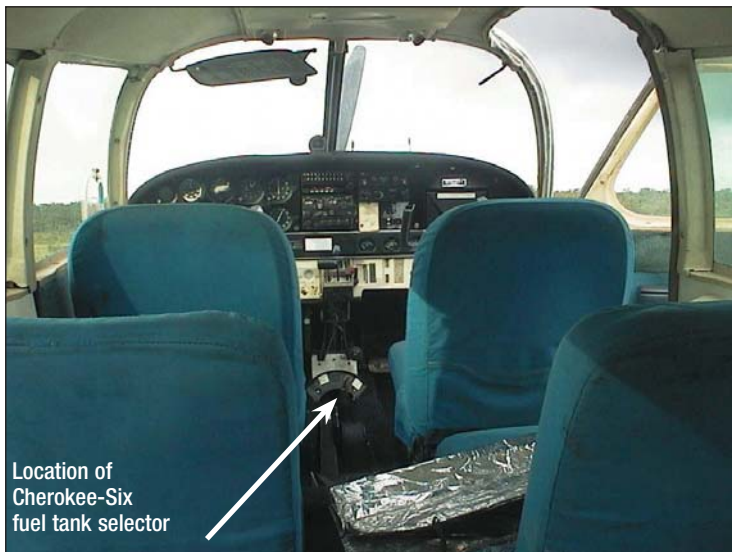
Position of the Cherokee Six fuel selector

The position of the fuel selector control on the cockpit floor of the Cherokee Six family of aircraft, increased the risk of a pilot or front seat passenger inadvertently knocking the control from its intended selection when entering or exiting the cockpit area. As highlighted in the Cherokee

Six Service Manual, there is the risk that, should the fuel selector not be in a positive selector detent position, there could be more than one fuel supply port open at the same time. In order to mitigate that risk, the Take-off Checks in the Cherokee Six require a pilot to confirm the selection of the correct fuel tank by the position of the fuel selector control and by detent 'feel'.

If a pilot does not confirm the position of the fuel selector by 'feel', there is the risk that an inadvertent or intermediate fuel tank selection might remain unnoticed, and of the attempt to use fuel from an empty or almost empty tank. Depending on the amount of fuel remaining in an aircraft's tanks, an indeterminate fuel-air mixture would result sometime after the unnoticed selection was made. Any such interruption to the delivery of fuel to an aircraft's engine would result in temporary power loss. That was consistent with the witness reports of abnormal engine performance shortly after takeoff in the accident at Hamilton Island.

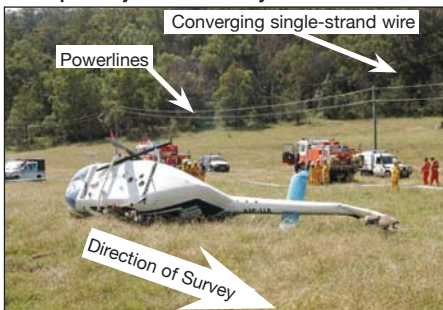
On 4 April 2006 a Bell Helicopter Company 206B III helicopter was being operated on a survey of powerlines in the St Albans area of New South Wales with a pilot, two power supply company personnel and a photographer on board. At about 1000 EST, the pilot observed a previously unseen single-strand telecommunication cable support wire rubbing against the copilot's door, and attempted to manoeuvre the helicopter clear of the wire. The helicopter lost directional control and commenced spinning to the right. The pilot cleared the wires and attempted a landing in an adjacent paddock. The helicopter came to rest on its right side and was severely damaged. One of the power supply company personnel received serious head injuries and the remaining occupants received minor injuries.

Helicopter adjacent to survey wires

Safety action undertaken as a result of this accident included:

- the power supply company acted to:
 - immediately suspend helicopter inspections
 - appoint an internal accident investigation team that would make recommendations for the recommencement of helicopter operations
 - engage an aviation risk management consultant to assess the hazards affecting the company's aerial surveillance operations and to assist the internal investigation team
 - implement a number of safety actions that were recommended by the internal investigation team.
- the telephone company removed the single-strand telecommunication cable support wire that was struck by the helicopter.
- The Civil Aviation Safety Authority in conjunction with the Aerial Agricultural Association of Australia, published a wirestrike article in the November–December 2006 issue of its *Flight Safety Australia* Magazine. ■

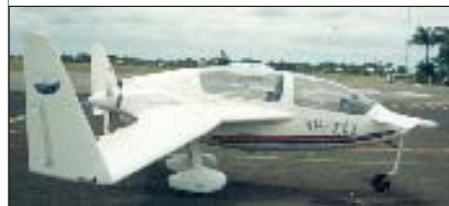
Gyroflug Speed Canard VH-ZXZ

At 0944 Eastern Standard Time on 19 October 2004, the Gyroflug Speed Canard aircraft departed Bundaberg, Qld, on a private flight to Parafield, SA, with a planned refuelling stop at Bourke, NSW. At about 1145, the pilot, who owned the aircraft and was the only occupant, radioed another pilot who was operating in the St George, Qld, area and advised that he was feeling dizzy, faint and disoriented, and was having difficulty lining up the aircraft to land on the St George runway. The aircraft remained airborne in the vicinity of St George for approximately 90 minutes. At about 1335, the aircraft impacted terrain 20 km south-west of St George and the pilot sustained fatal injuries.

There was no evidence that the aircraft was not capable of normal operation at the time of the accident. During a routine aviation medical examination in 2003, the pilot was diagnosed with diabetes. The pilot apparently became incapacitated during flight and was unable to manoeuvre the aircraft to a successful landing.

It could not be established why the pilot became incapacitated, however a diabetes-related condition could not be ruled out.

As a result of this investigation, the Australian Transport Safety Bureau and the Civil Aviation Safety Authority undertook a number of relevant safety actions. In 2005, the Australian Transport Safety Bureau released Aviation Research Report B2005/0027, titled *Diabetes mellitus and its effects on pilot performance and flight safety: A review*. The Civil Aviation Safety Authority completed a literature review of diabetes mellitus and aeromedical certification. This review compared the requirements of various regulatory authorities regarding aeromedical certification of pilots with diabetes. It also considered the medical reporting requirements for Designated Aviation Medical Examiners (DAMES). ■
