Australian Transport Safety Bureau

What's next for aviation safety research?

Final ATSB investigation report on Boeing 737-476 in-flight engine malfunction

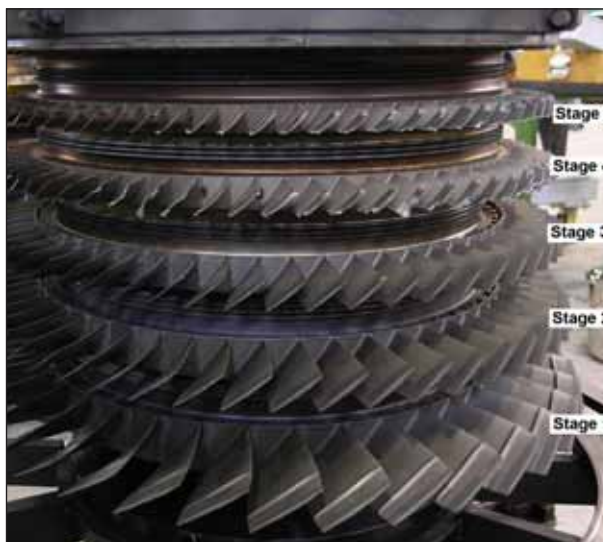
subsequently removed and disassembled at the operator's maintenance facility. The teardown revealed that a single dowel pin had come loose from its installed position within stage-three of the HPC and was ingested by the downstream rotating hardware, resulting in damage to the HPC rotor and stator components.

Further examination of the HPC stator components revealed that the dowel pin had come loose due to excessive clearance

and recession of the stage-three stator shroud anti-rotation pins.

- added an inspection requirement to the current CFM56-3 engine shop manual to verify the stator shroud anti-rotation pin height during piece part inspection

- modified the engine shop manual to include a stator shroud anti-rotation pin height check whenever a new pin was reinstalled into a stator shroud that was being returned to service from overhaul

- redesigned the anti-rotation pin and field released the new part into the CFM56-3 fleet in July 2007
- released a service bulletin (CFM56-3 S/B 72-1091) in December 2007 to all operators and maintenance personnel of CFM56-3 engines to alert that the stator shroud anti-rotation pin design had changed, and recommended that the old design pins be replaced with the redesigned part into existing engines. ■

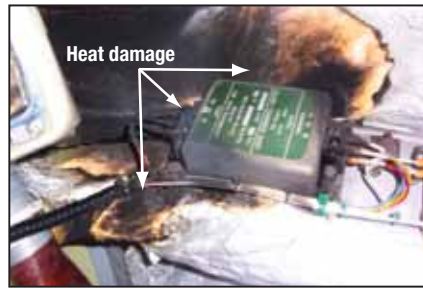
The flight crew recalled noticing a smell on the flight deck as the aircraft climbed through about FL130, but commented that it was different from the oil-like smell historically associated with the operation of the BAe 146, and to the normal smells associated with the operation of the aircraft's galley. The pilot in command recalled that, shortly after, there were a number of 'popping noises' accompanied by a series of bright yellow flashes and some glowing behind the escape rope panel on the copilot's side of the flight deck.

The investigation determined that the aircraft's 'A' windscreen electrostatic filter had failed. That failure was consistent with an electrical arcing event.

In response to this and a number of other similar failures in the UK and in Europe, the aircraft manufacturer undertook a number of safety actions, including issuing a Service Information Letter advising operators to check the correct positioning of the insulation blankets in the vicinity of their aircraft electrostatic filters at the next available opportunity. The Australian Transport Safety Bureau has issued two safety recommendations that seek to reduce the likelihood of electrical arcing events in 'A' windscreen filters in BAe 146 aircraft. ■

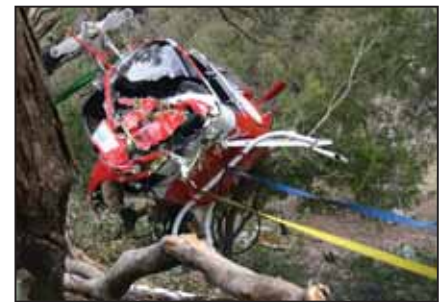
The helicopter descended into trees on the side of a steep hill and the rotors severed several large branches, before the helicopter came to rest supported by trees. The occupants reported that the engine was still running after the helicopter came to rest, however, only at about idle power. The pilot then shut the engine down via the throttle and both occupants exited the helicopter. The pilot received facial and eye injuries during the impact while the shooter had minor injuries.

While only 23 L of fuel was physically recovered from the helicopter's fuel tank, the assessment of the fuel remaining by the investigation determined there would have been sufficient fuel in the helicopter for continued flight at the time of the accident. Examination and testing of the engine and components, and the fuel system was unable to determine what led to the sudden loss of power.
